**Belews Creek Innovative
Streambank Stabilization
Seminar and Hands-On
Construction Workshop
April 10 – 12, 2012
(A Dave Derrick USACE Project)**

**Bank stabilization project funded
through an EPA 319 Implementation
grant obtained by Belews Creek
Watershed Partnership-
a citizen based non-profit organization**

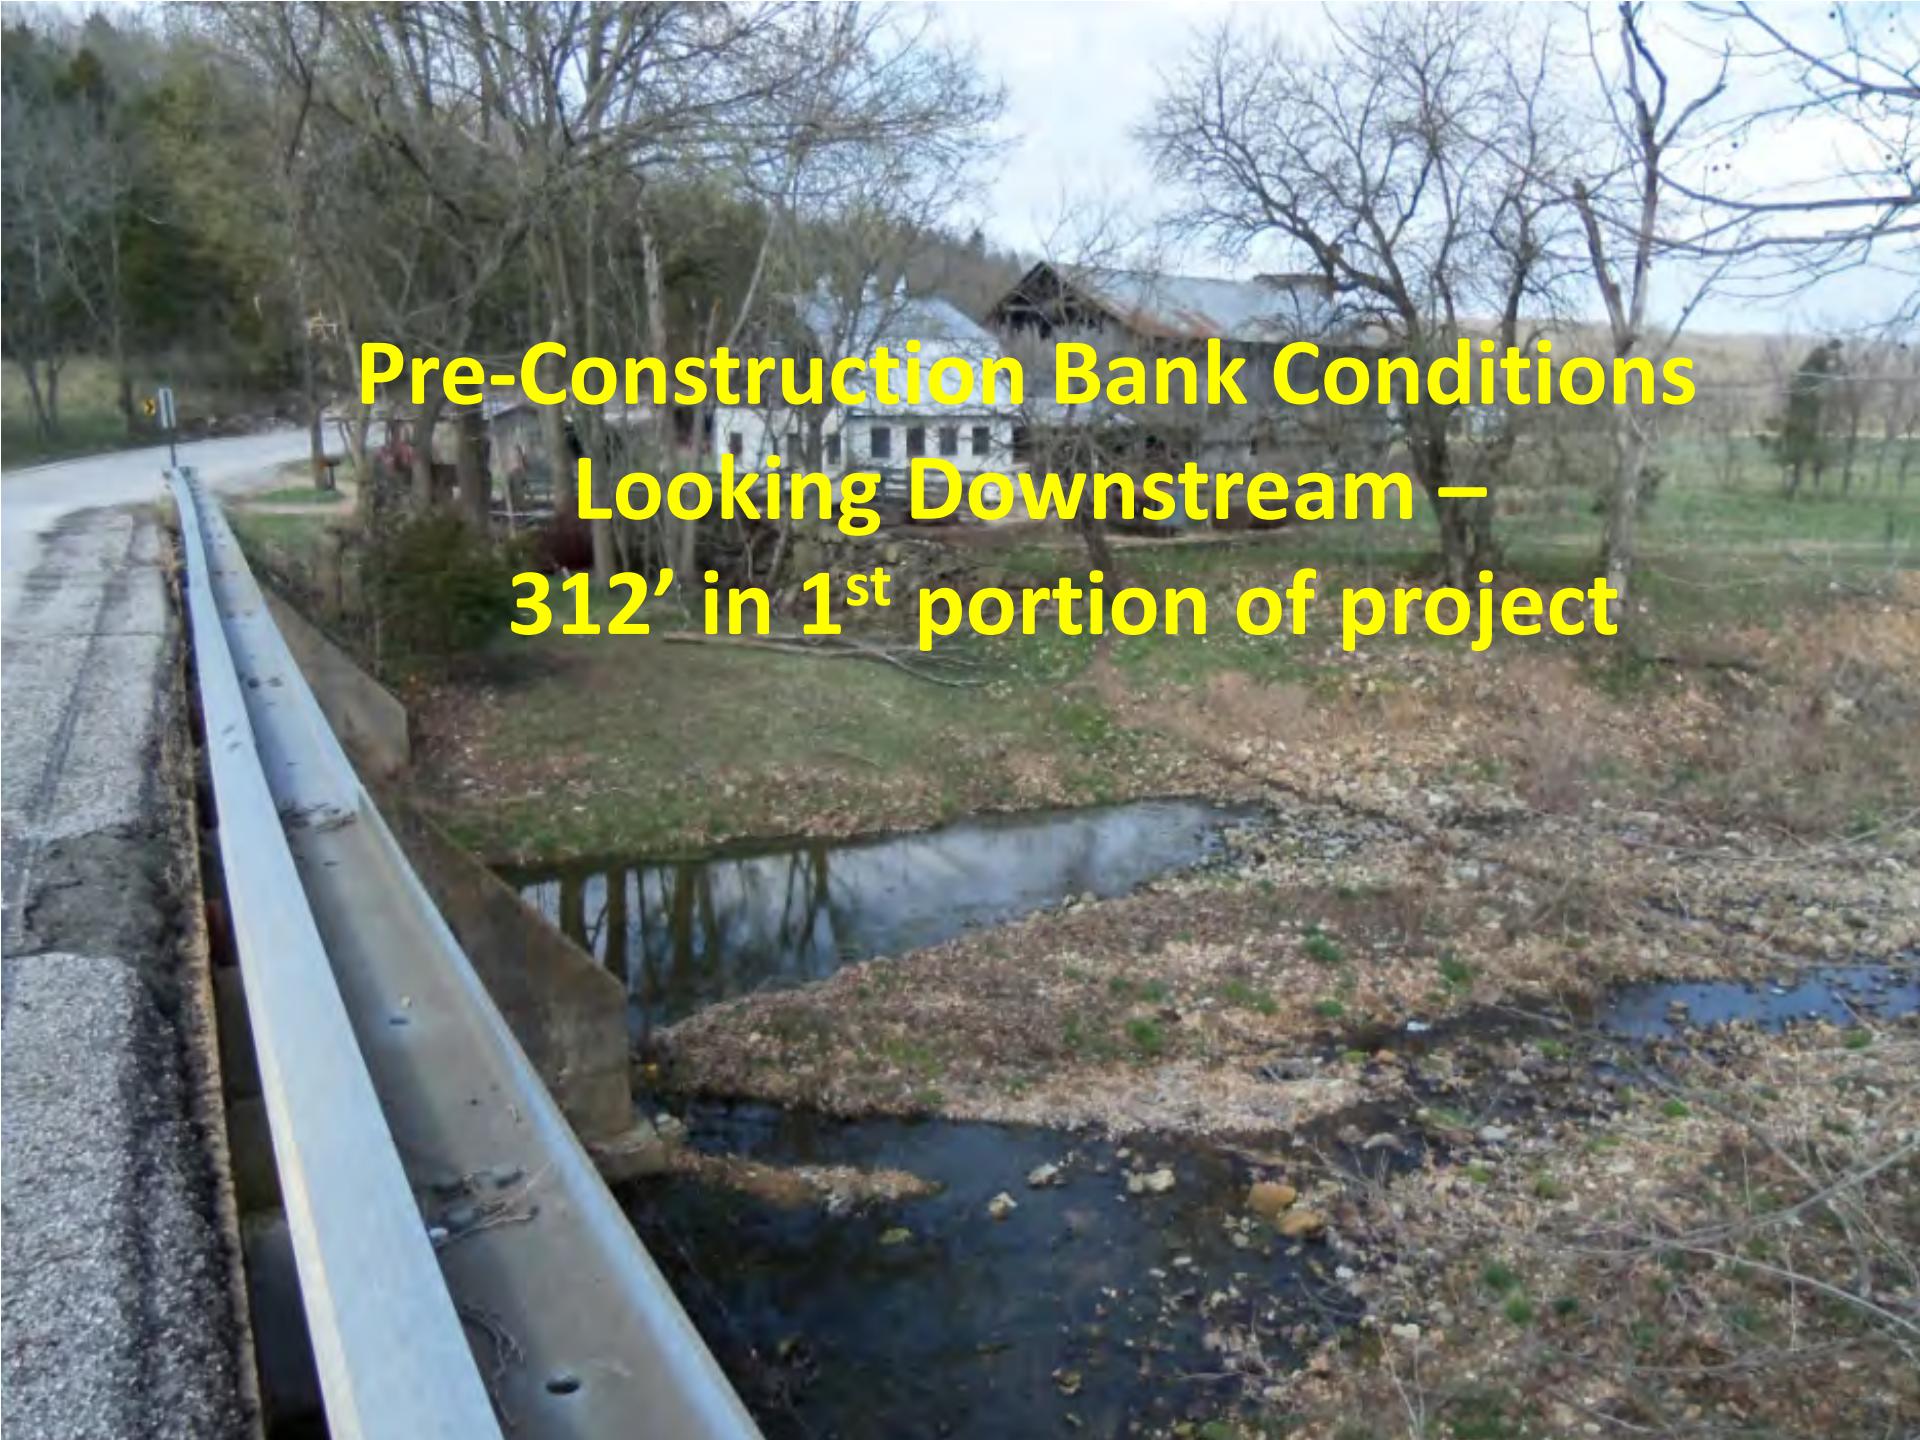
**Pre-Construction Bank Conditions
Looking Downstream –
312' in 1st portion of project**

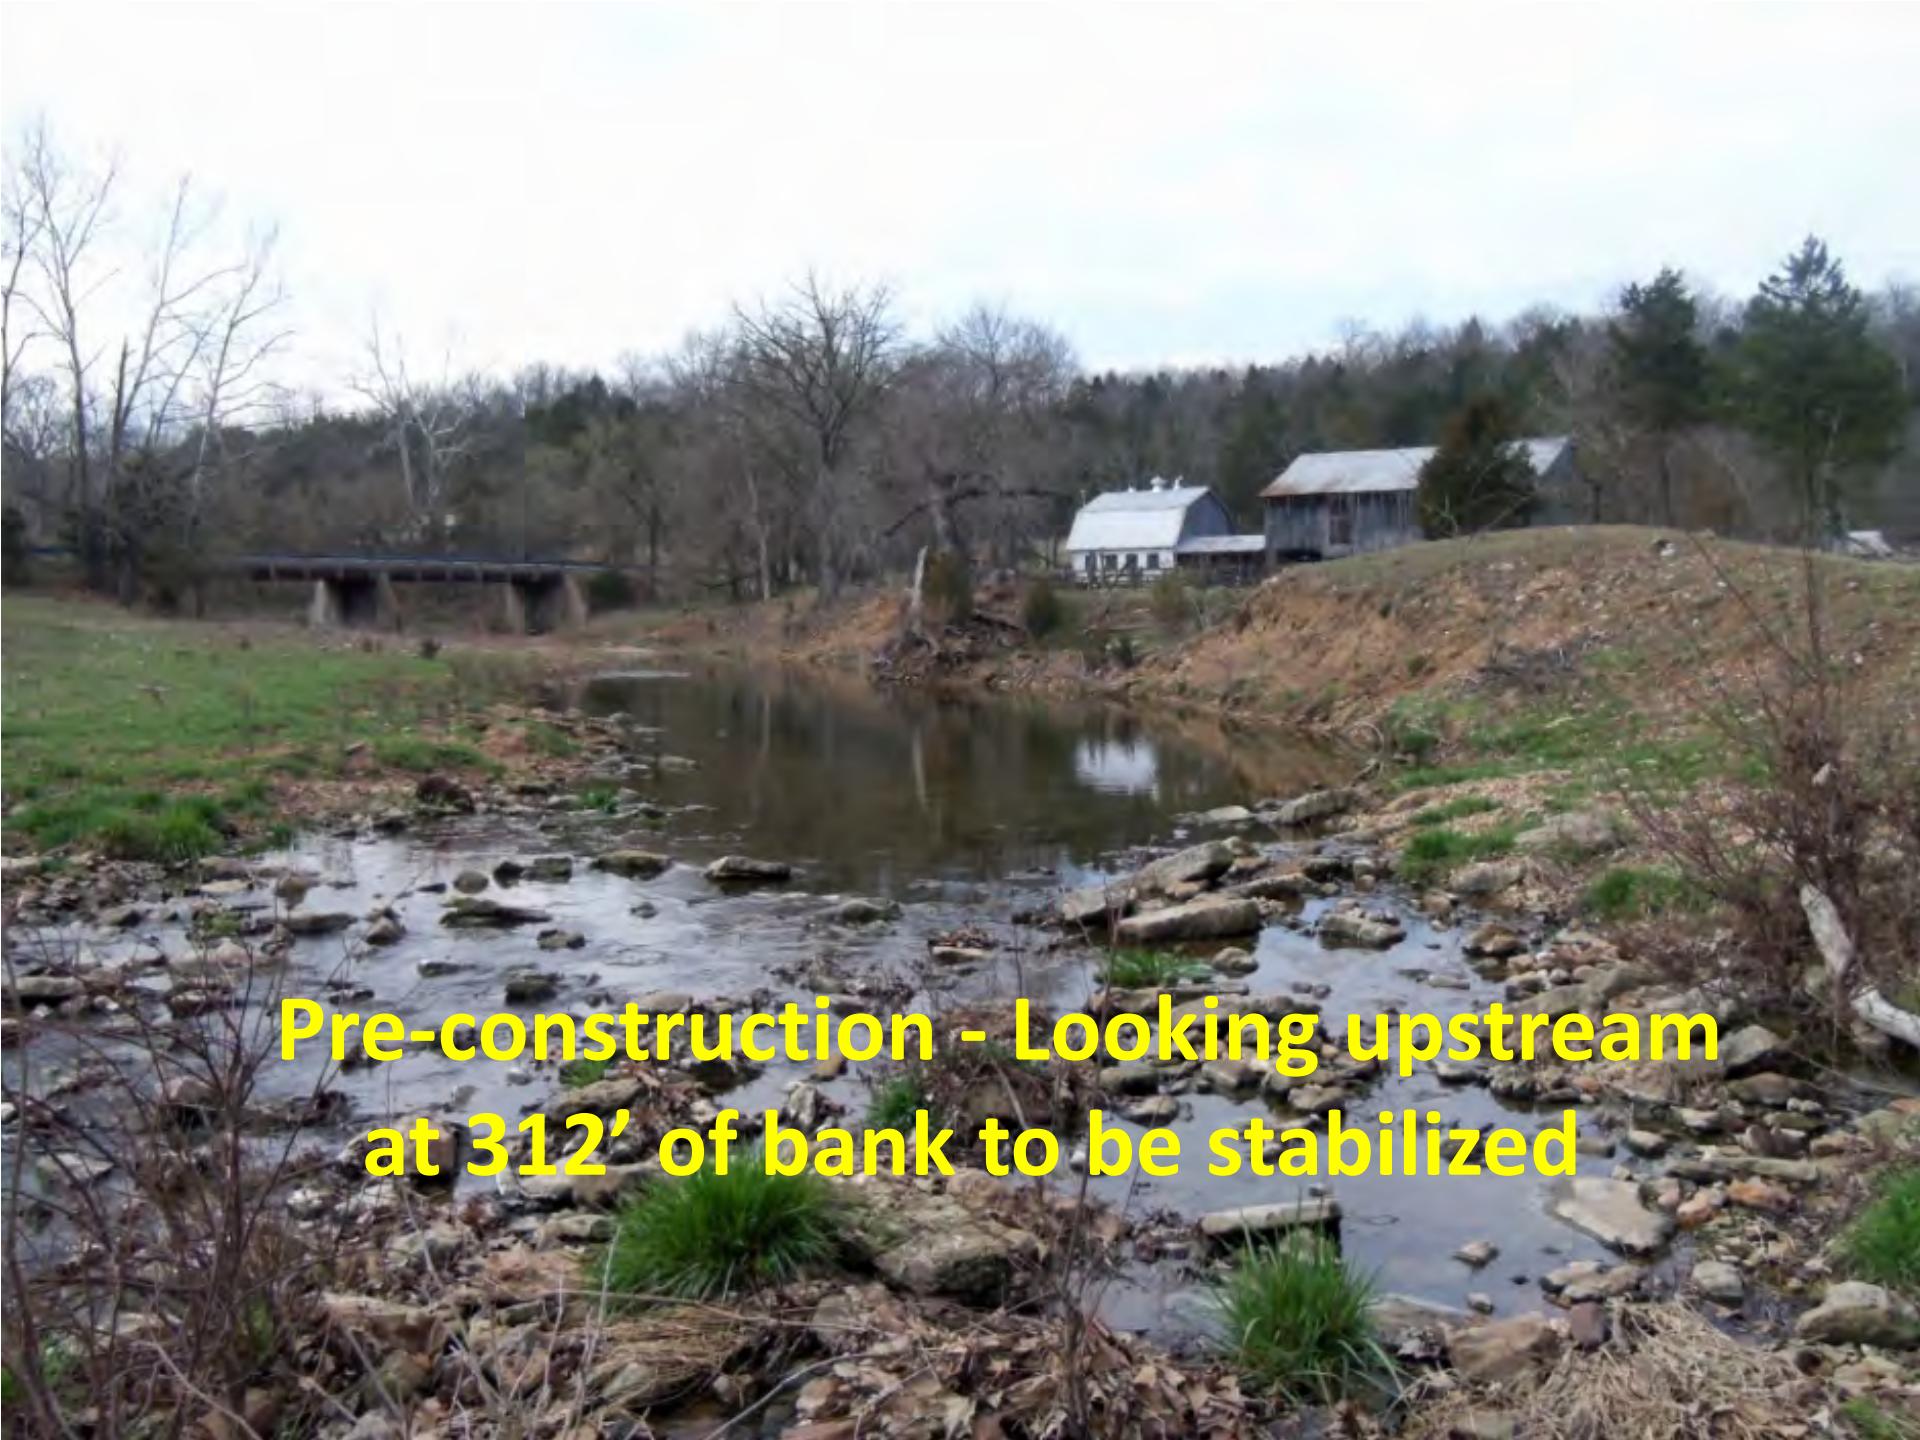
Pre-construction - Looking upstream
at 312' of bank to be stabilized

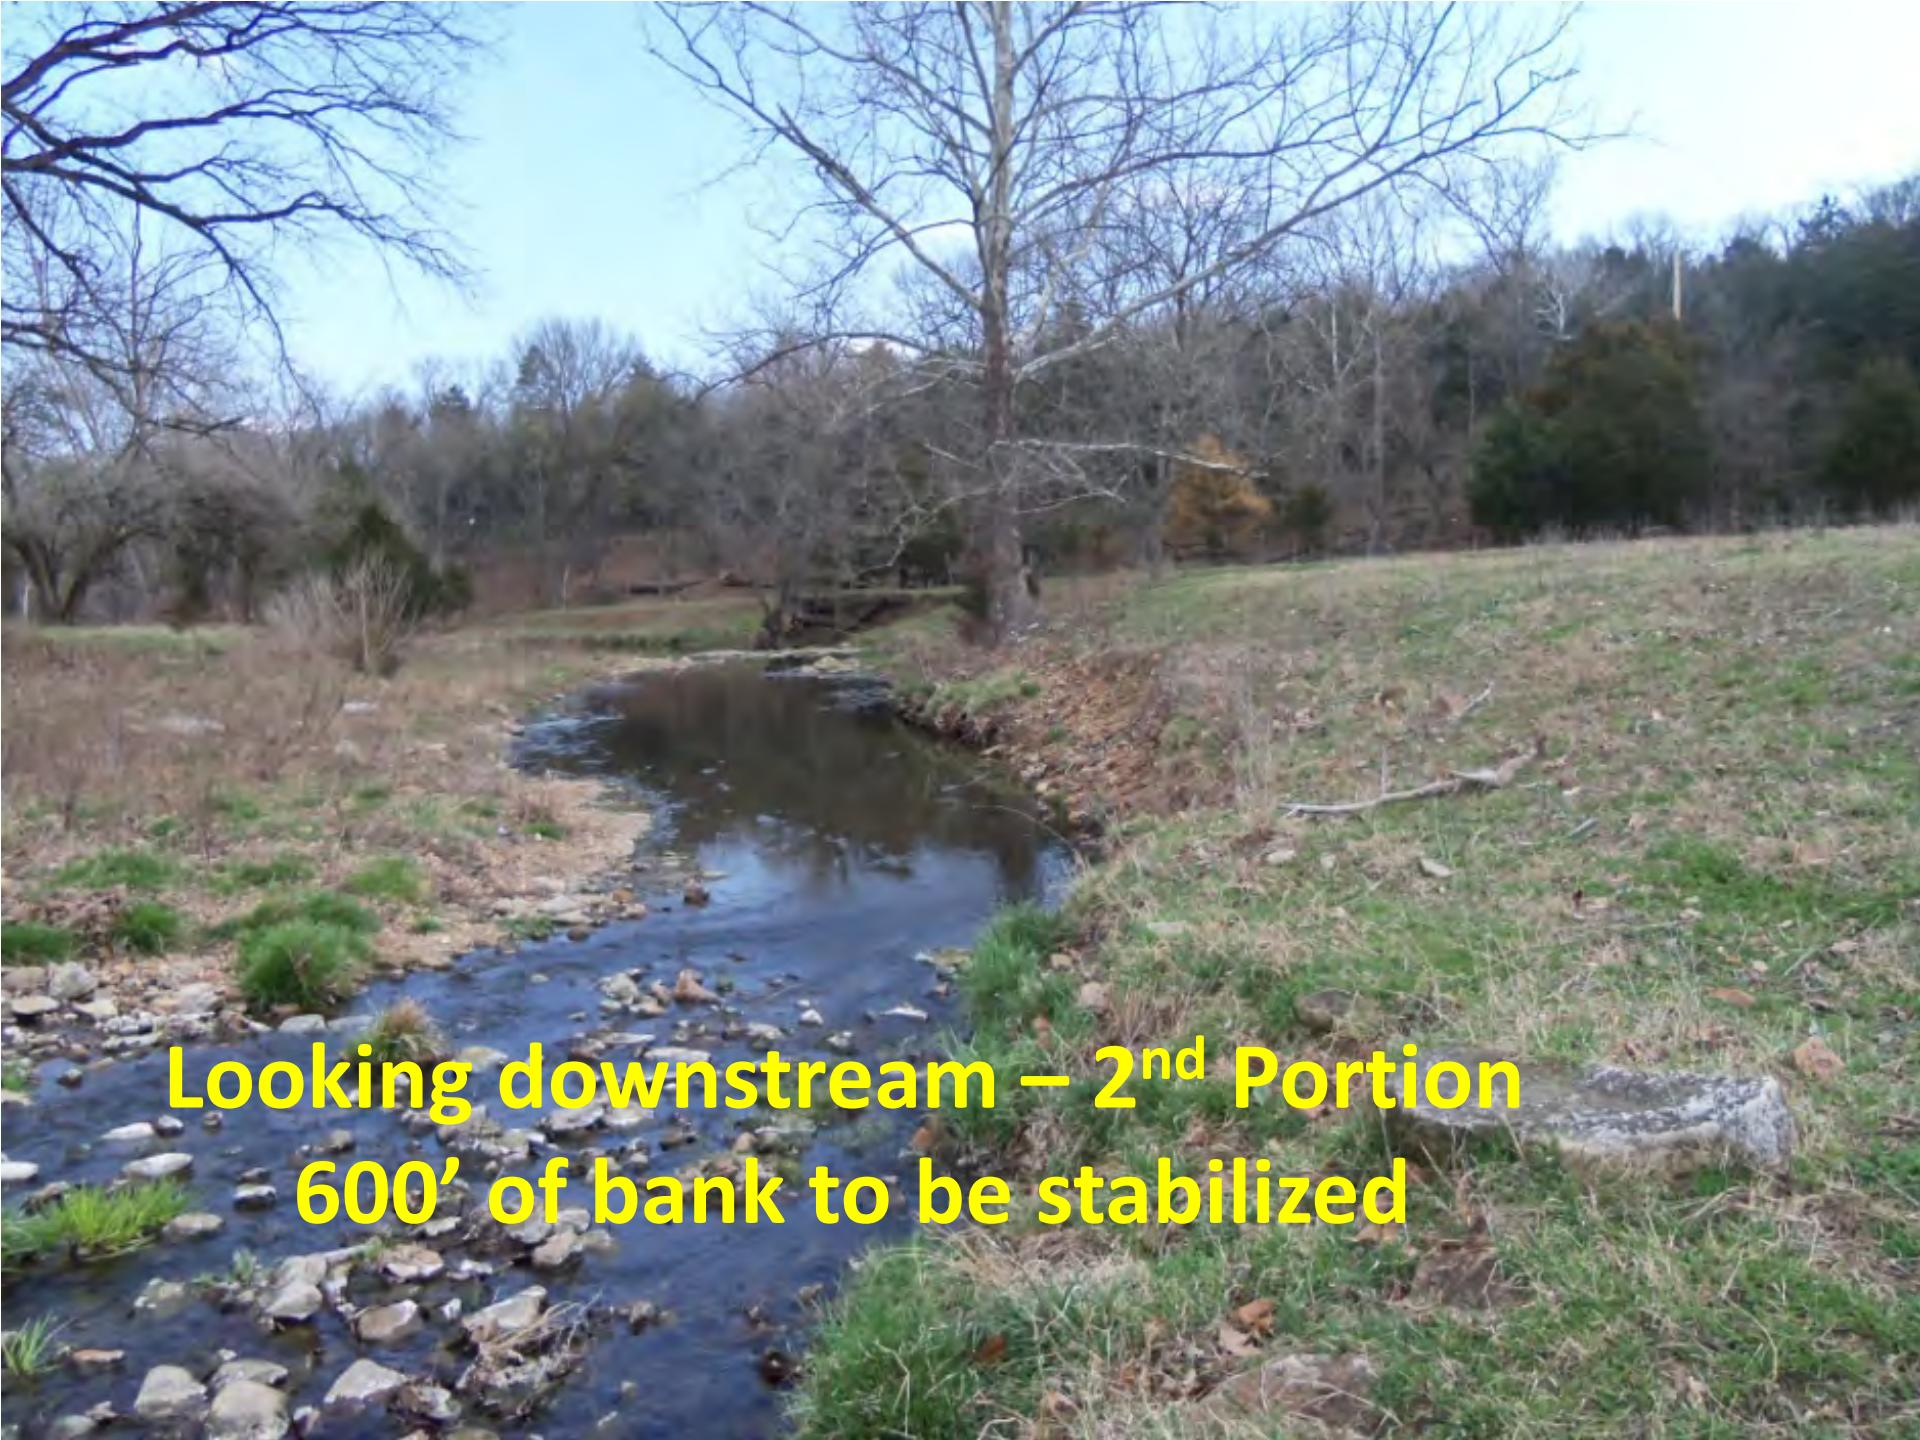
Looking downstream – 2nd Portion
600' of bank to be stabilized

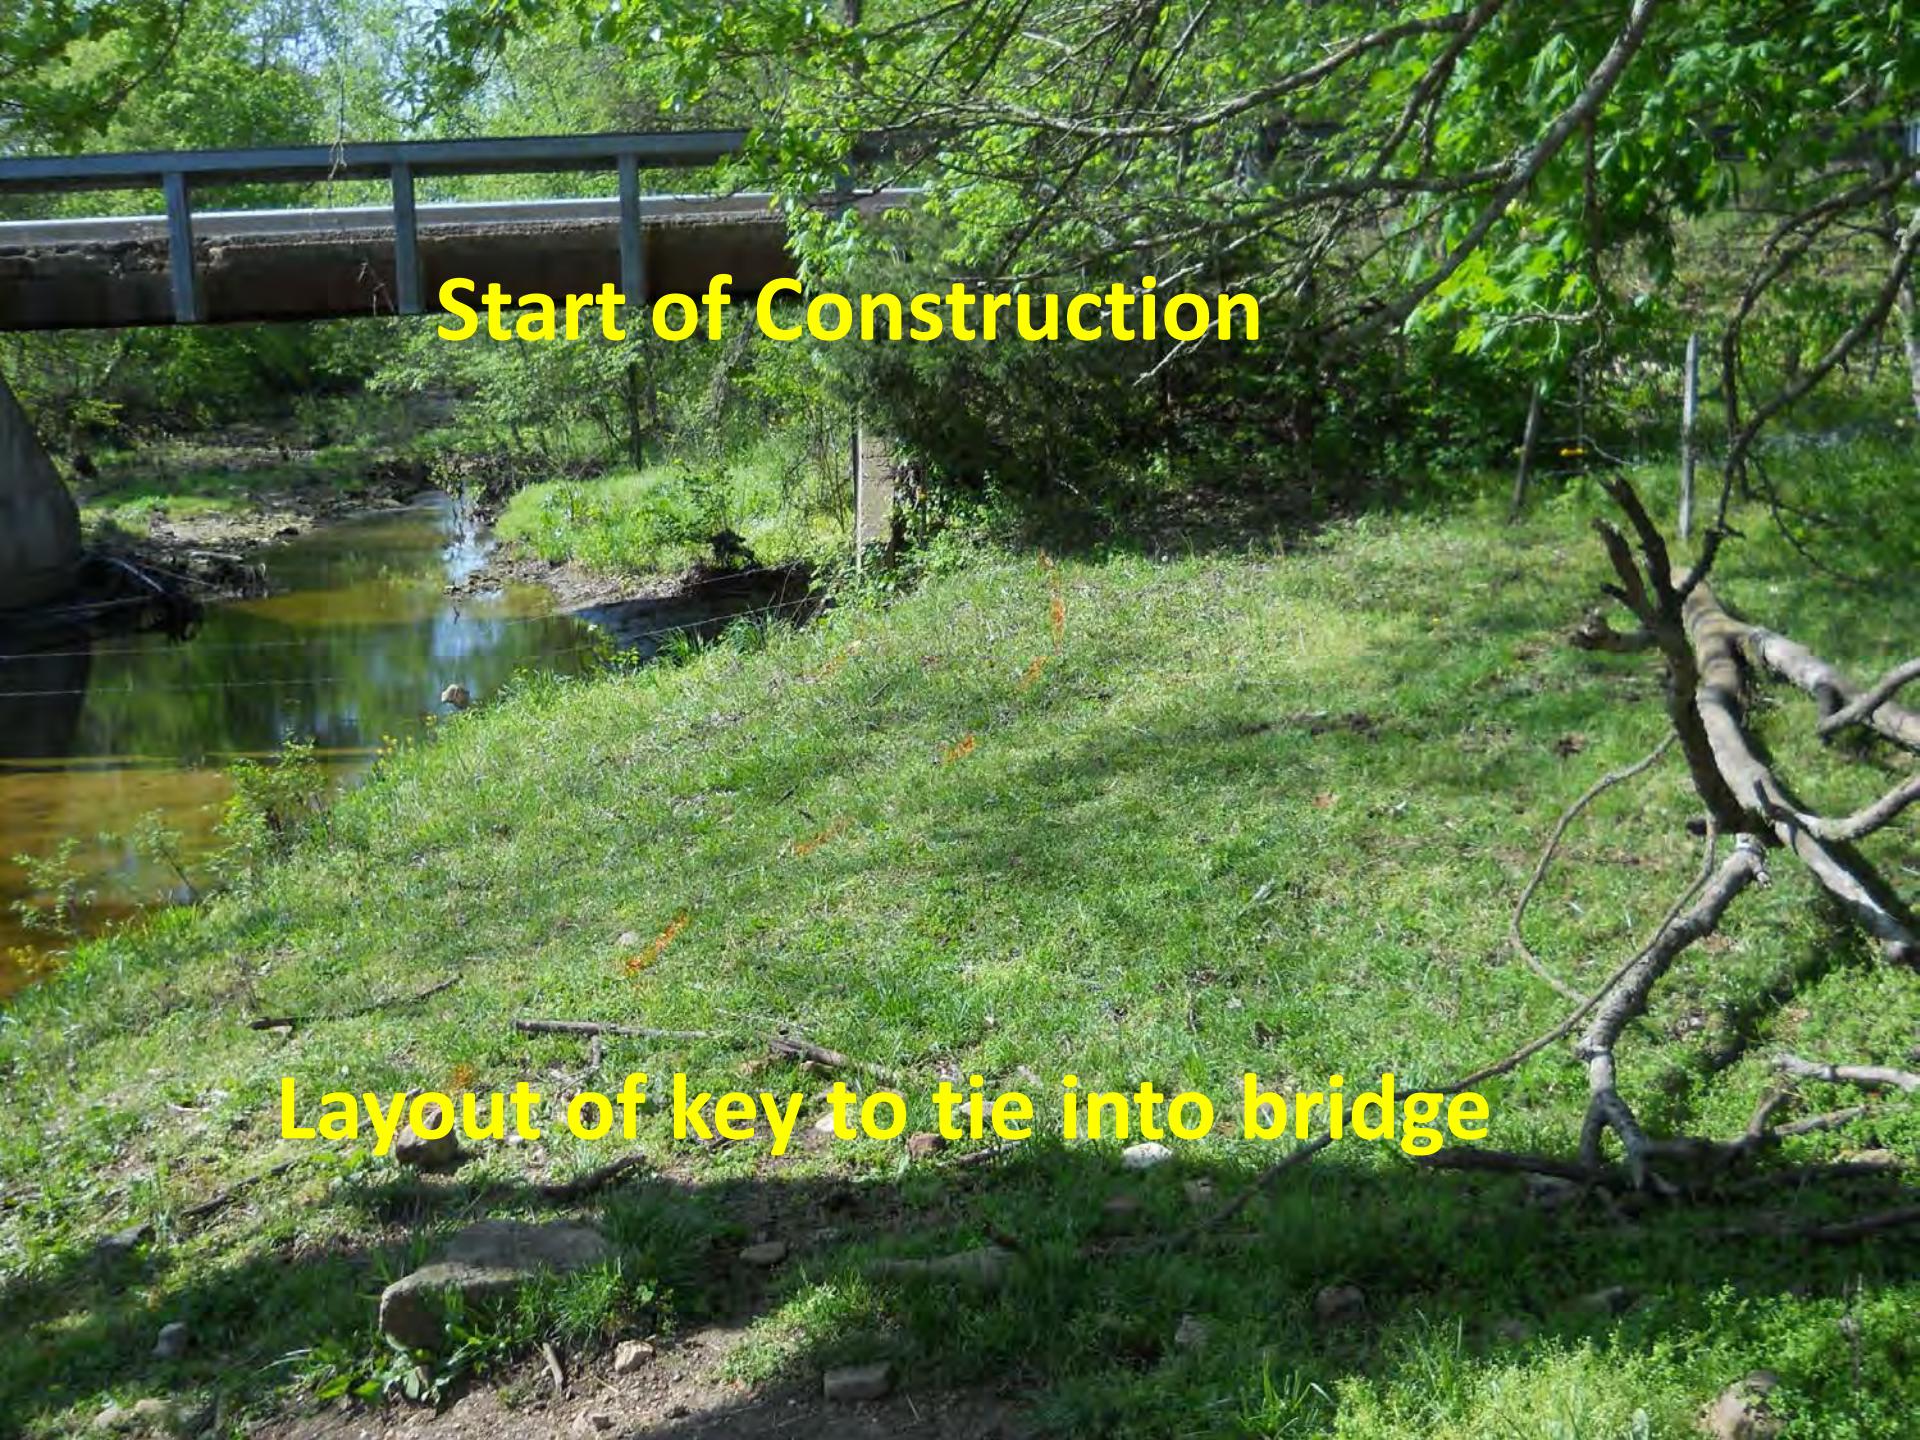
Layout of key to tie into bridge

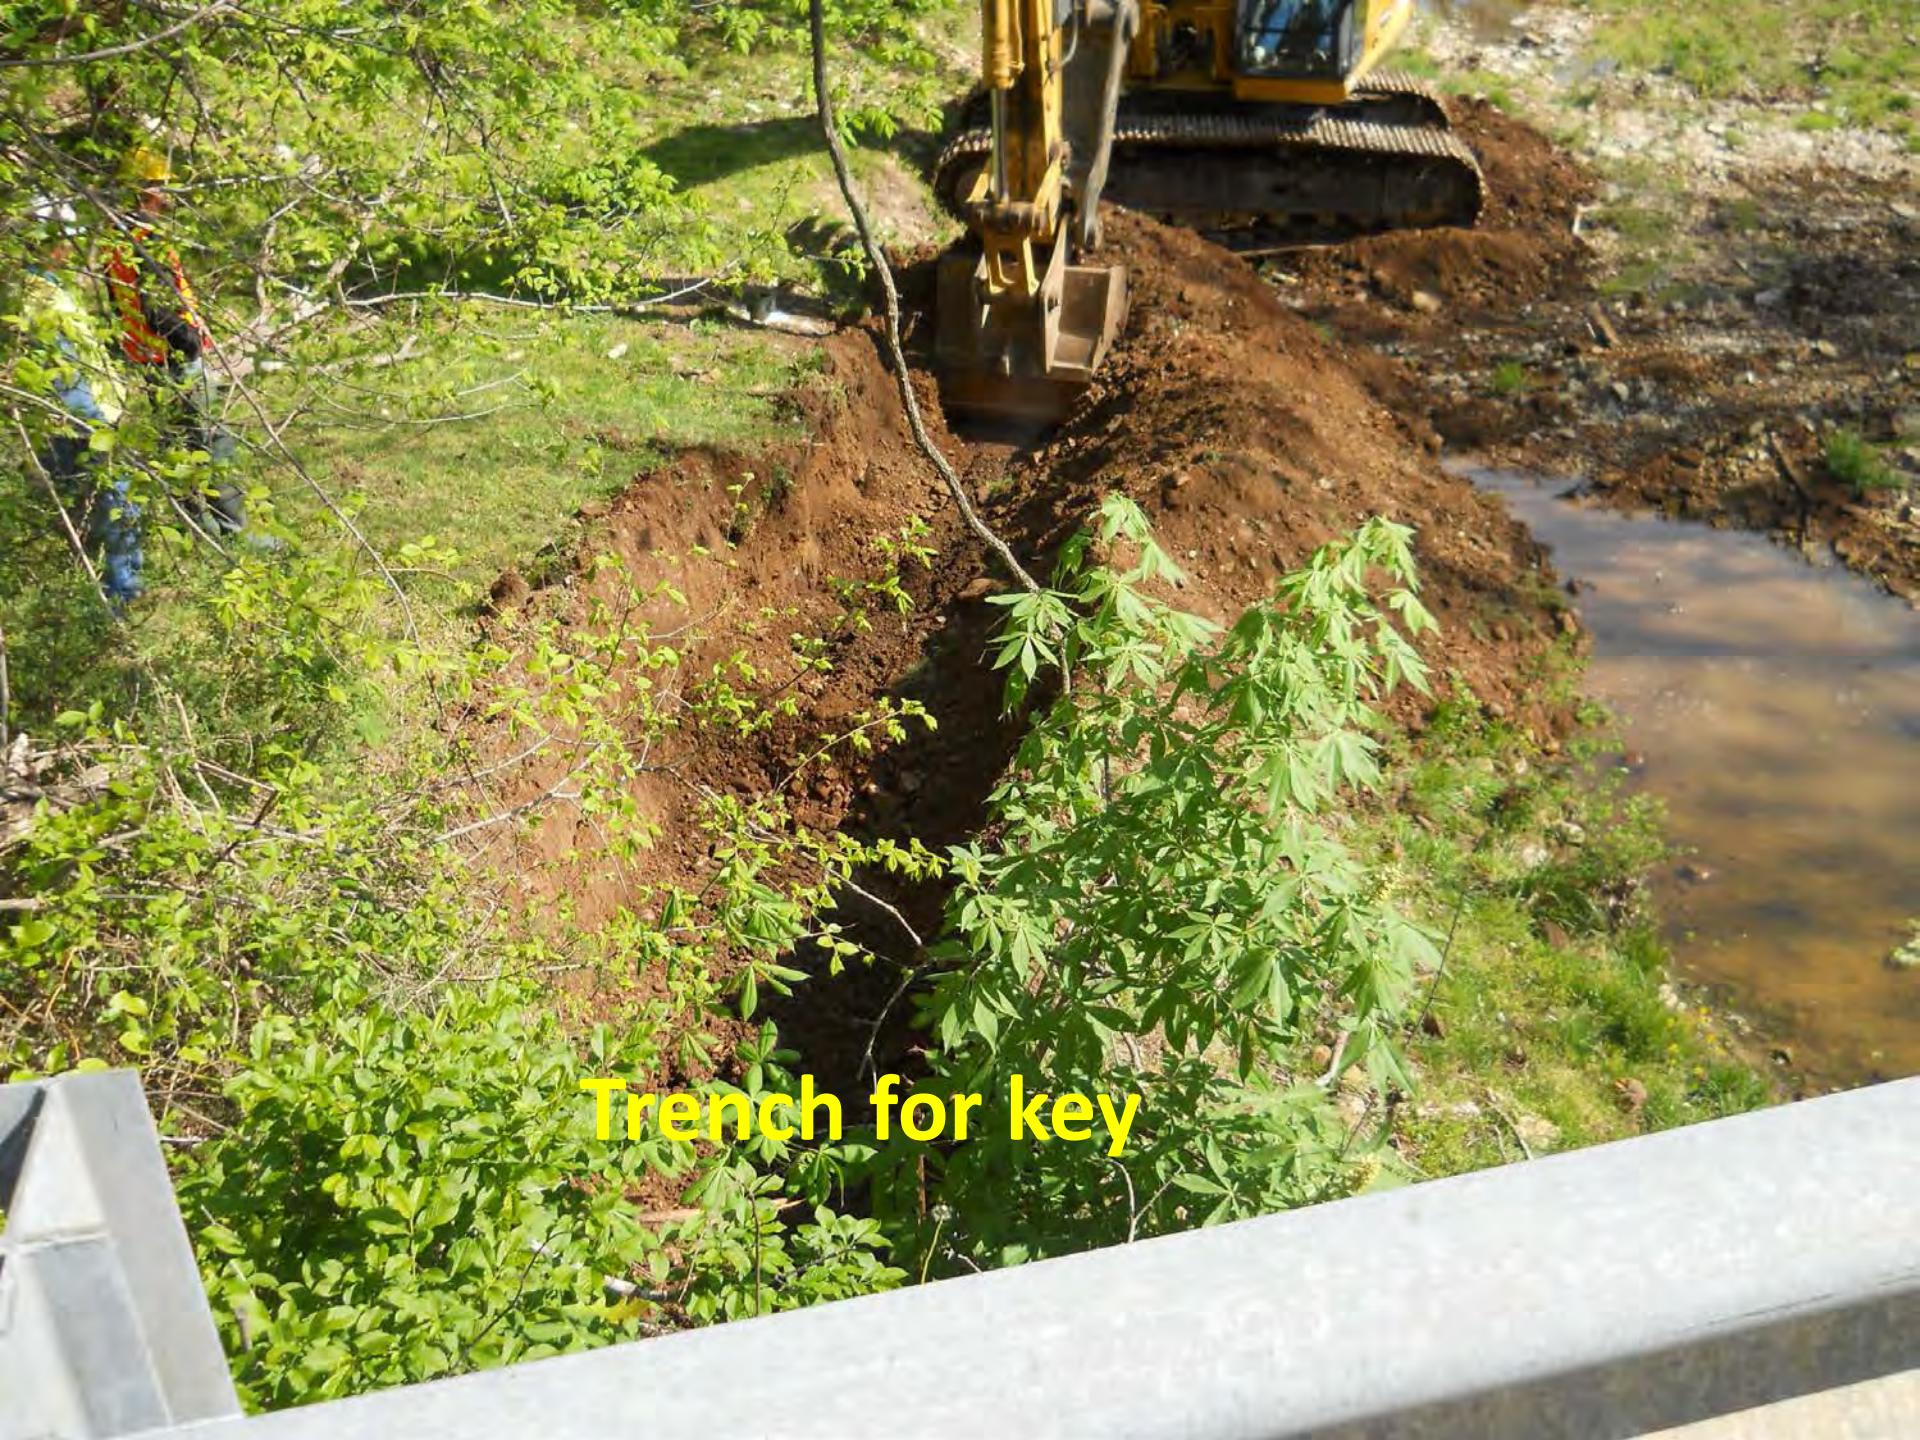
Trench for key

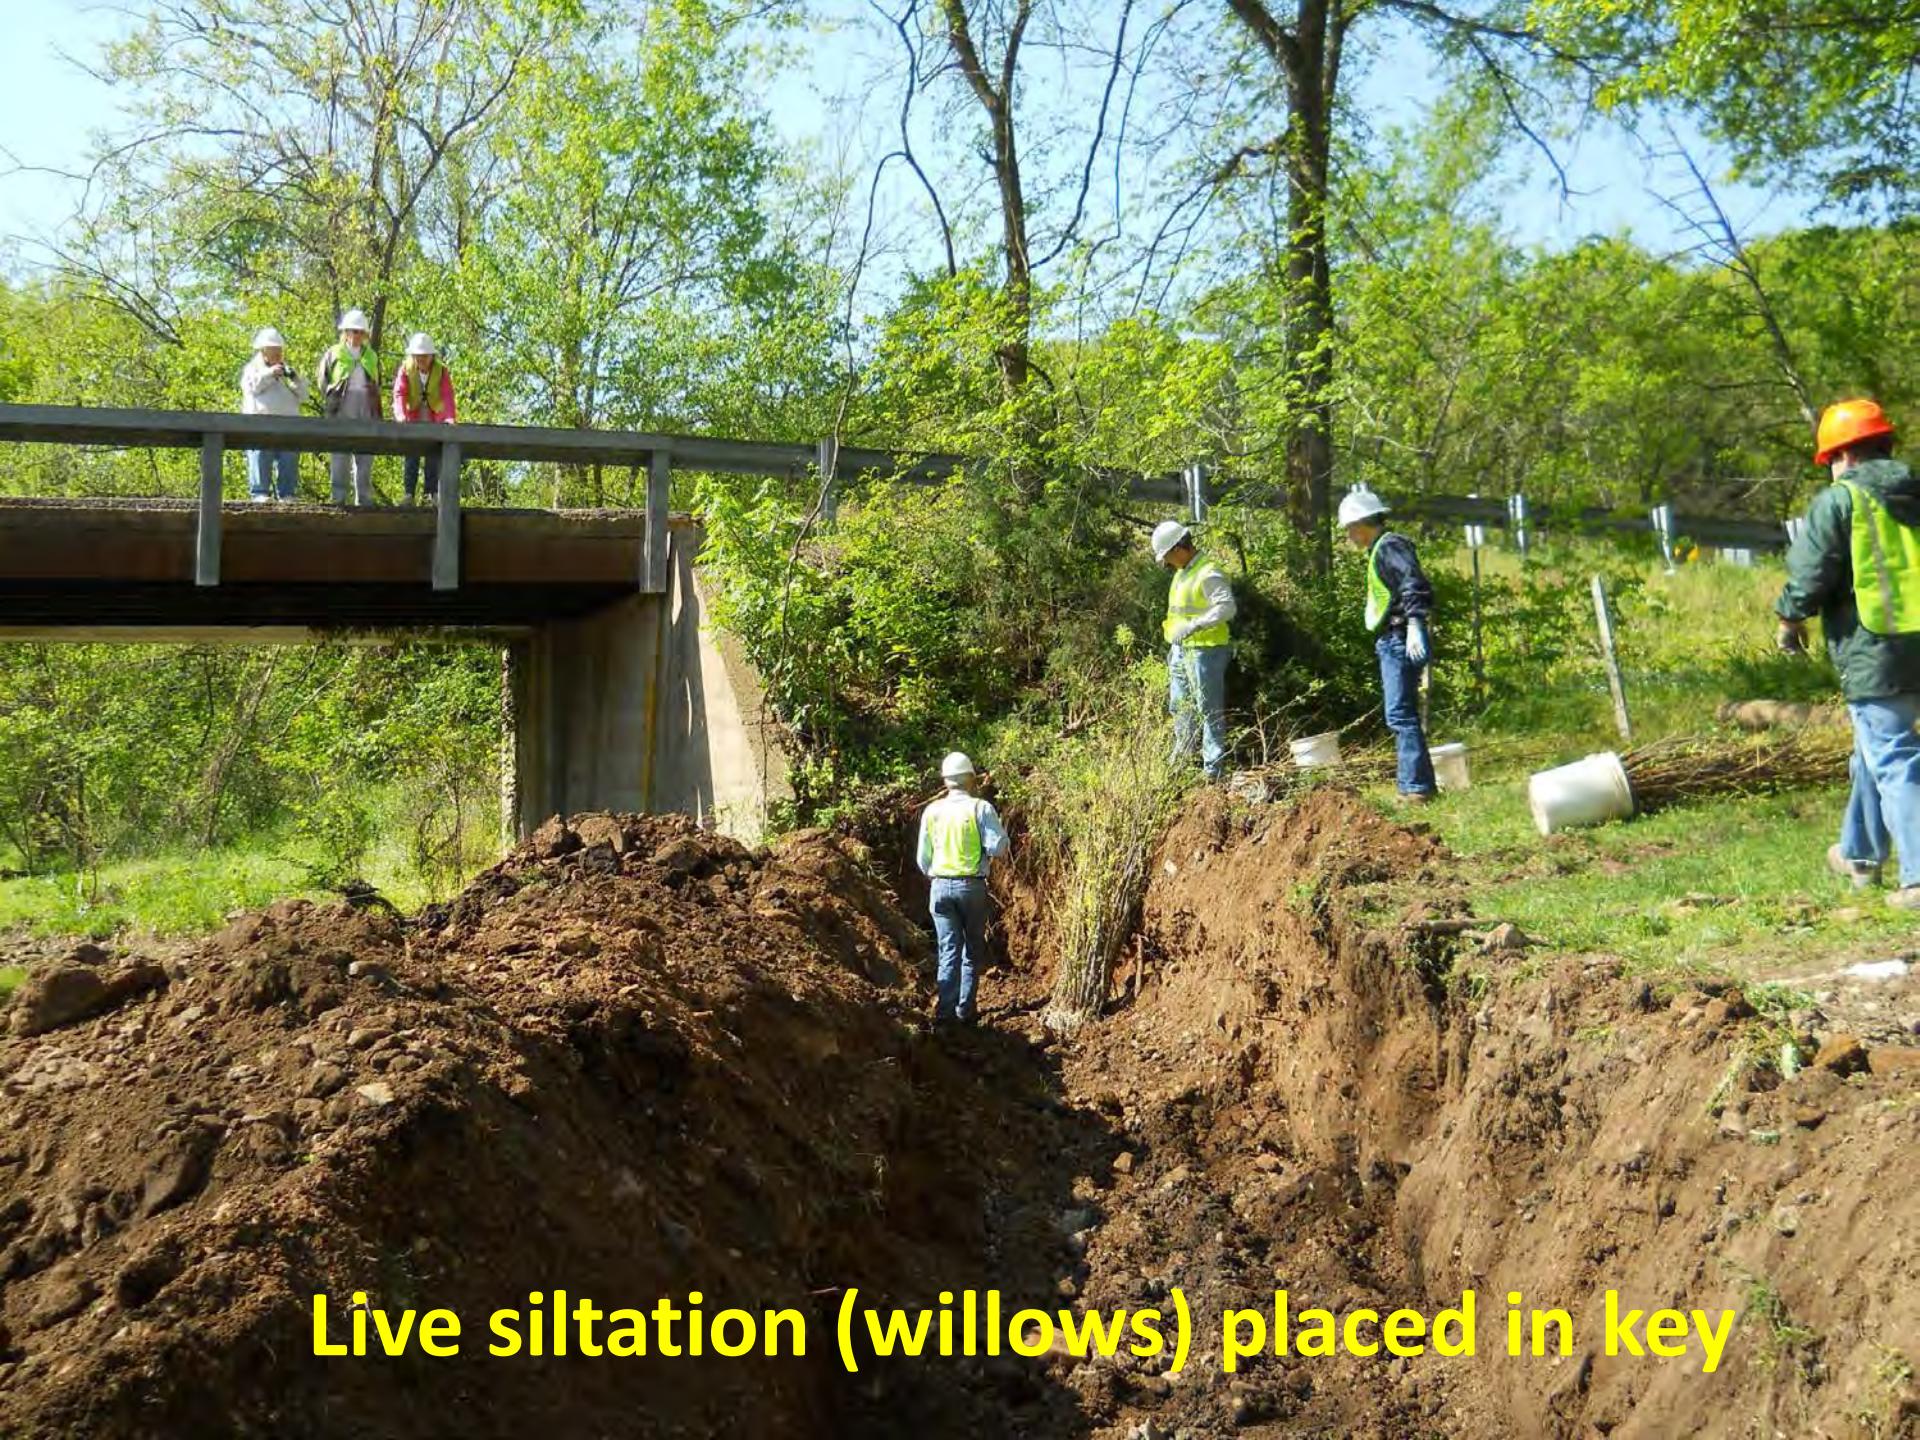
Live siltation (willows) placed in key

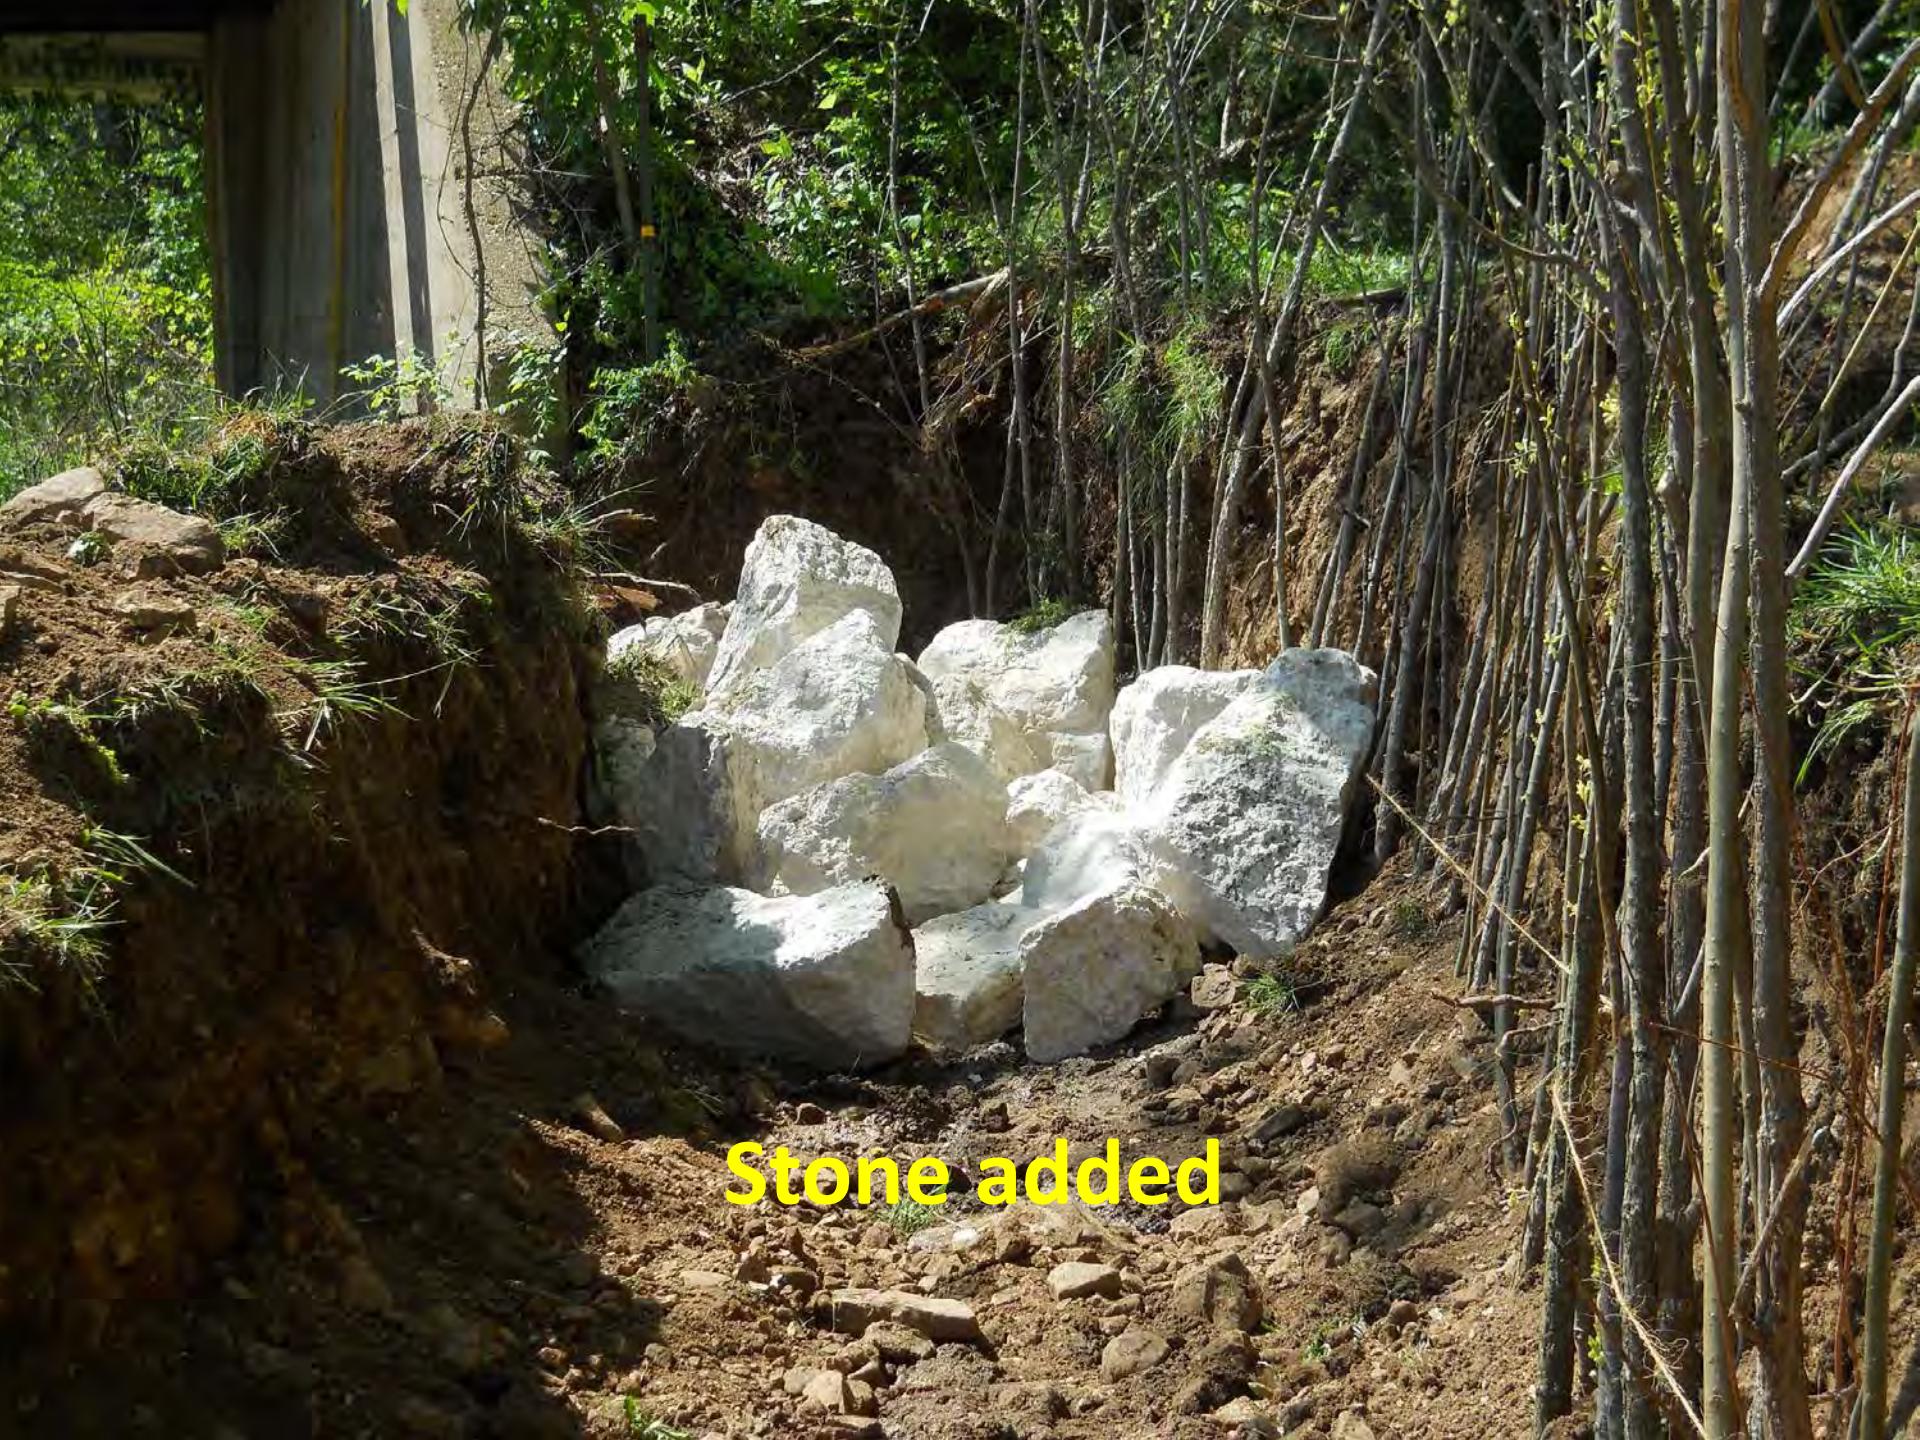
Stone added

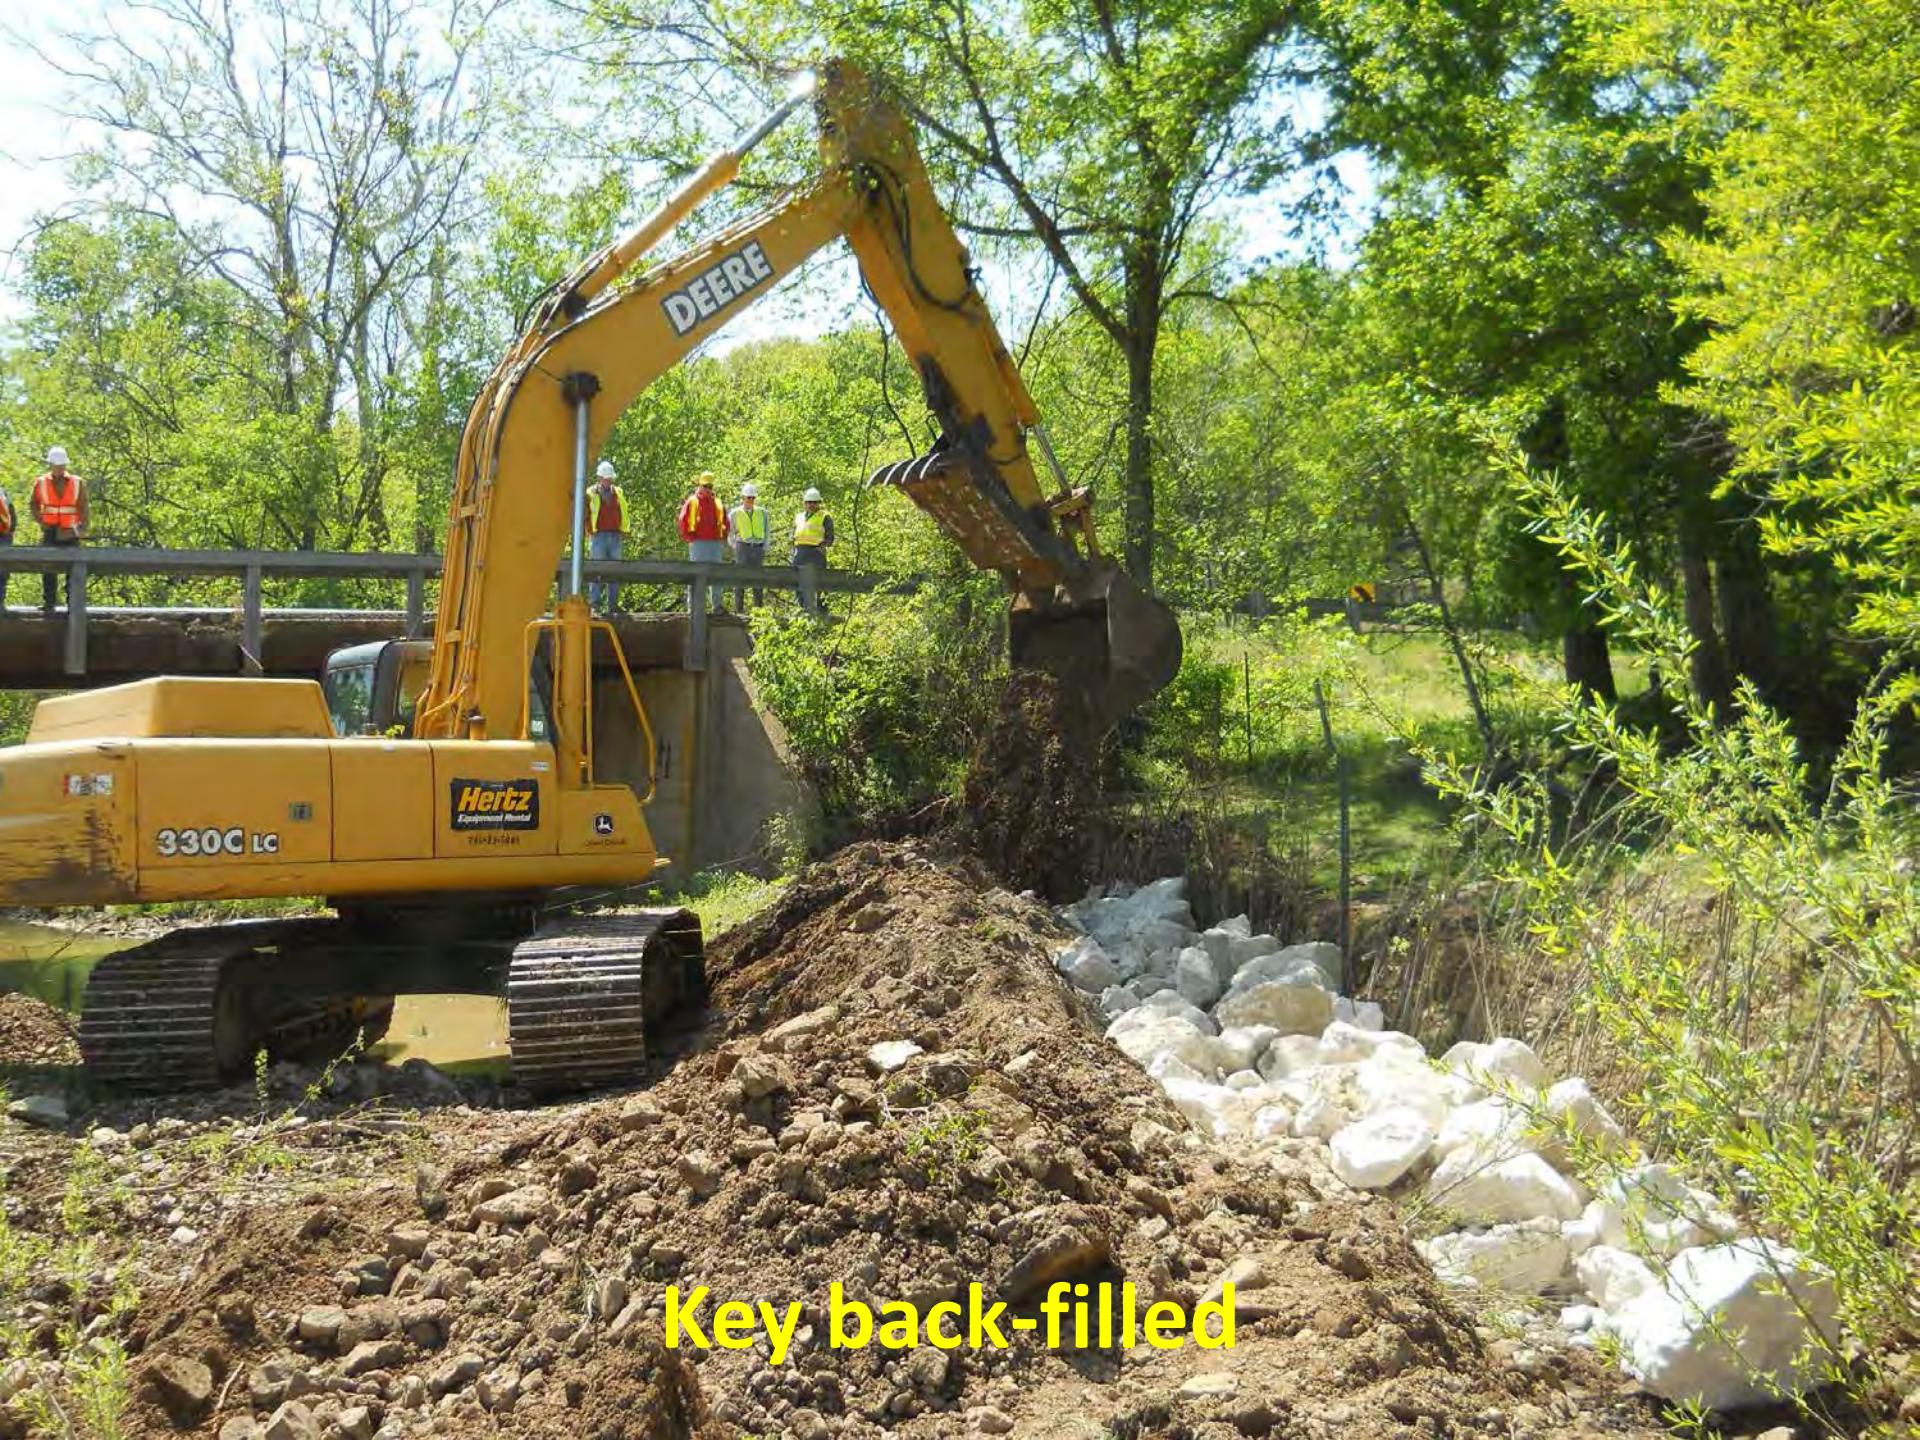
Key back-filled
