**Belews Creek Innovative
Streambank Stabilization
Seminar and Hands-On
Construction Workshop
April 10 – 12, 2012
(A Dave Derrick USACE Project)**

**Bank stabilization project funded
through an EPA 319 Implementation
grant obtained by Belews Creek
Watershed Partnership-
a citizen based non-profit organization**

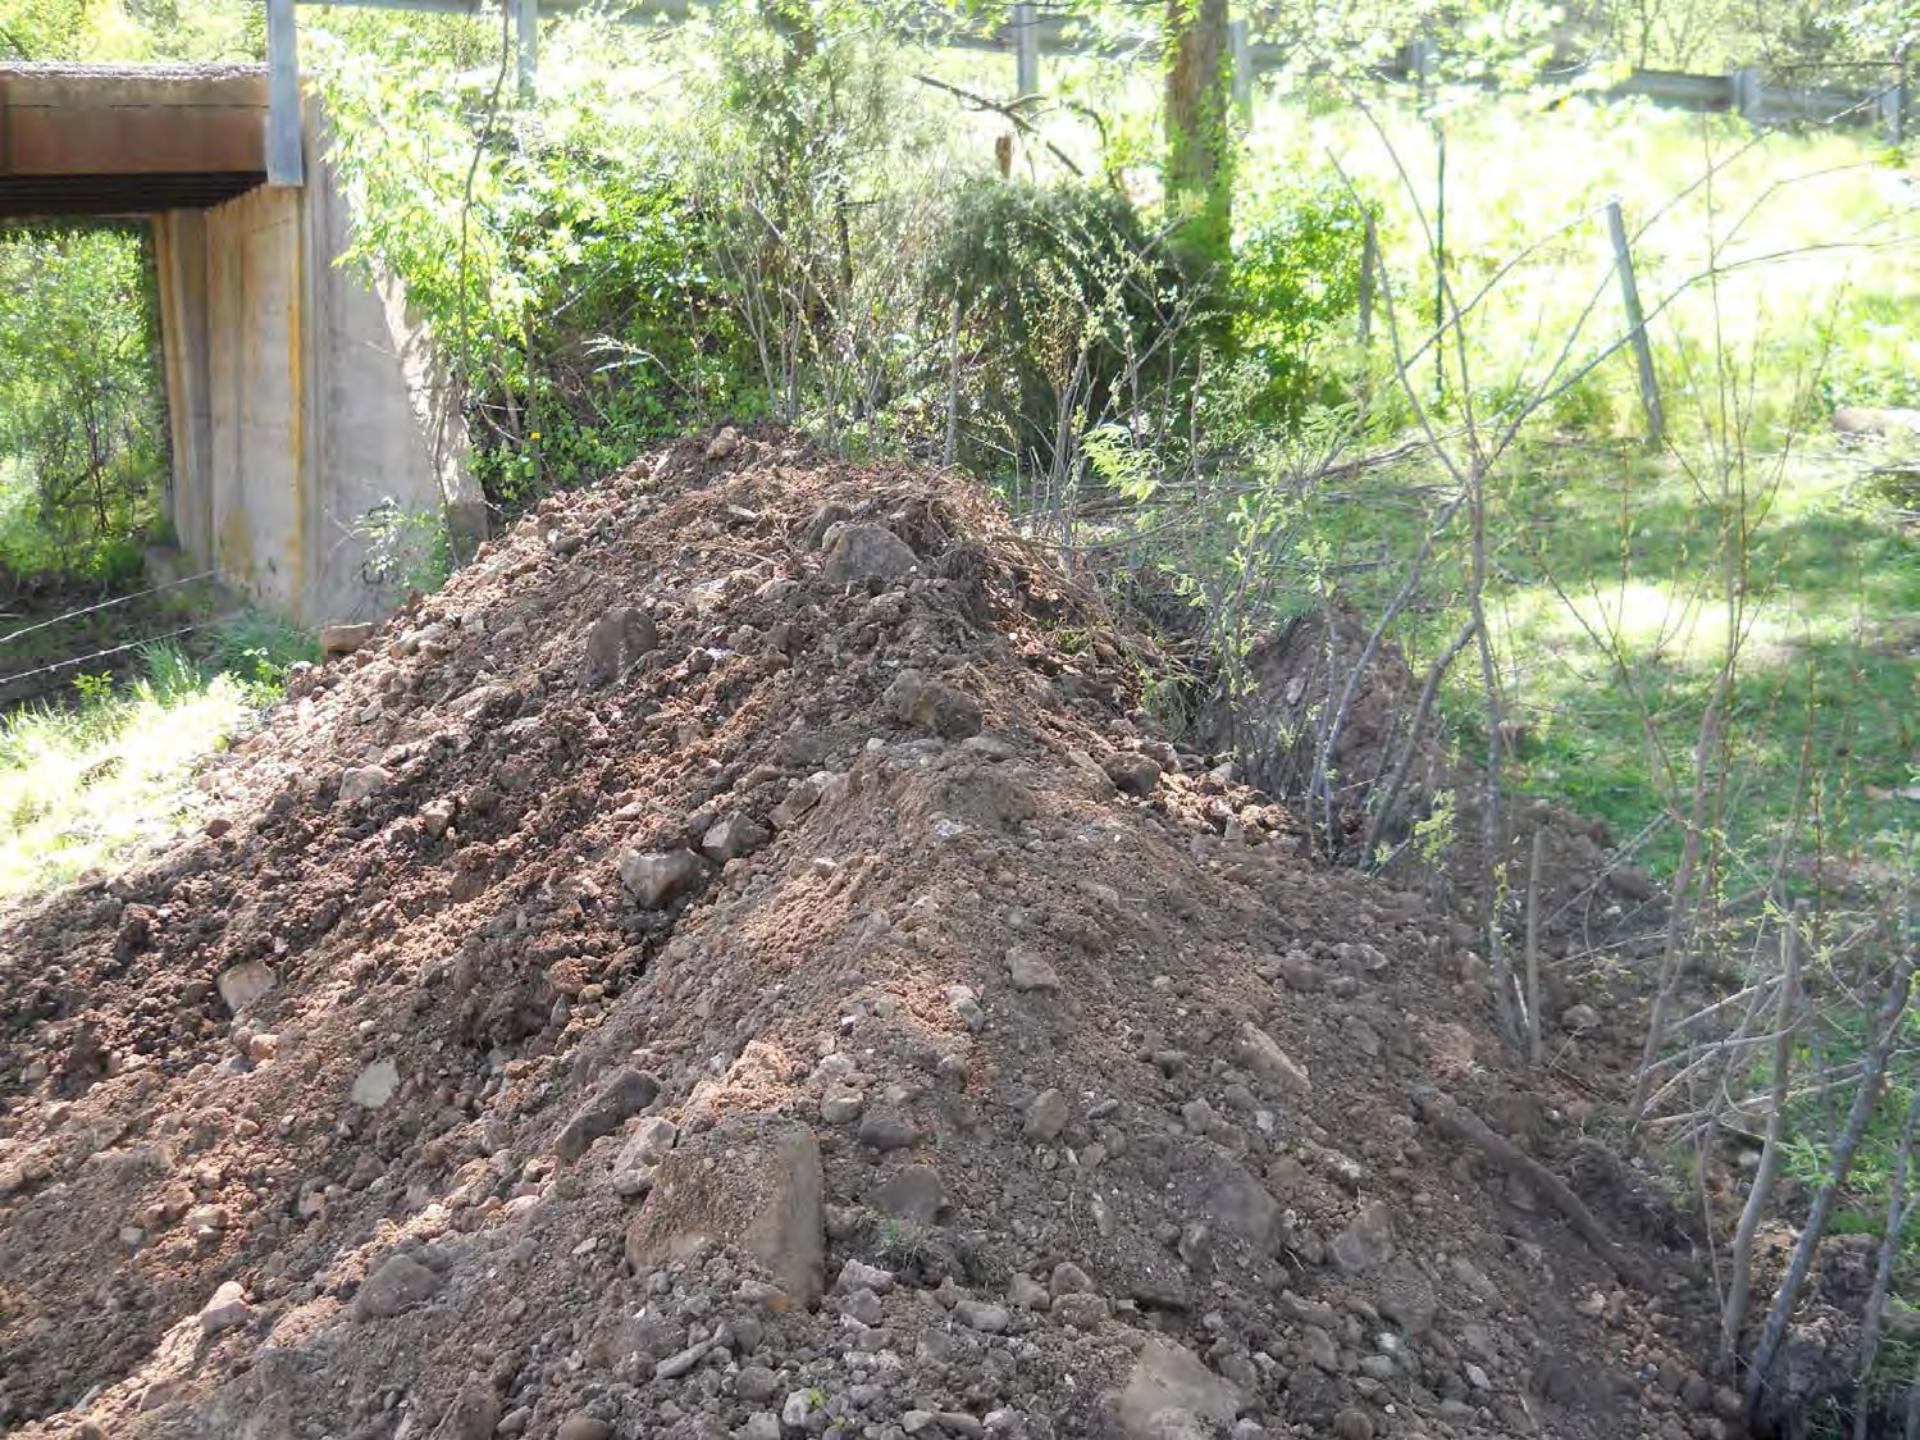
Start of Longitudinal Peak Stone Toe Protection (LPSTP)

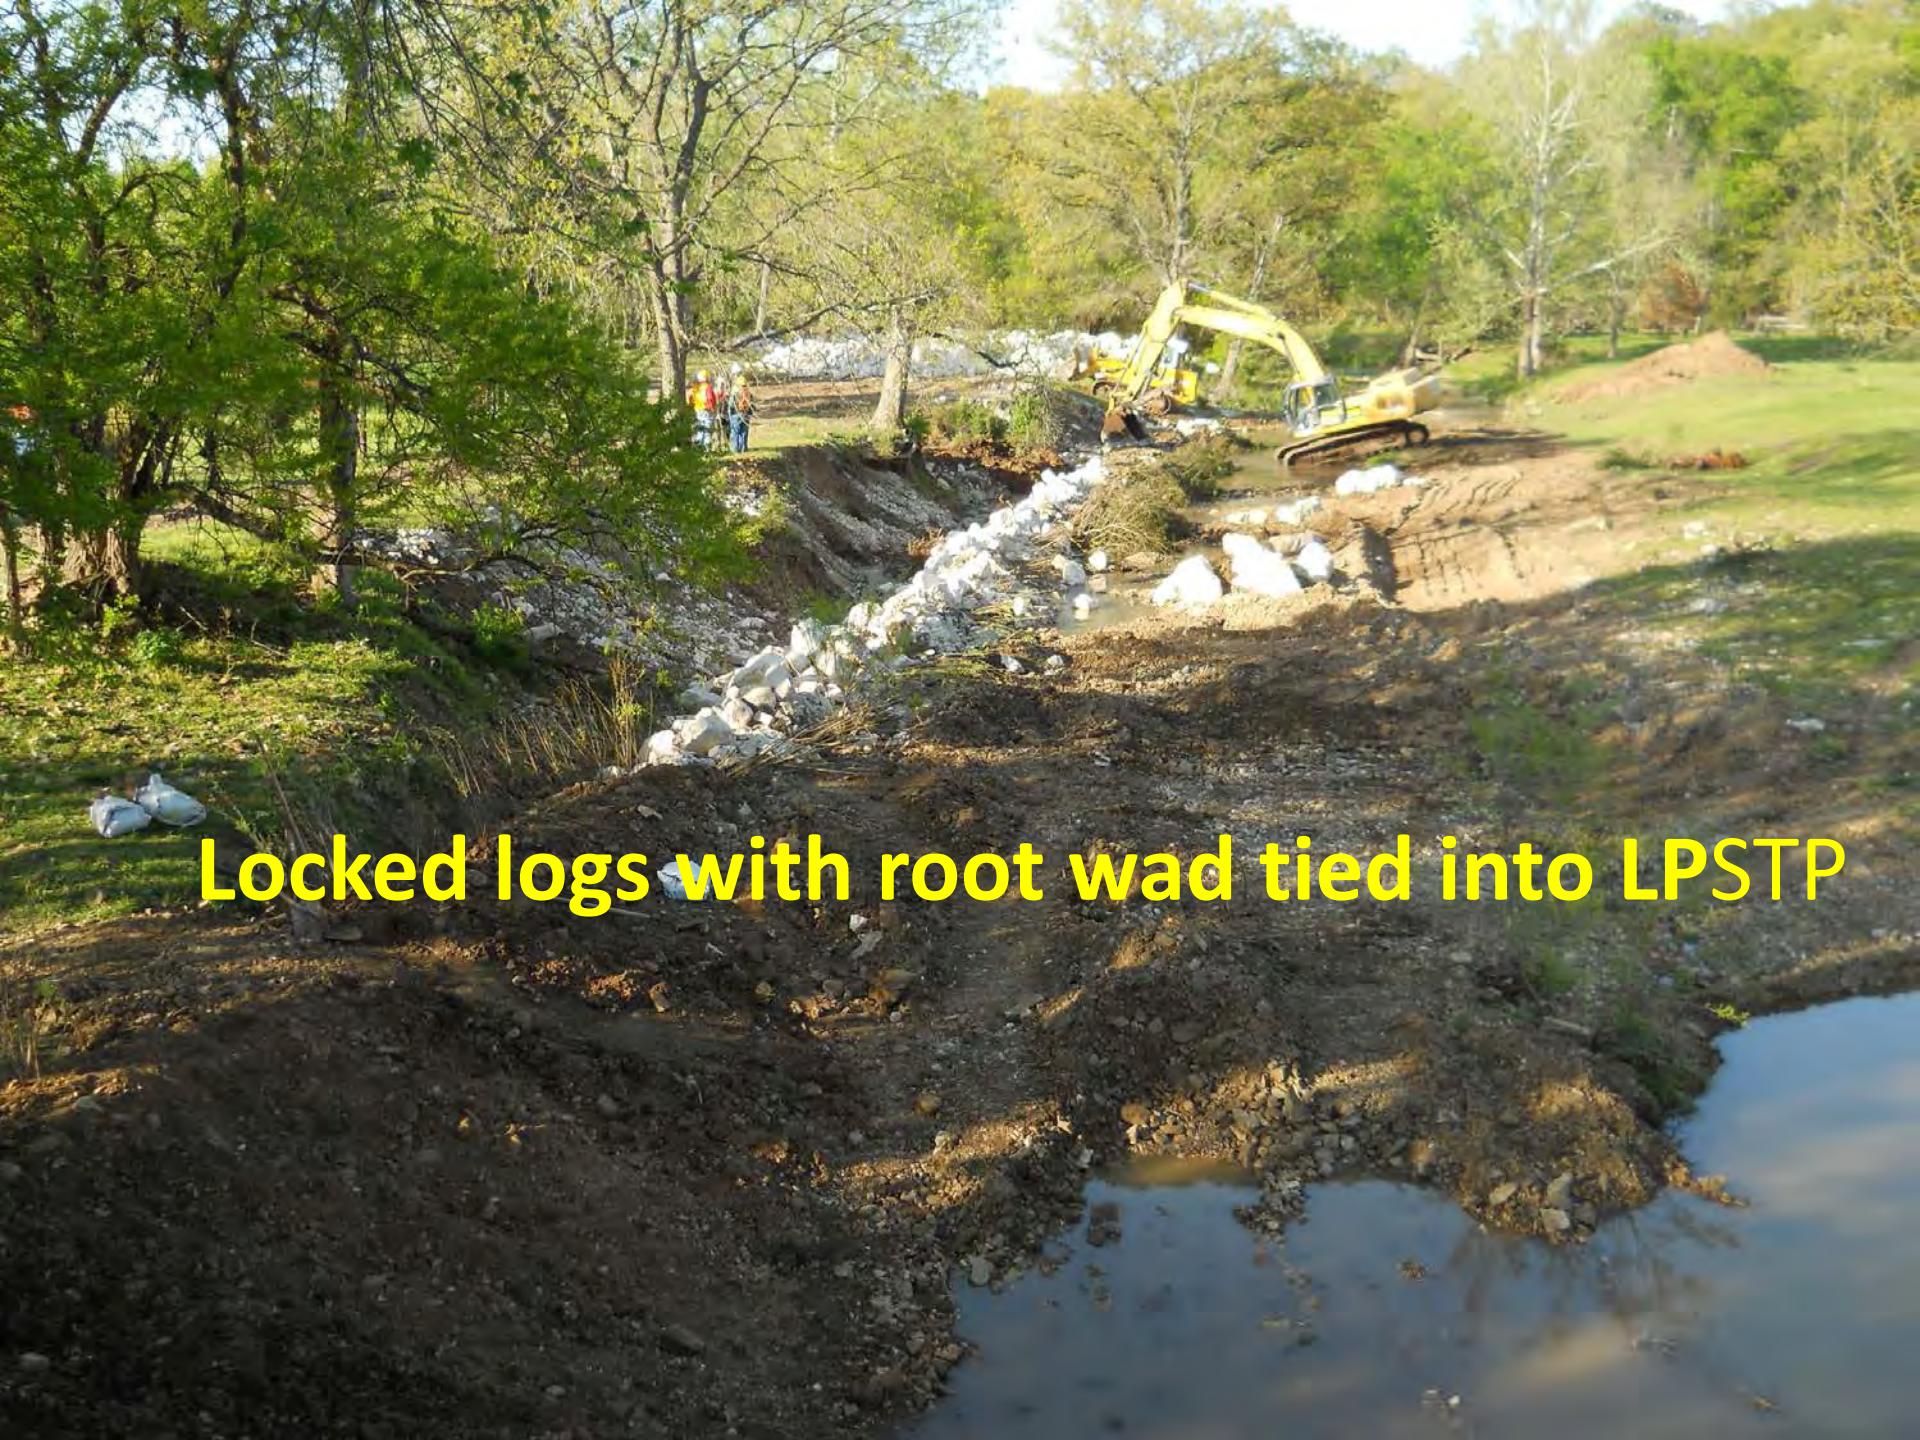
Locked logs with root wad tied into LPSTP

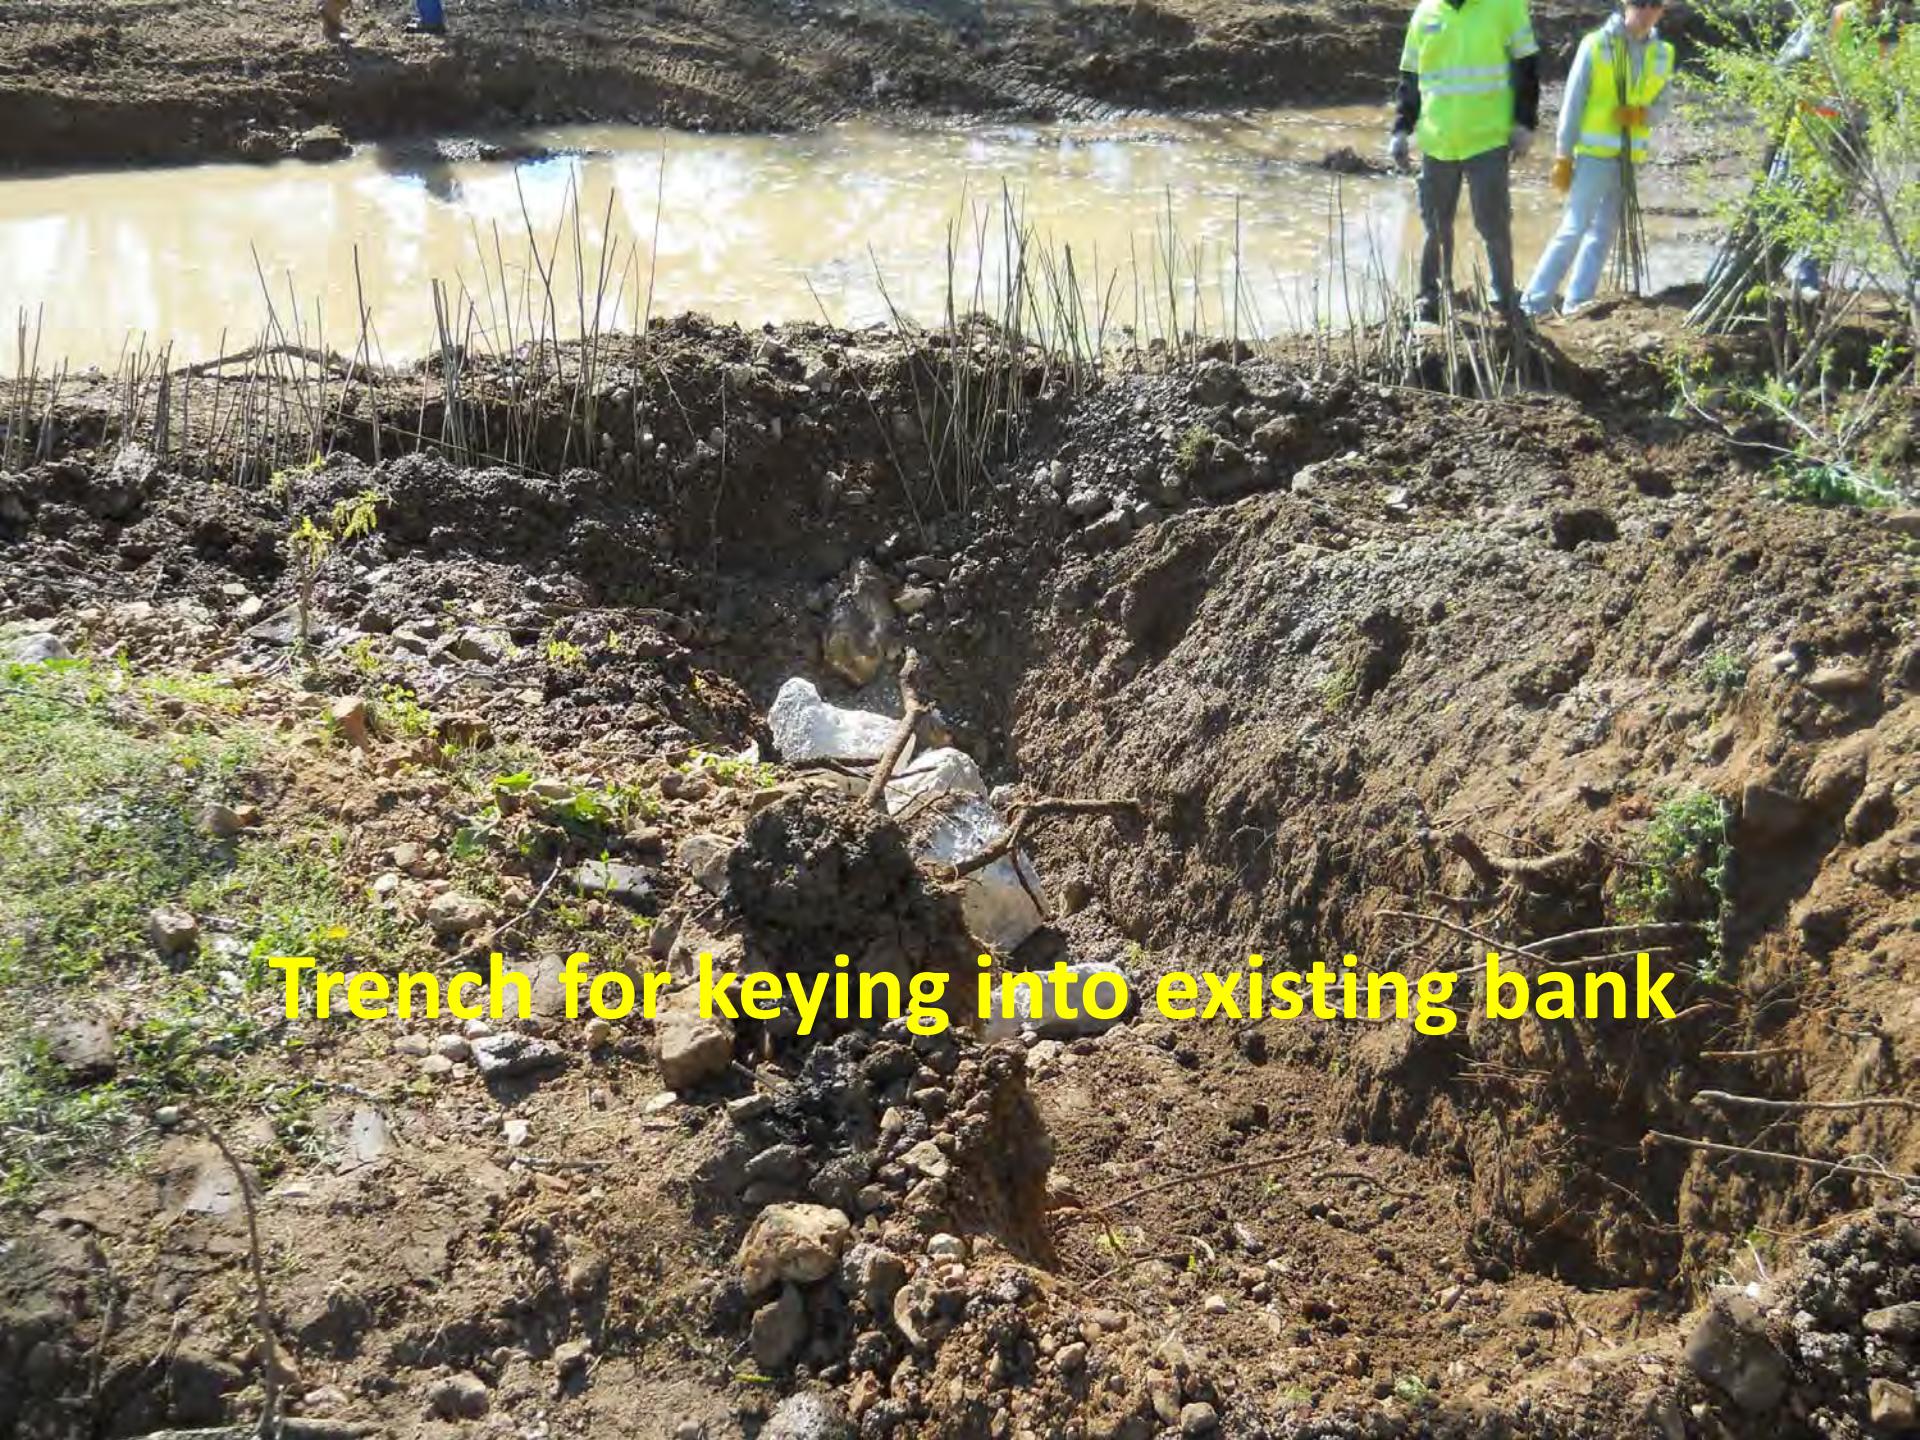
Trench for keying into existing bank

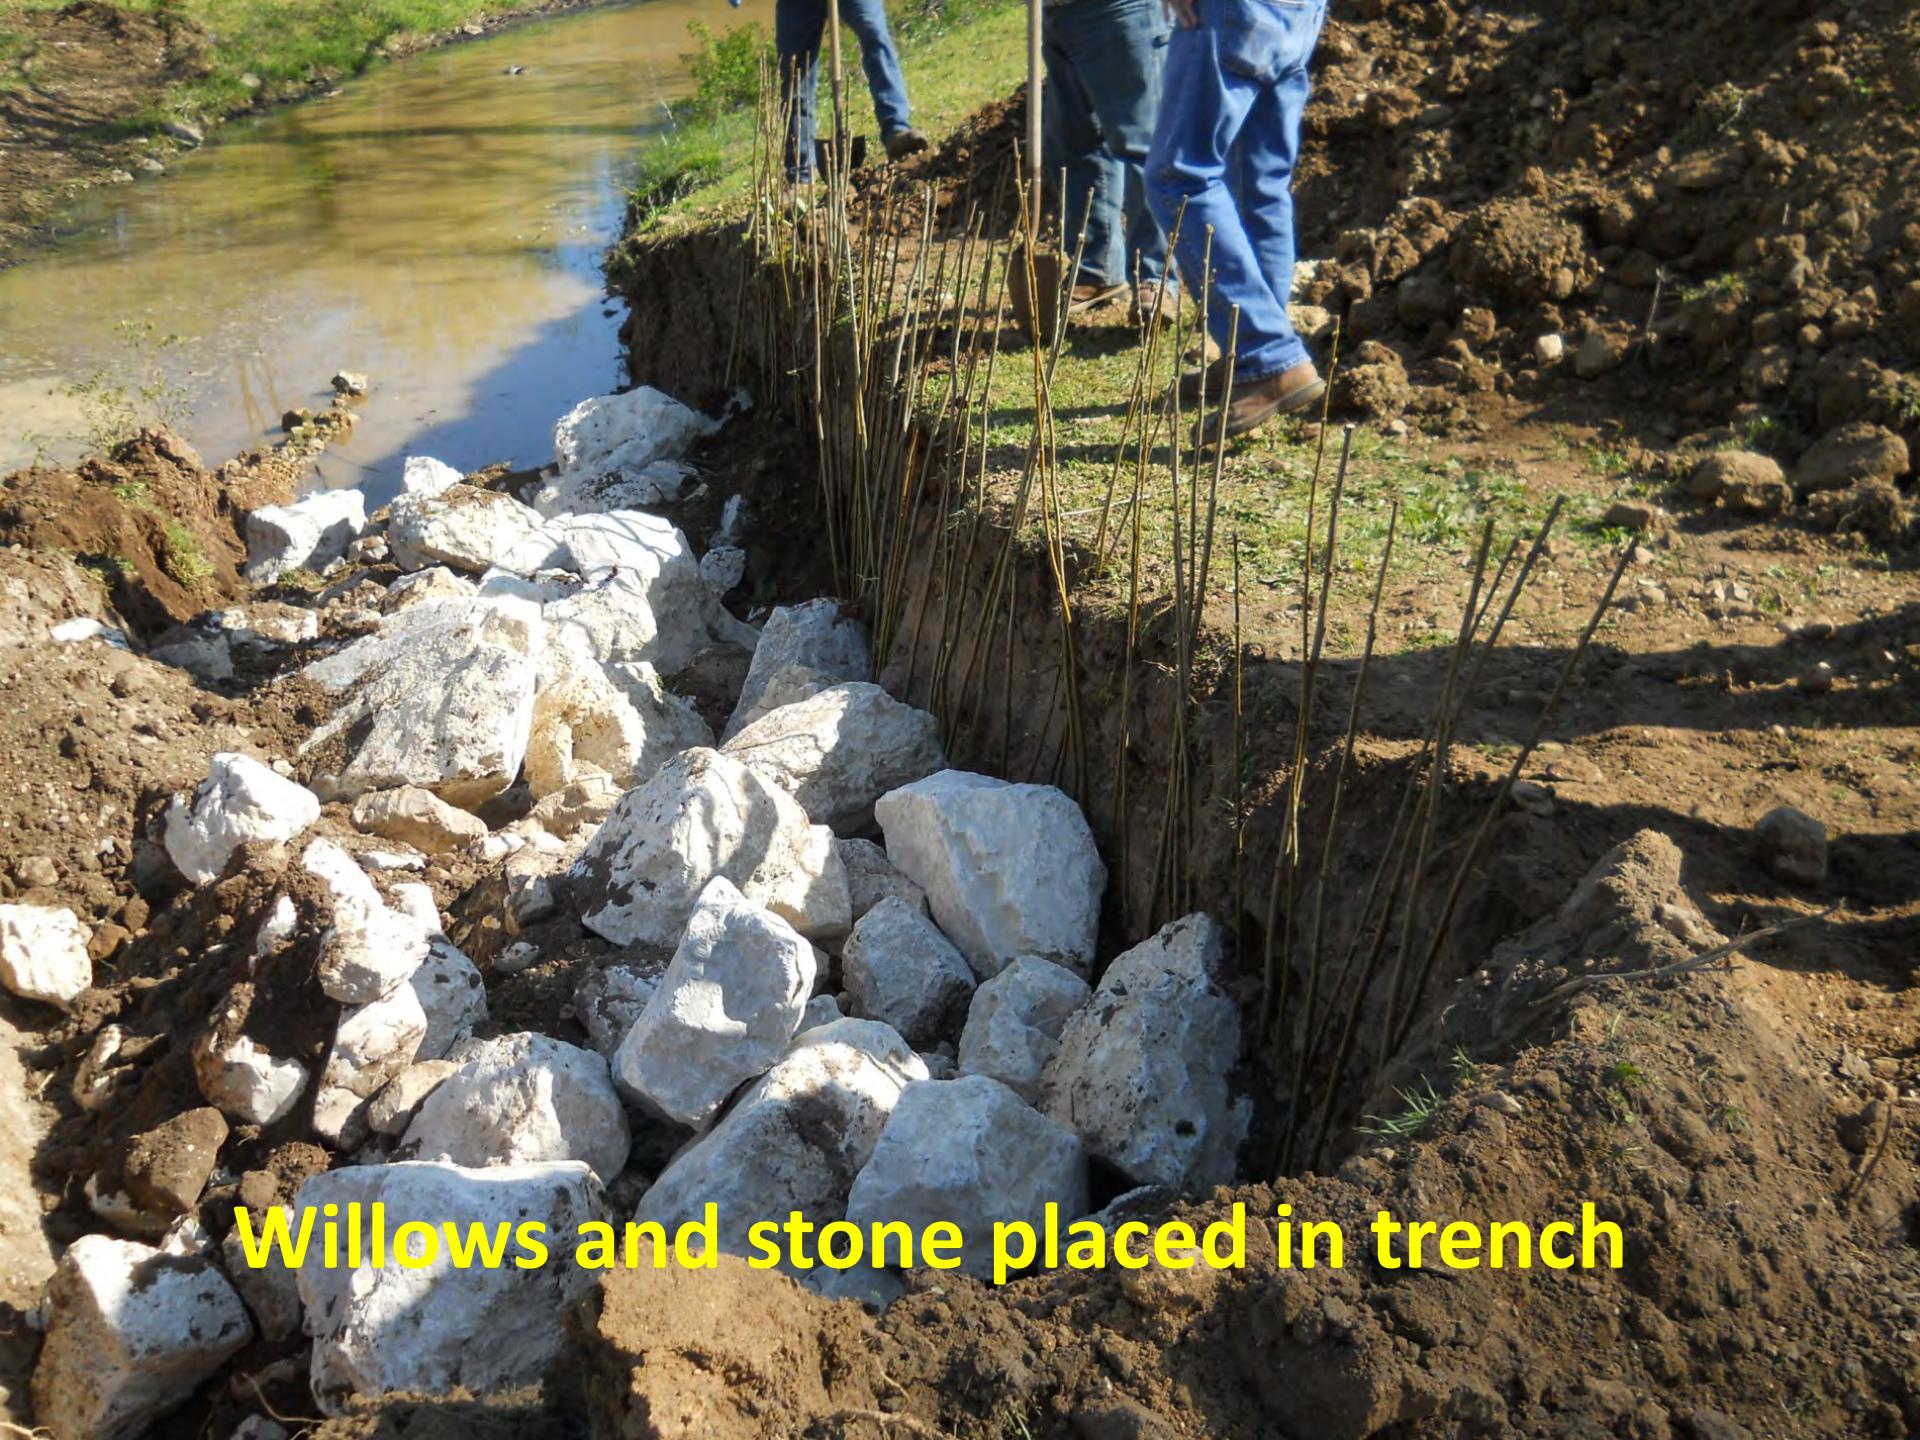
Willows and stone placed in trench

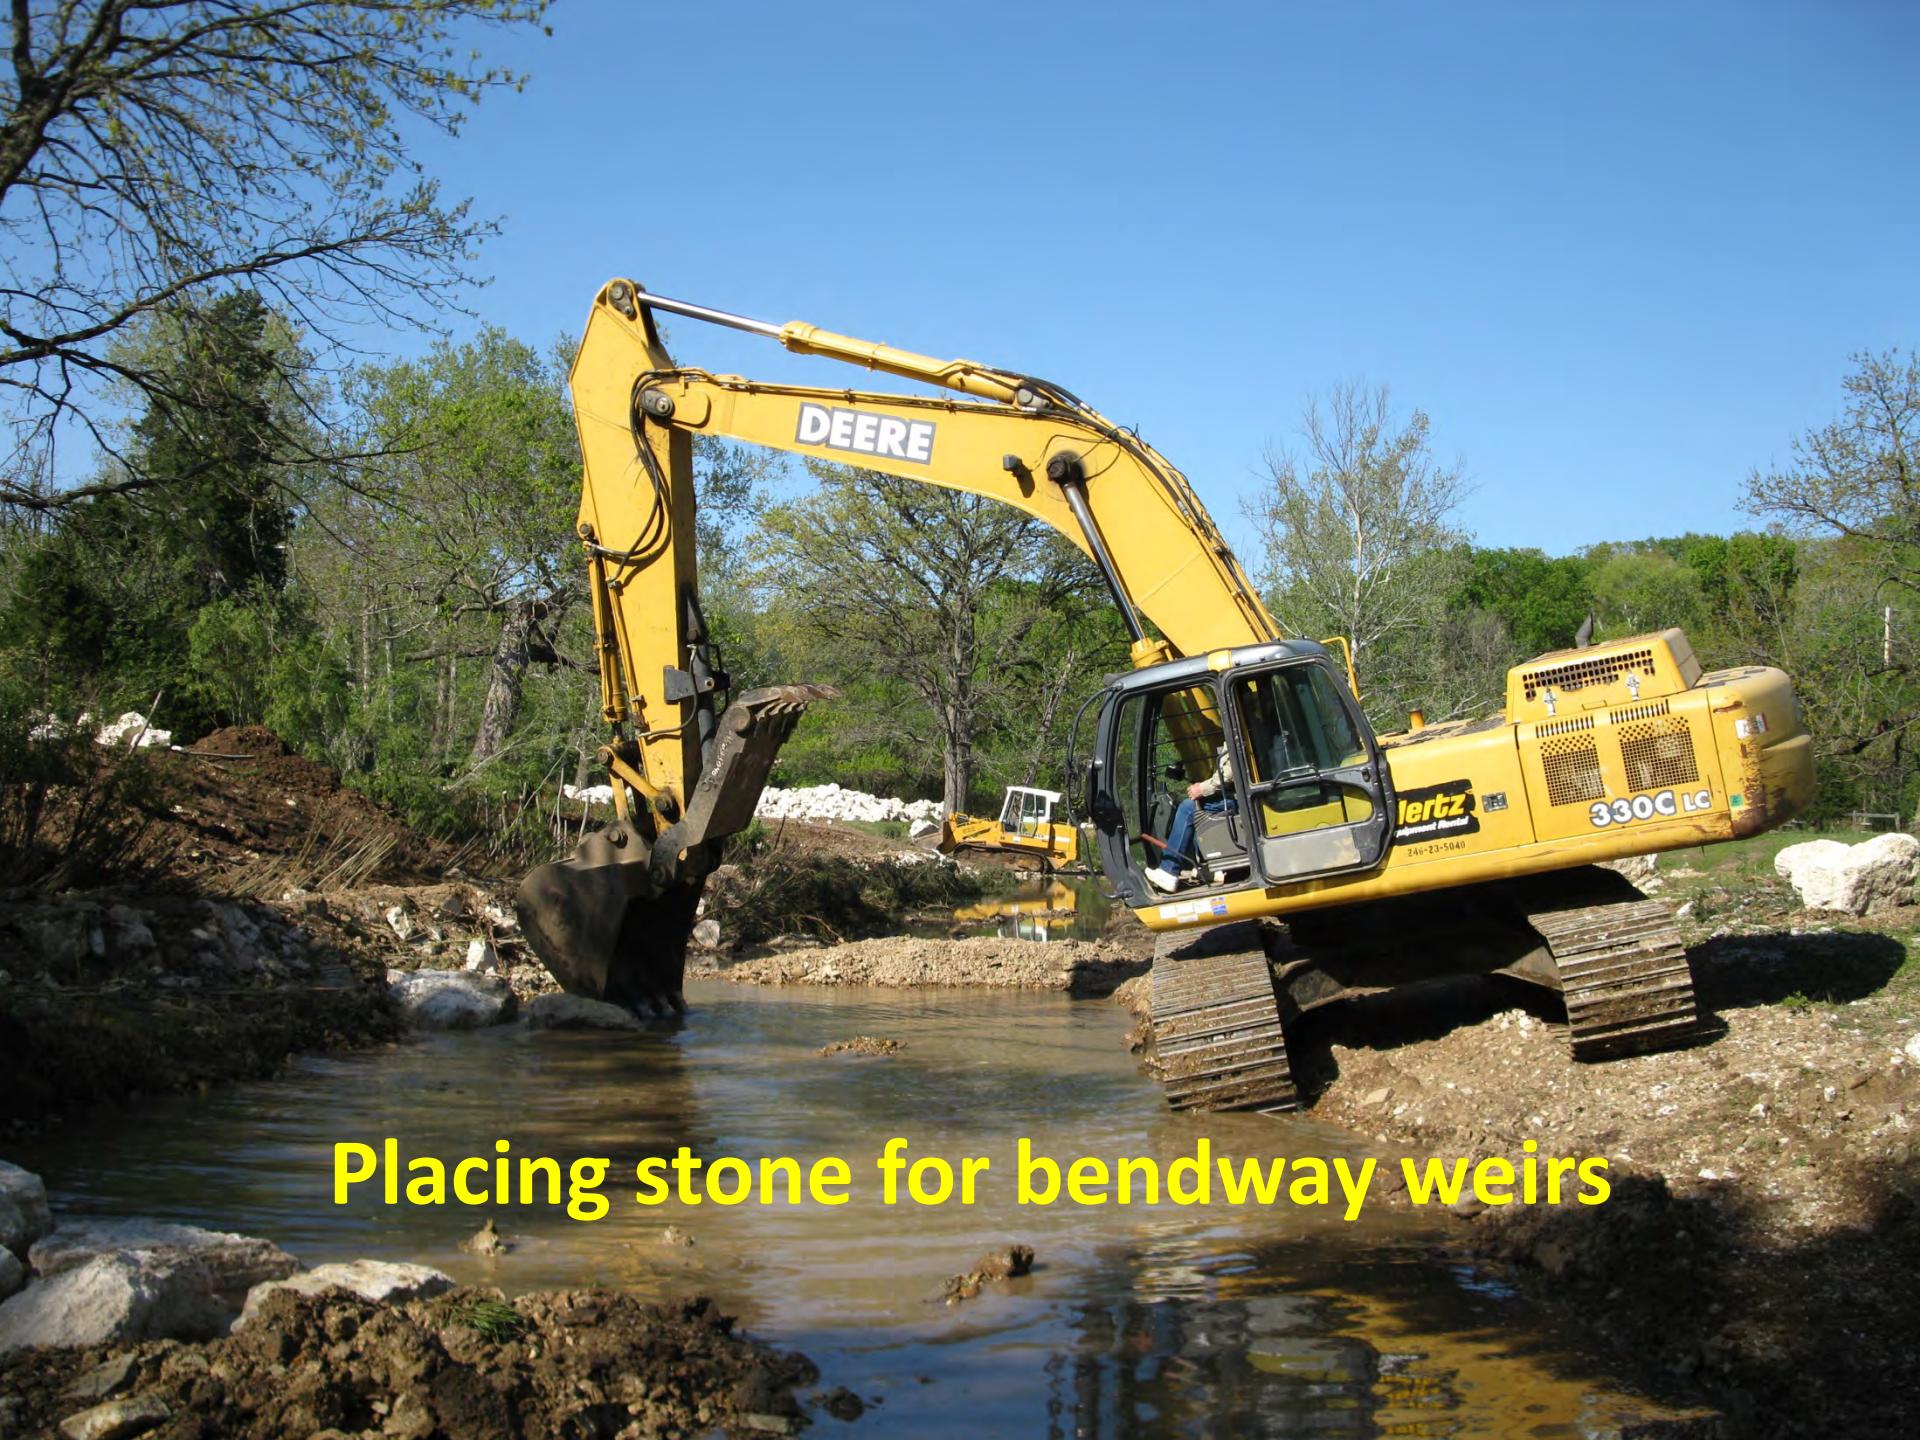
Placing stone for bendway weirs

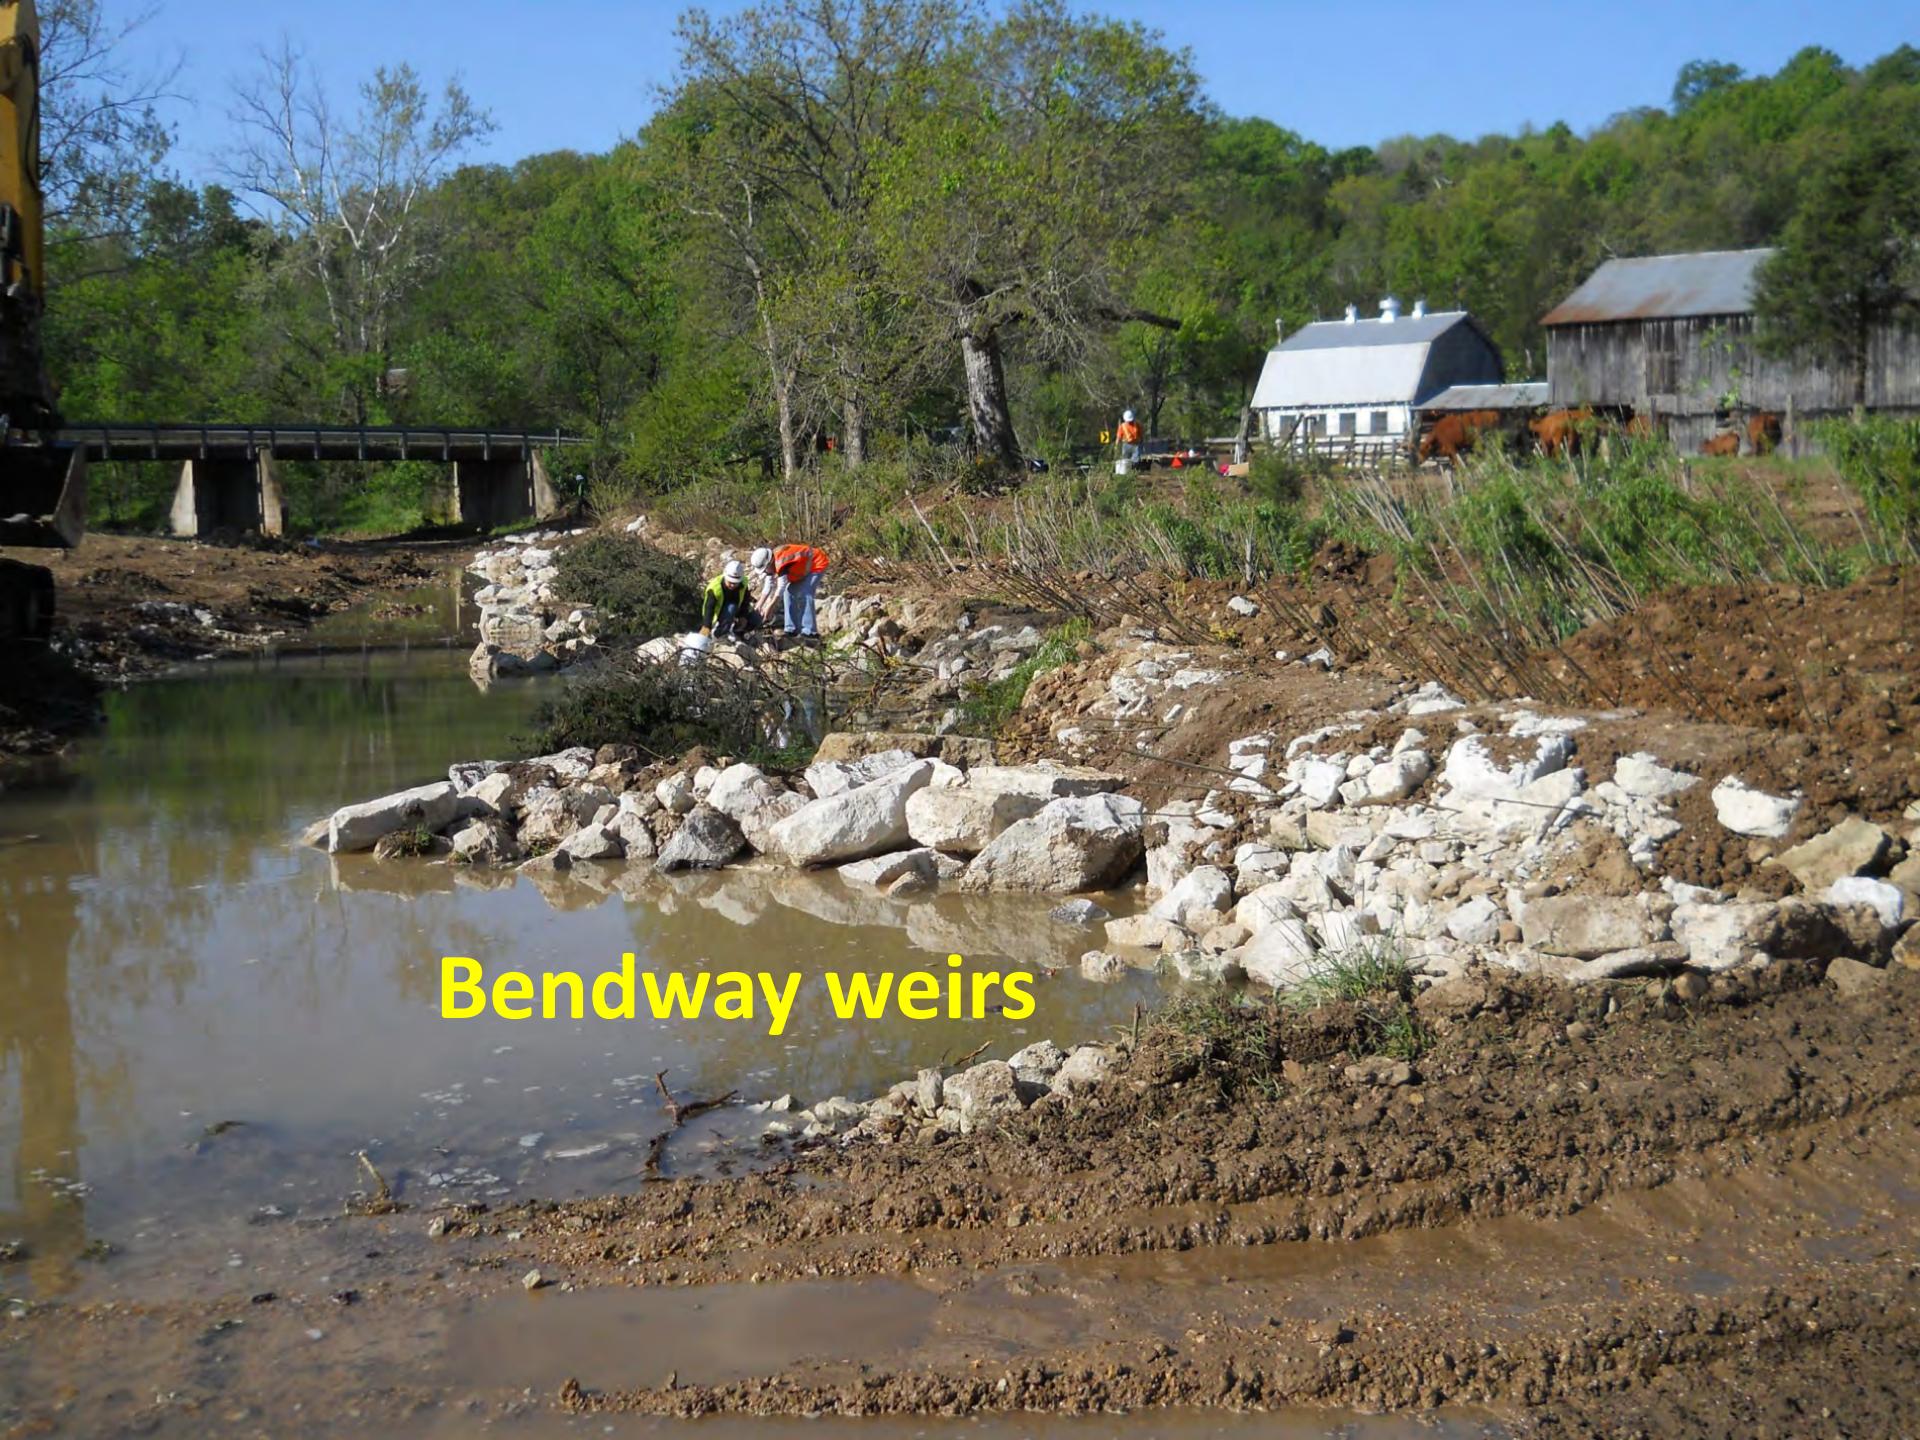
Bendway weirs

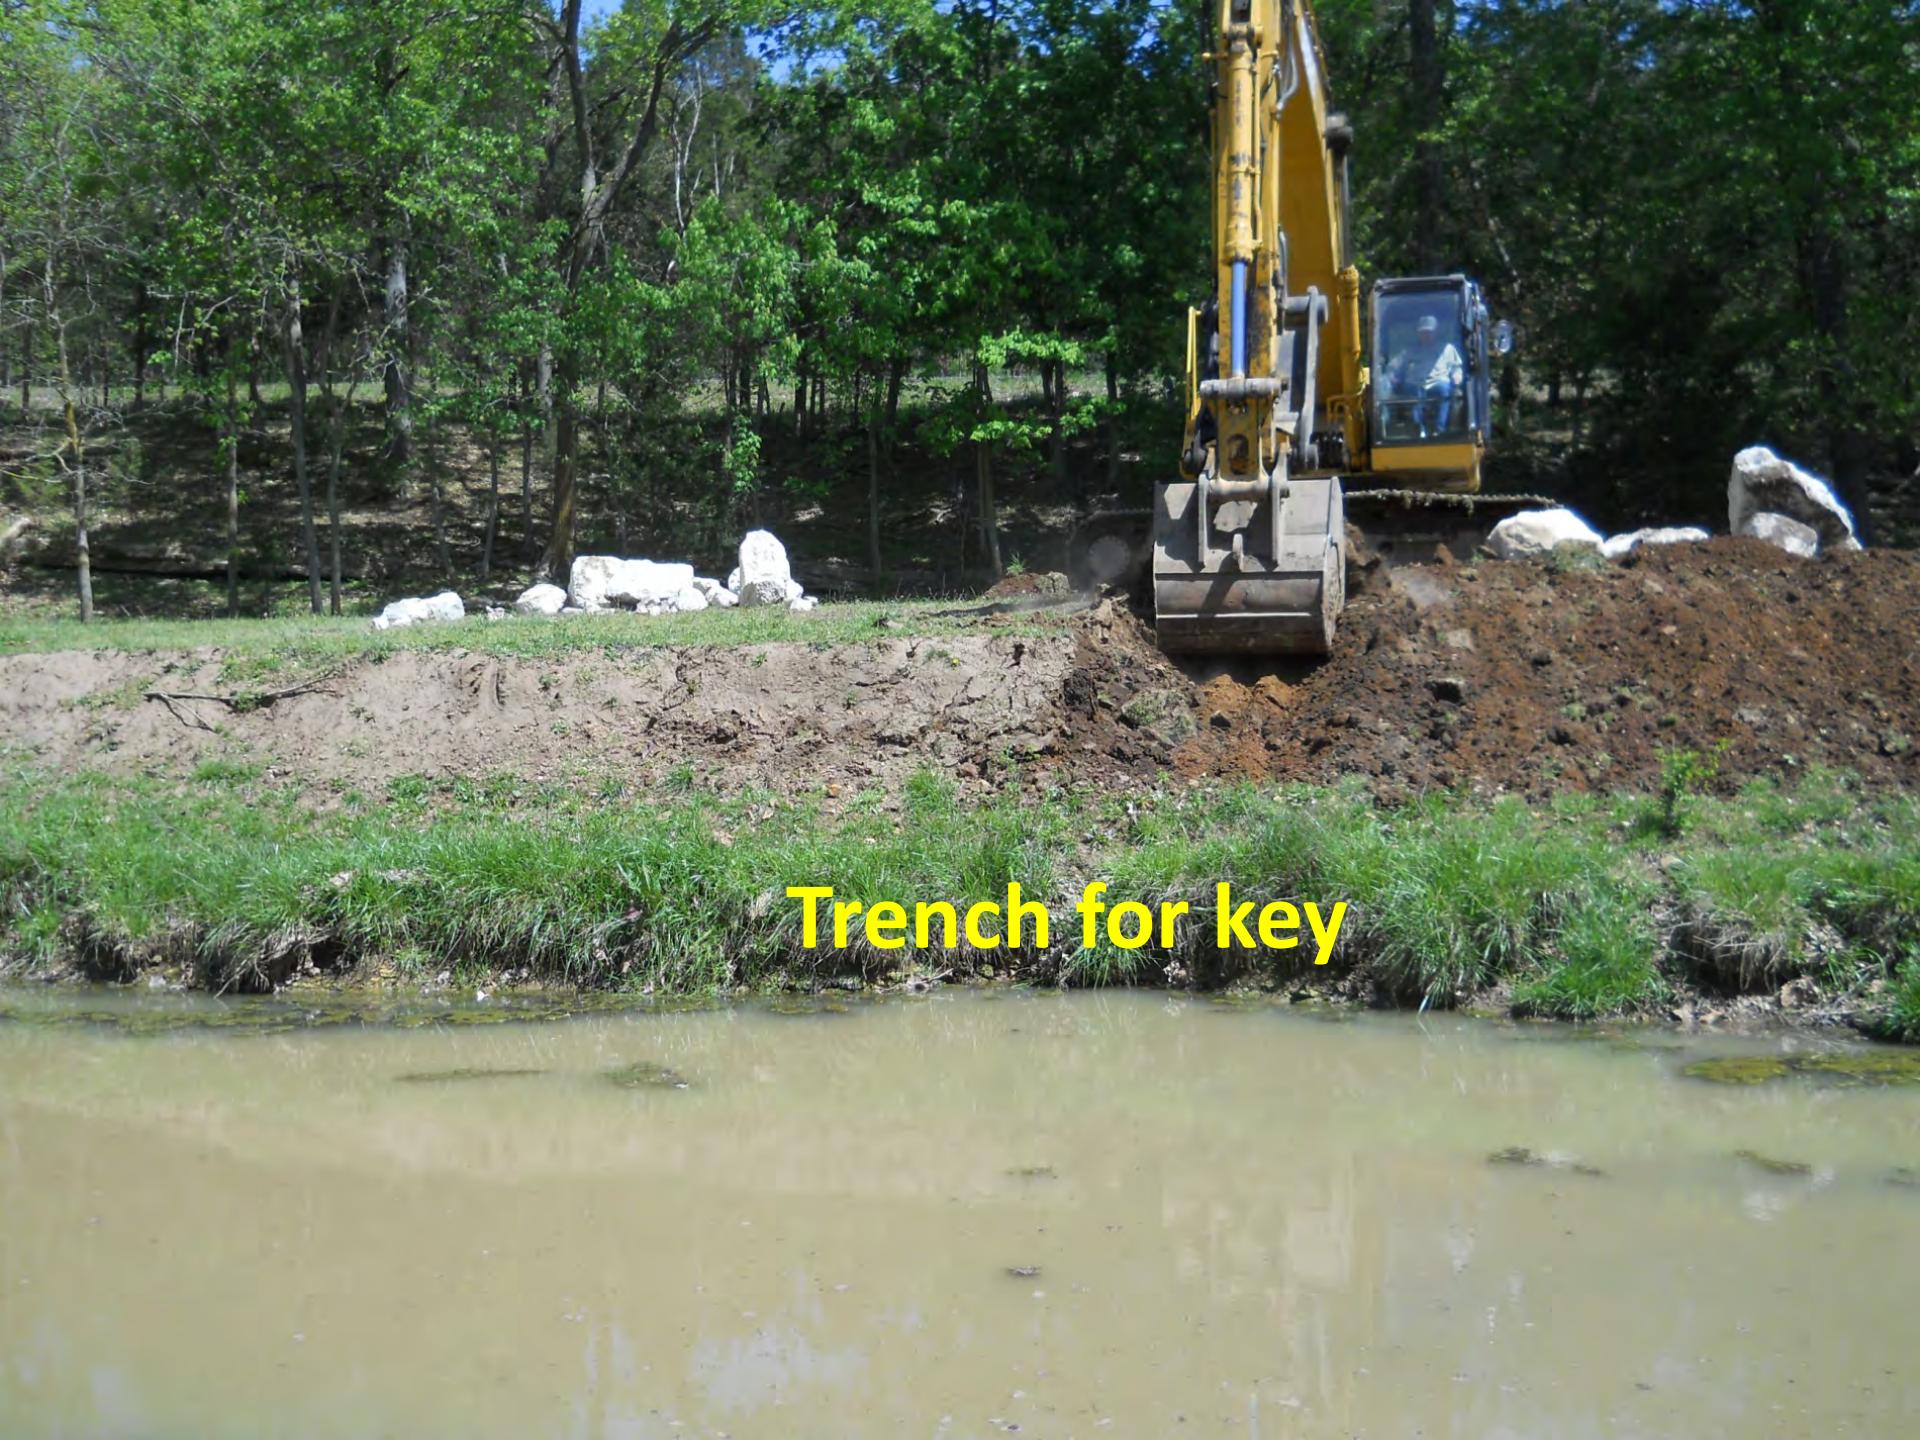
Trench for key

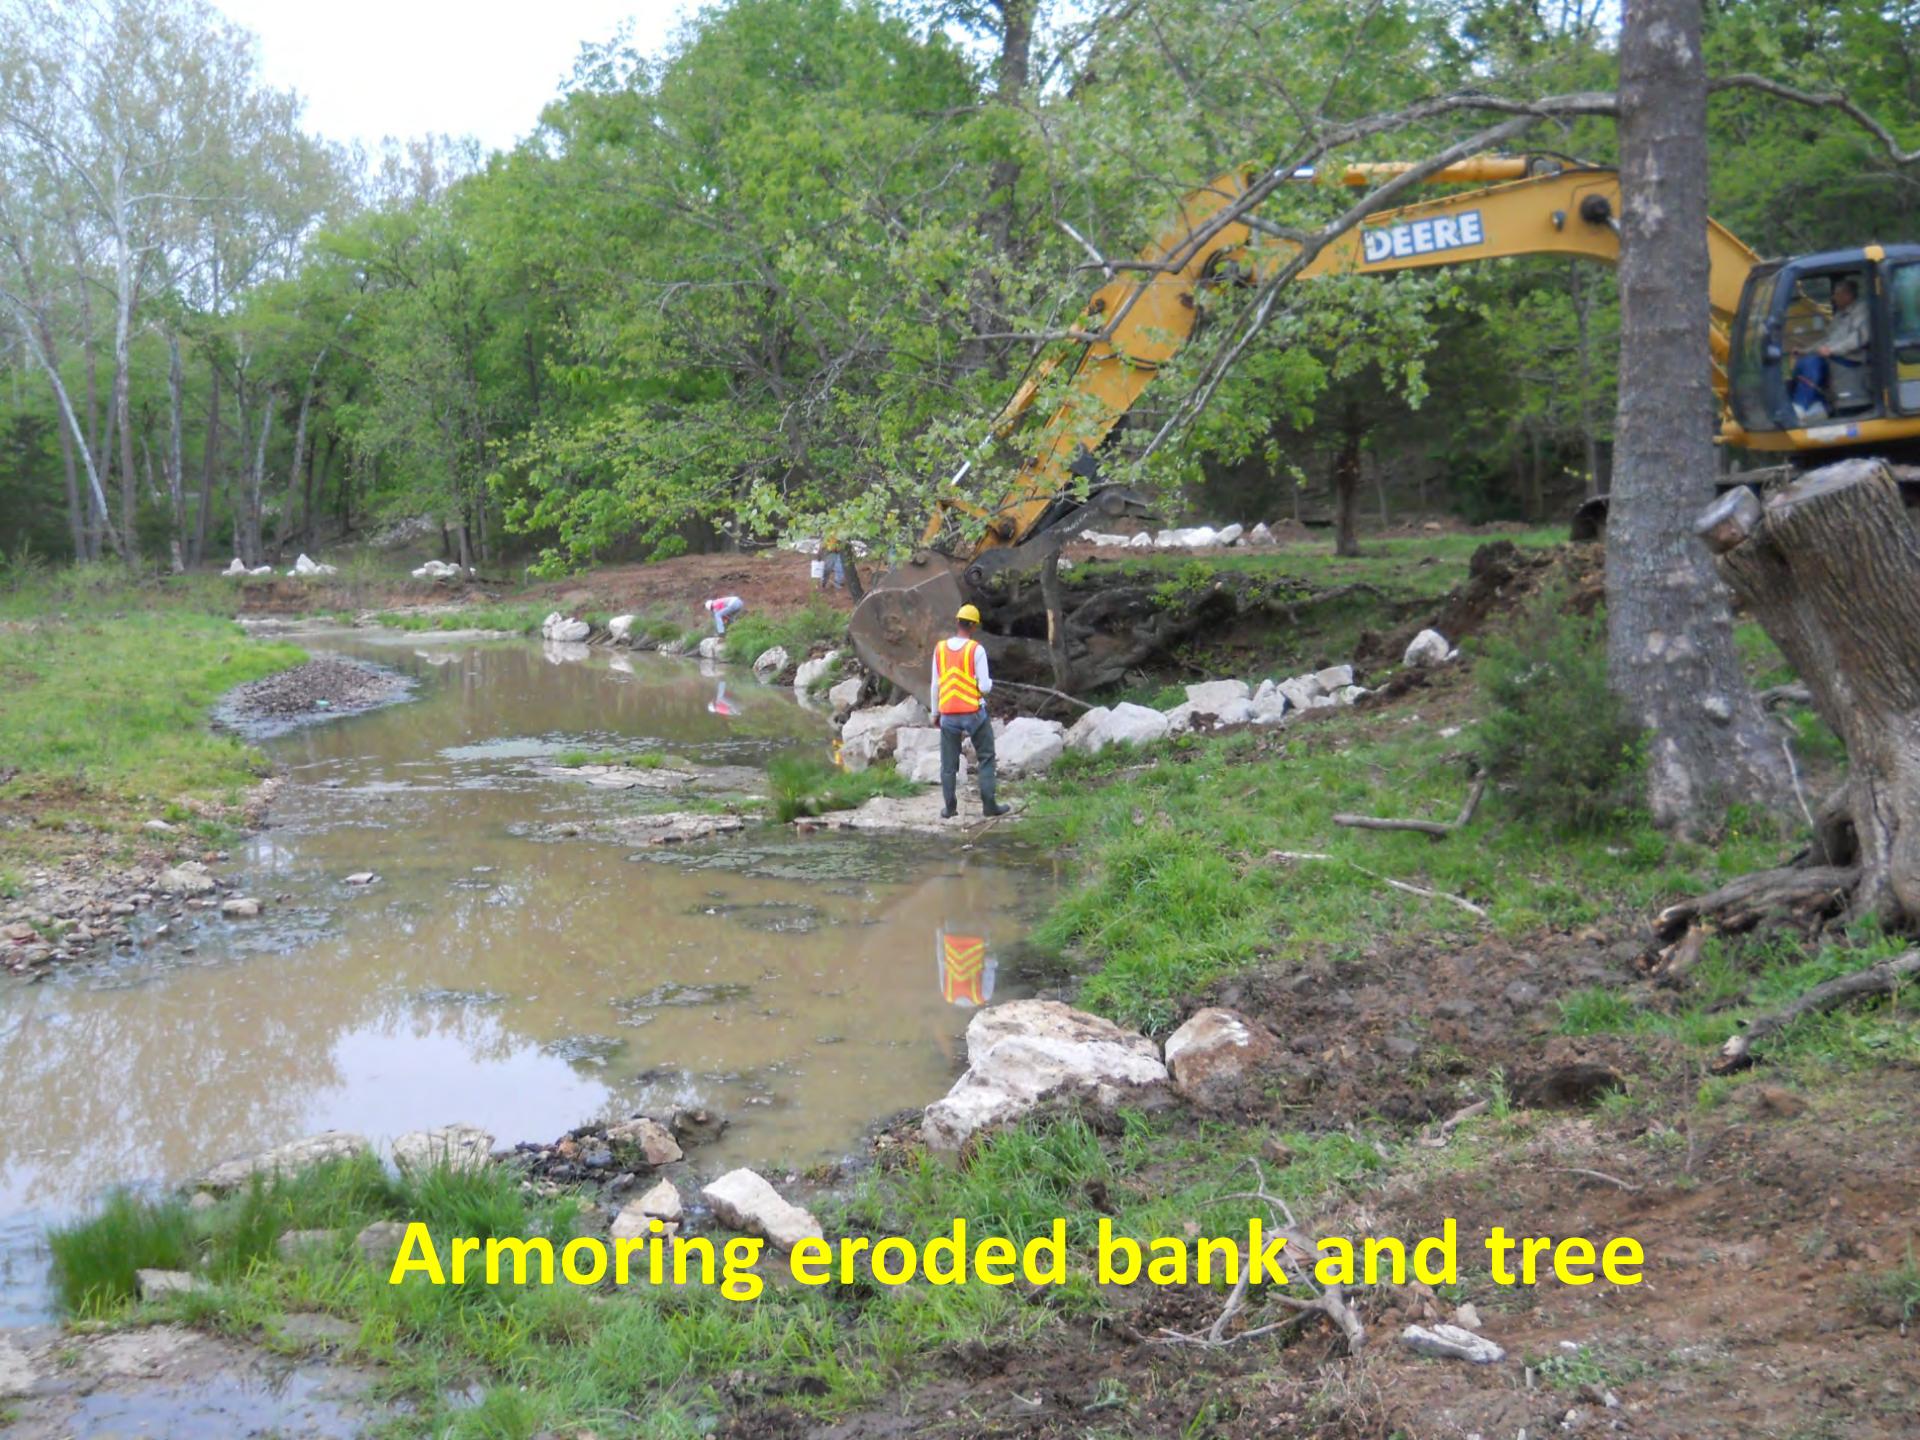
Armoring eroded bank and tree
