**Belews Creek Innovative
Streambank Stabilization
Seminar and Hands-On
Construction Workshop
April 10 – 12, 2012
(A Dave Derrick USACE Project)**

**Bank stabilization project funded
through an EPA 319 Implementation
grant obtained by Belews Creek
Watershed Partnership-
a citizen based non-profit organization**

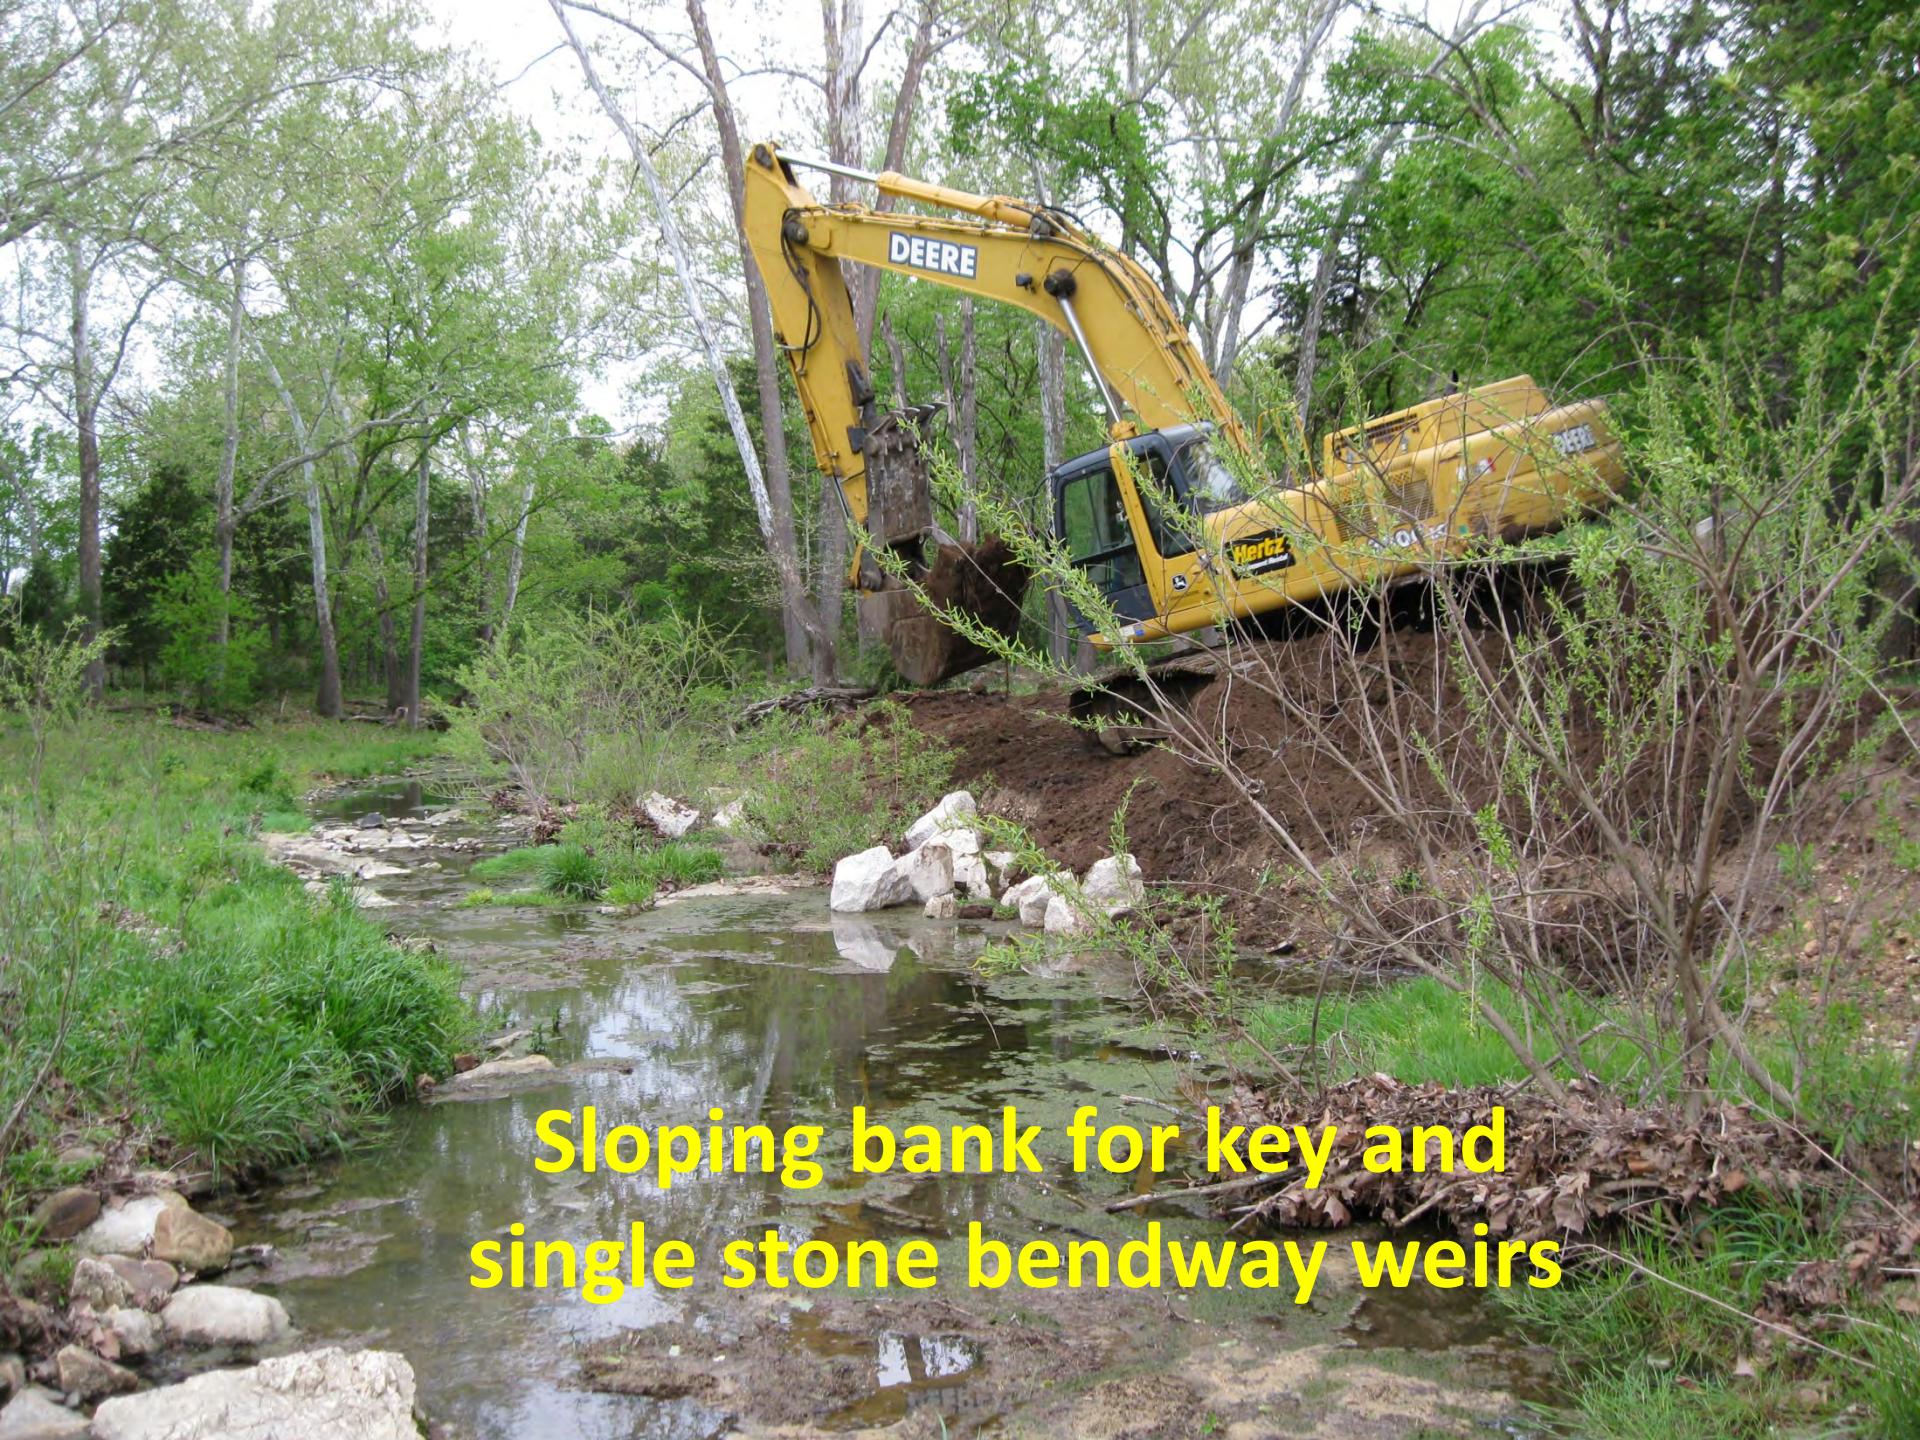
**Sloping bank for key and
single stone bendway weirs**

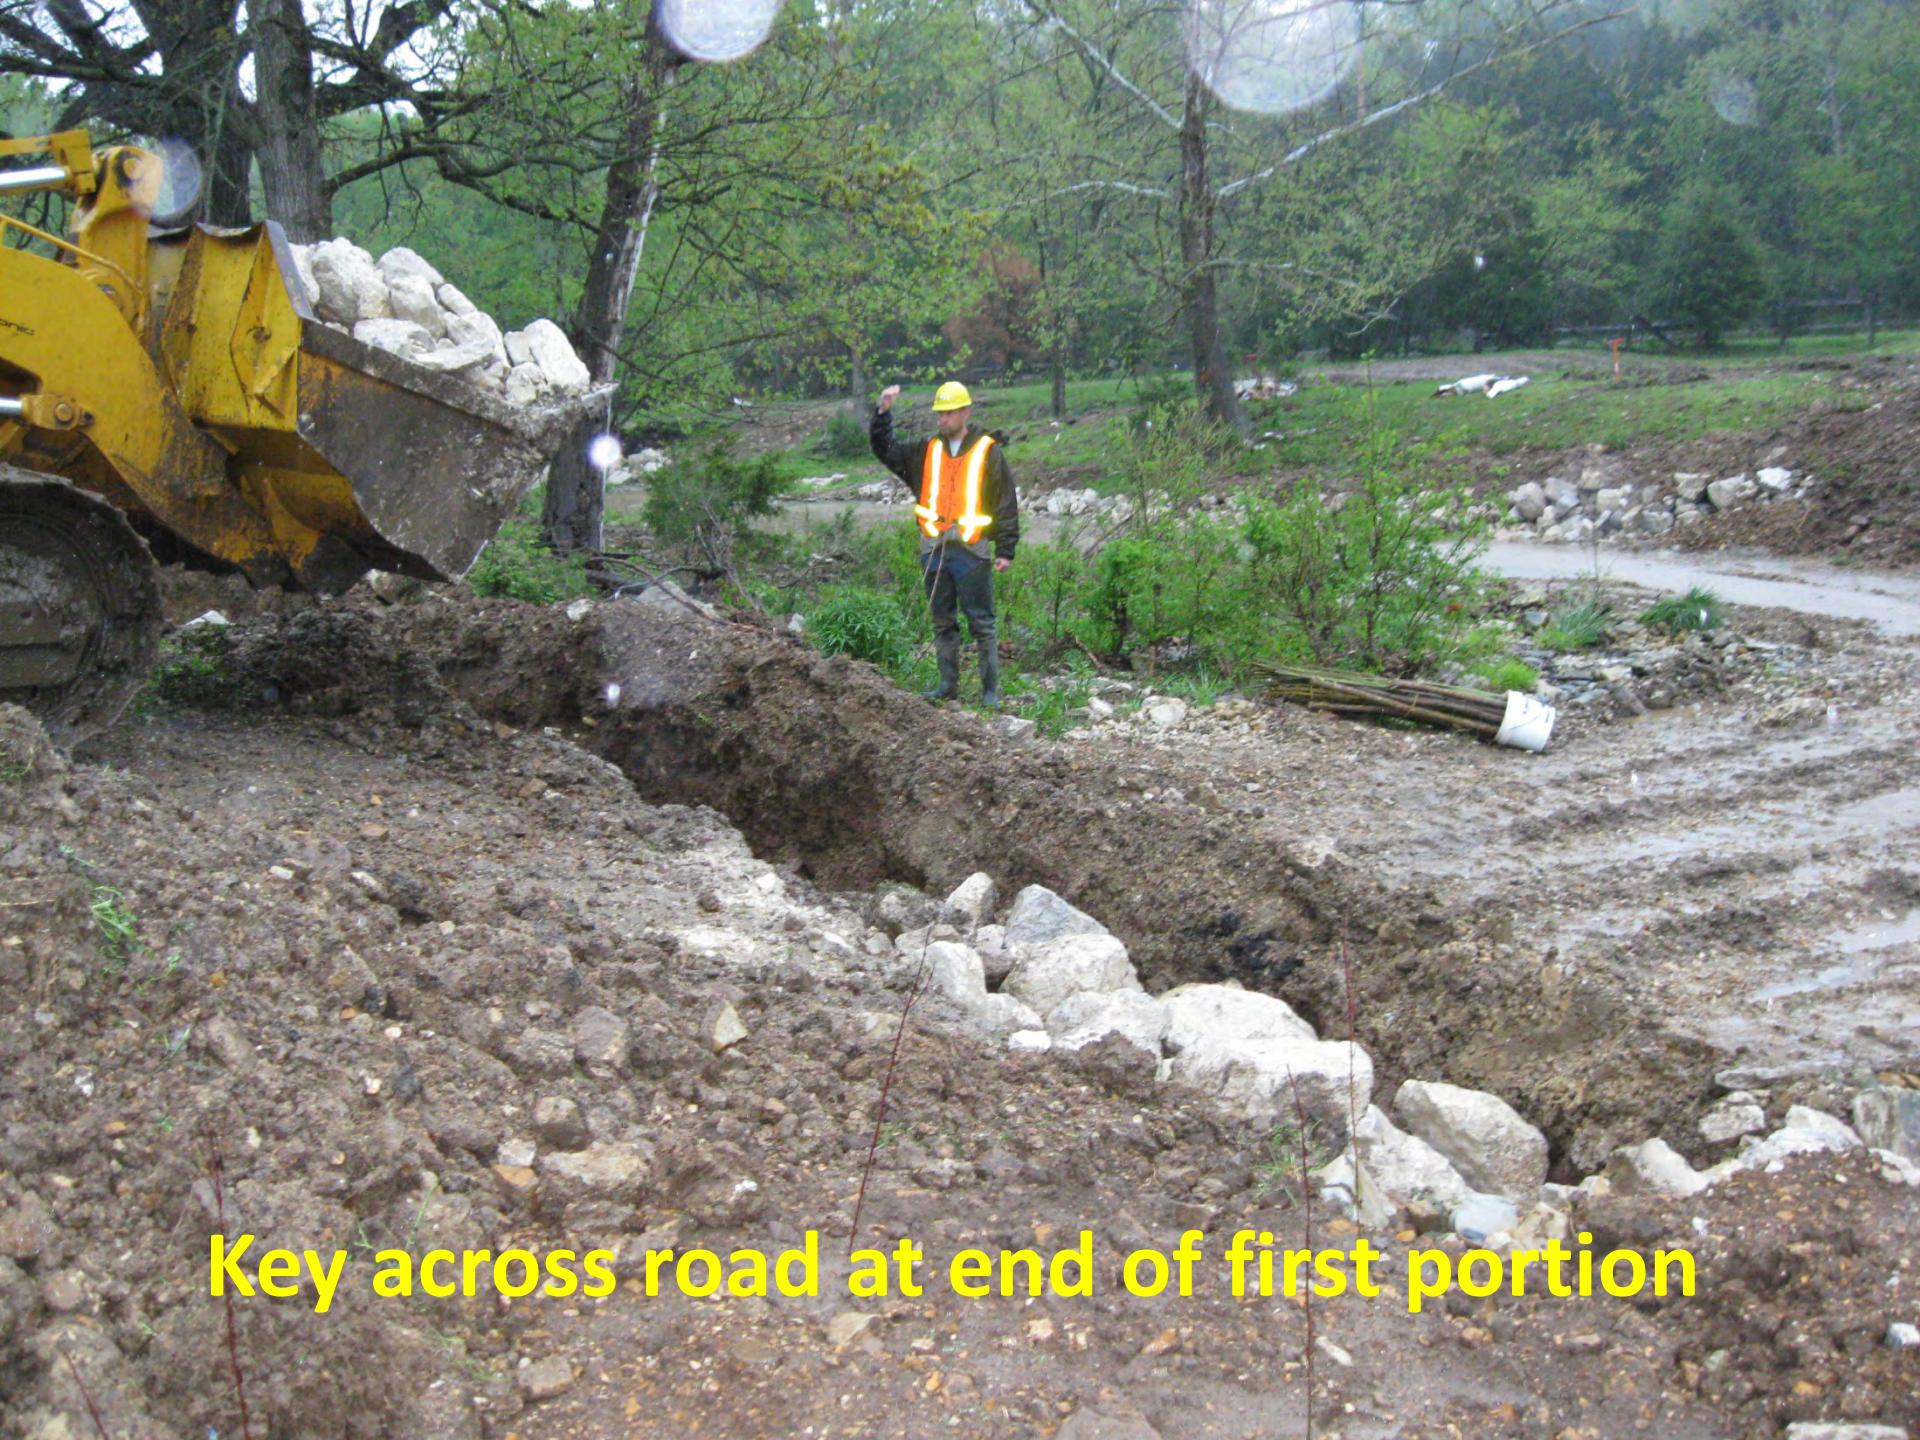
Key across road at end of first portion

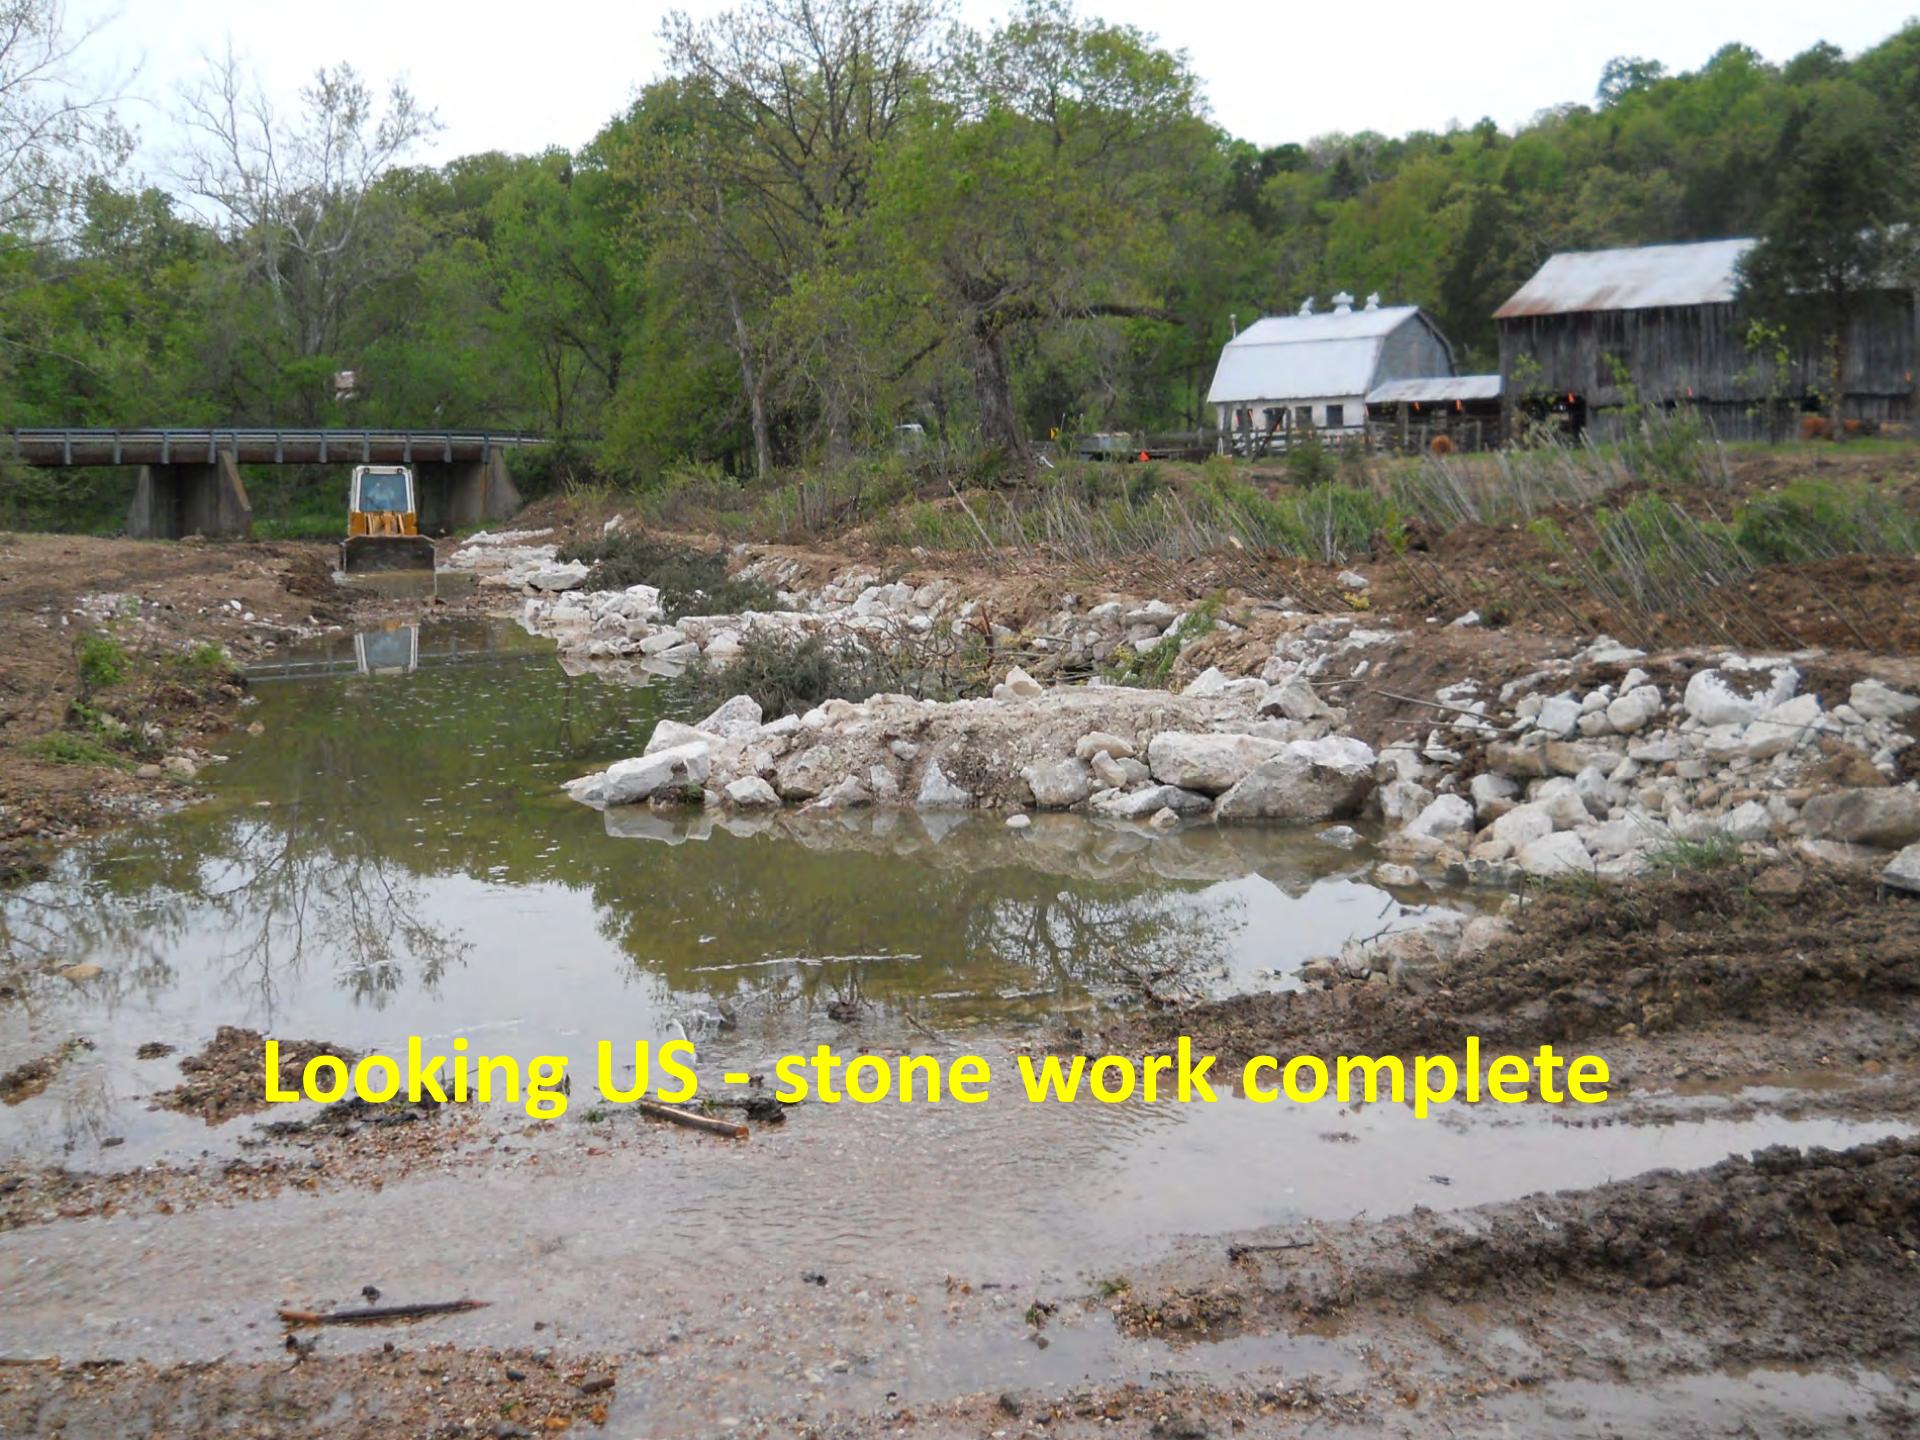
Looking US - stone work complete

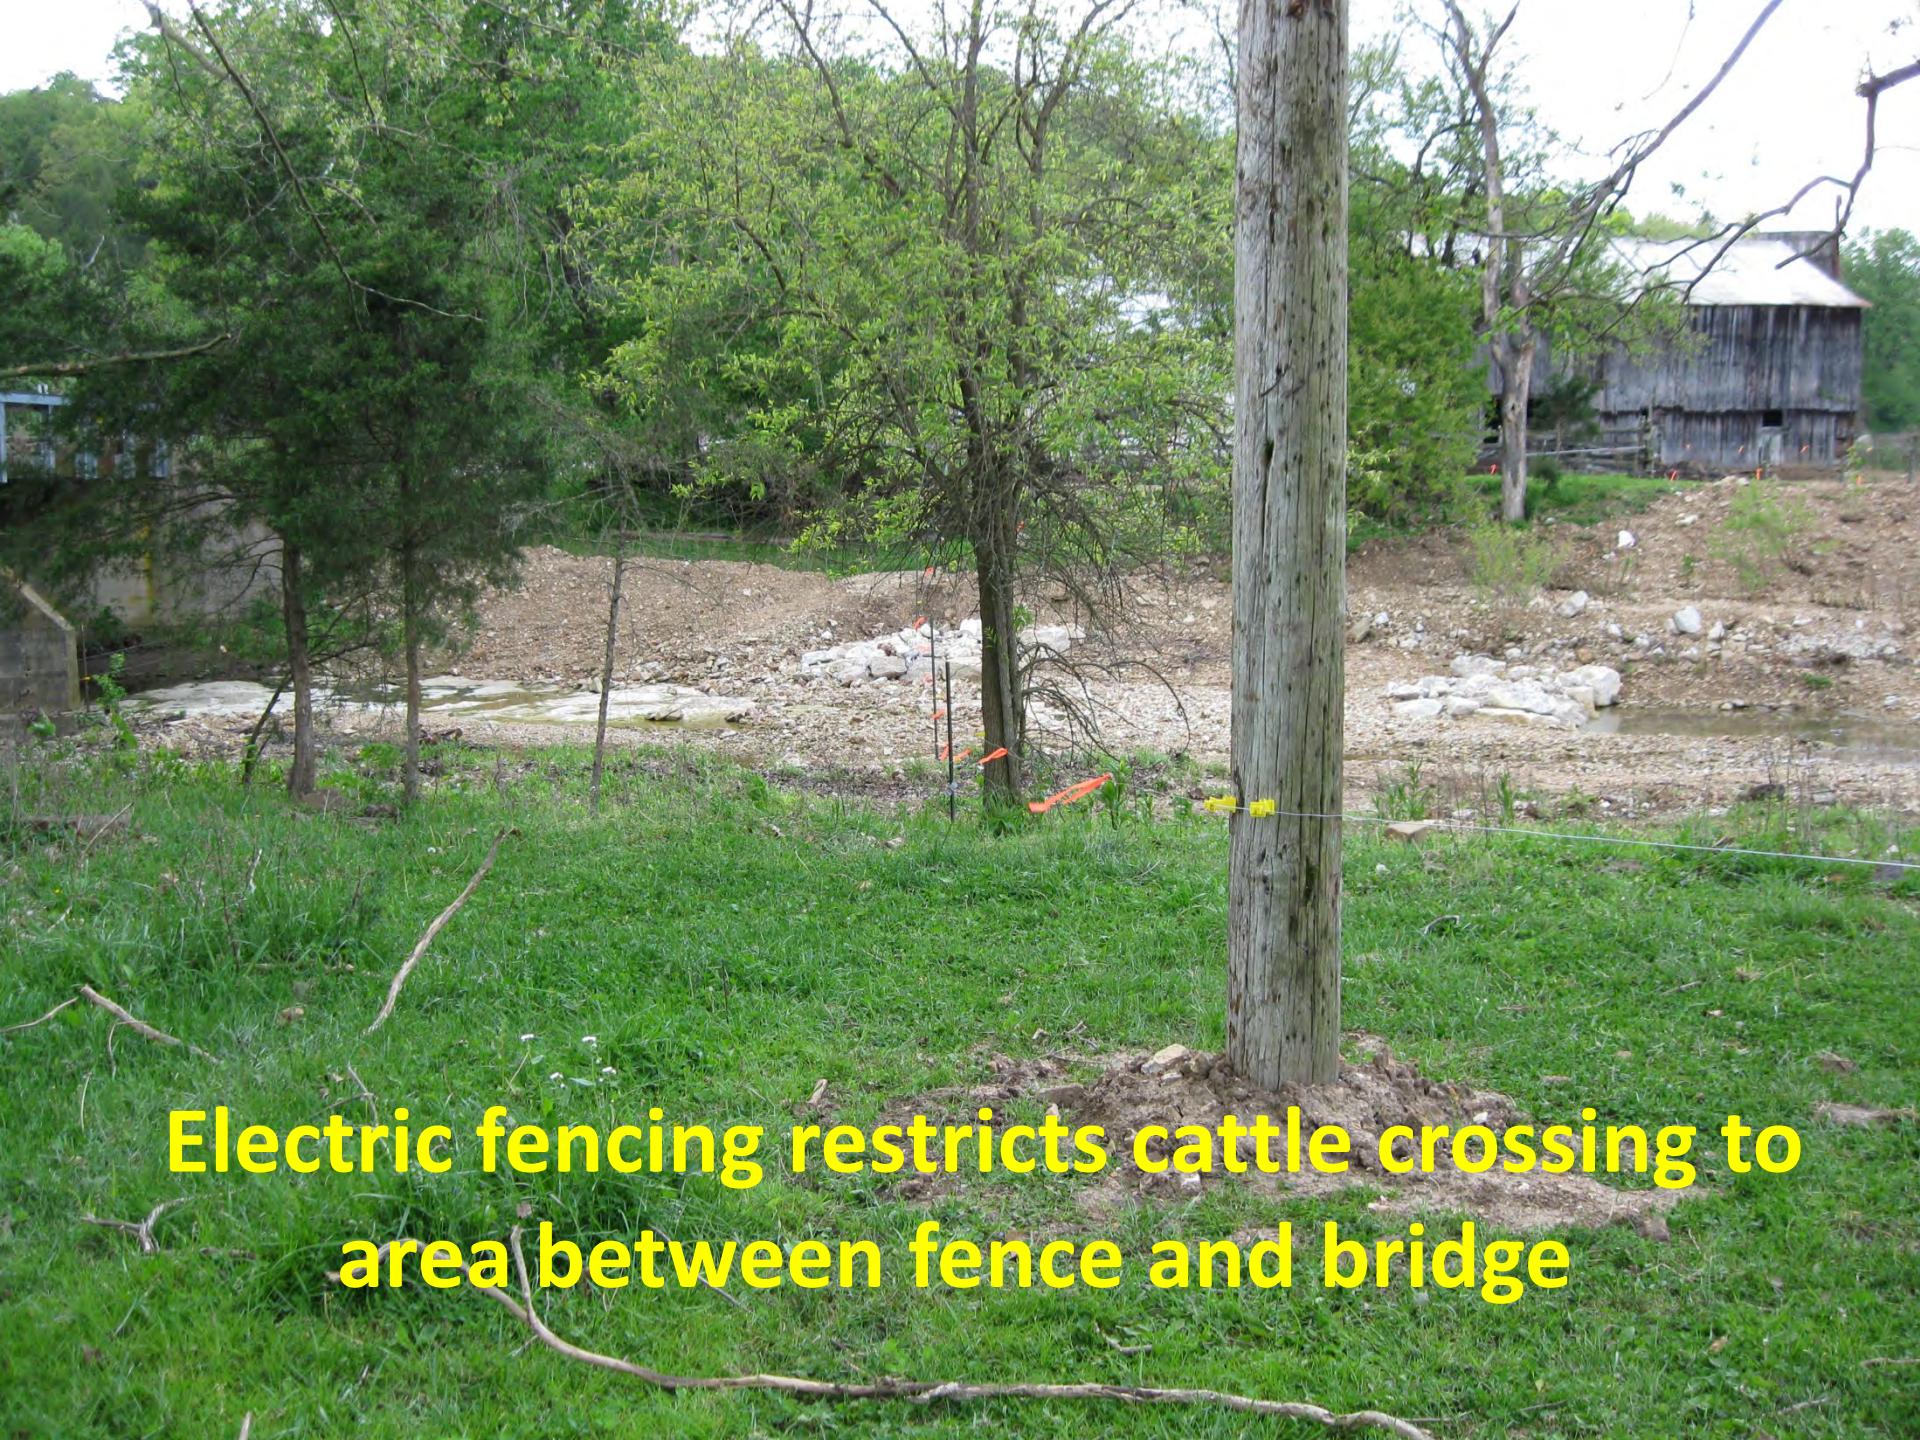
Electric fencing restricts cattle crossing to
area between fence and bridge

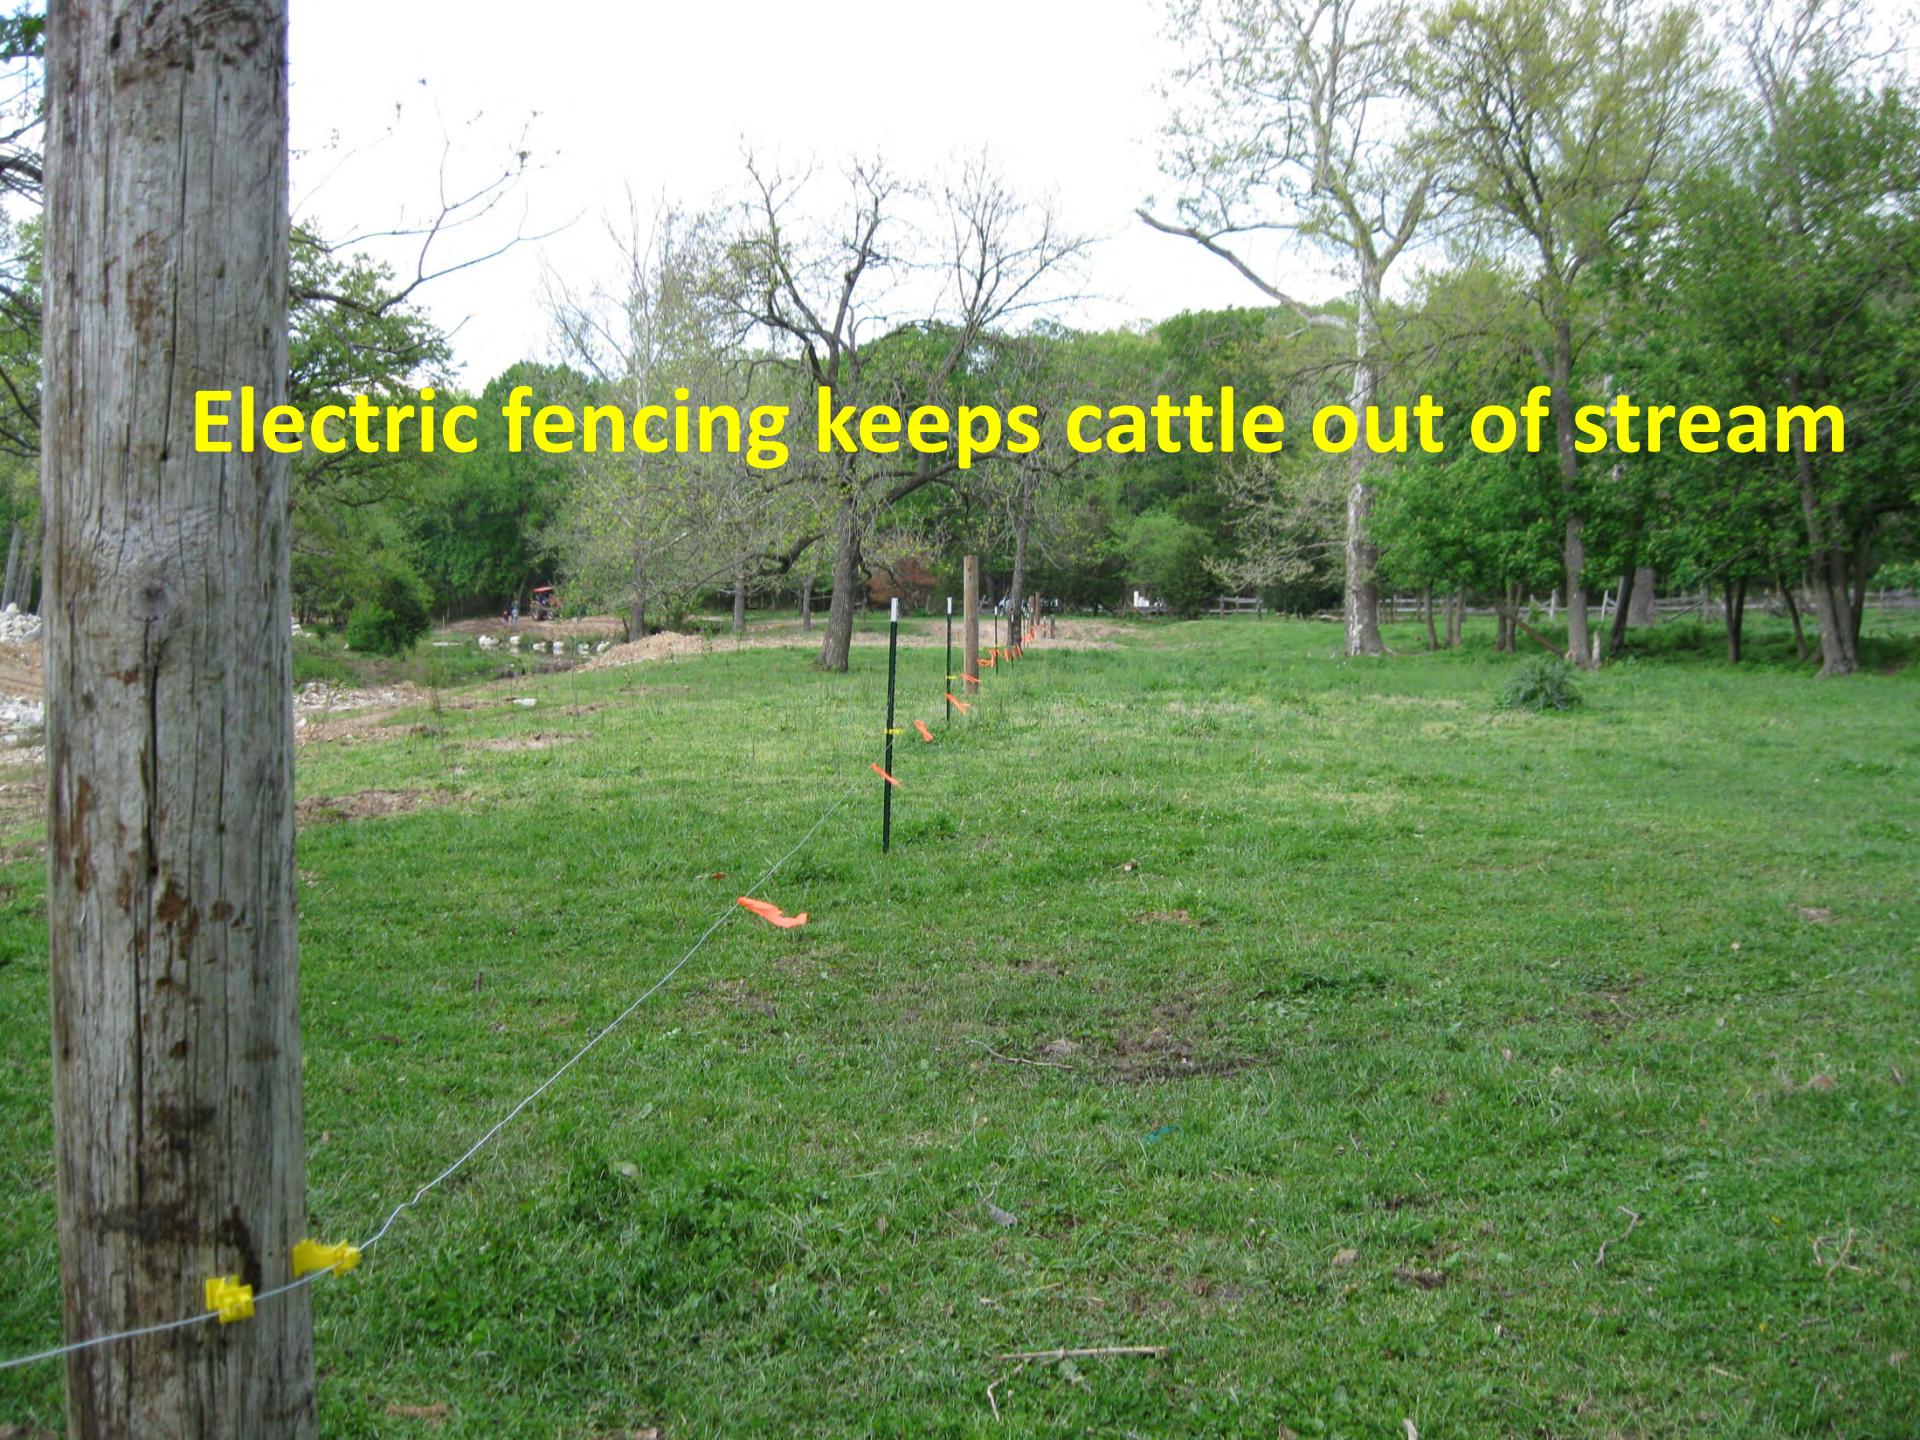
Electric fencing keeps cattle out of stream

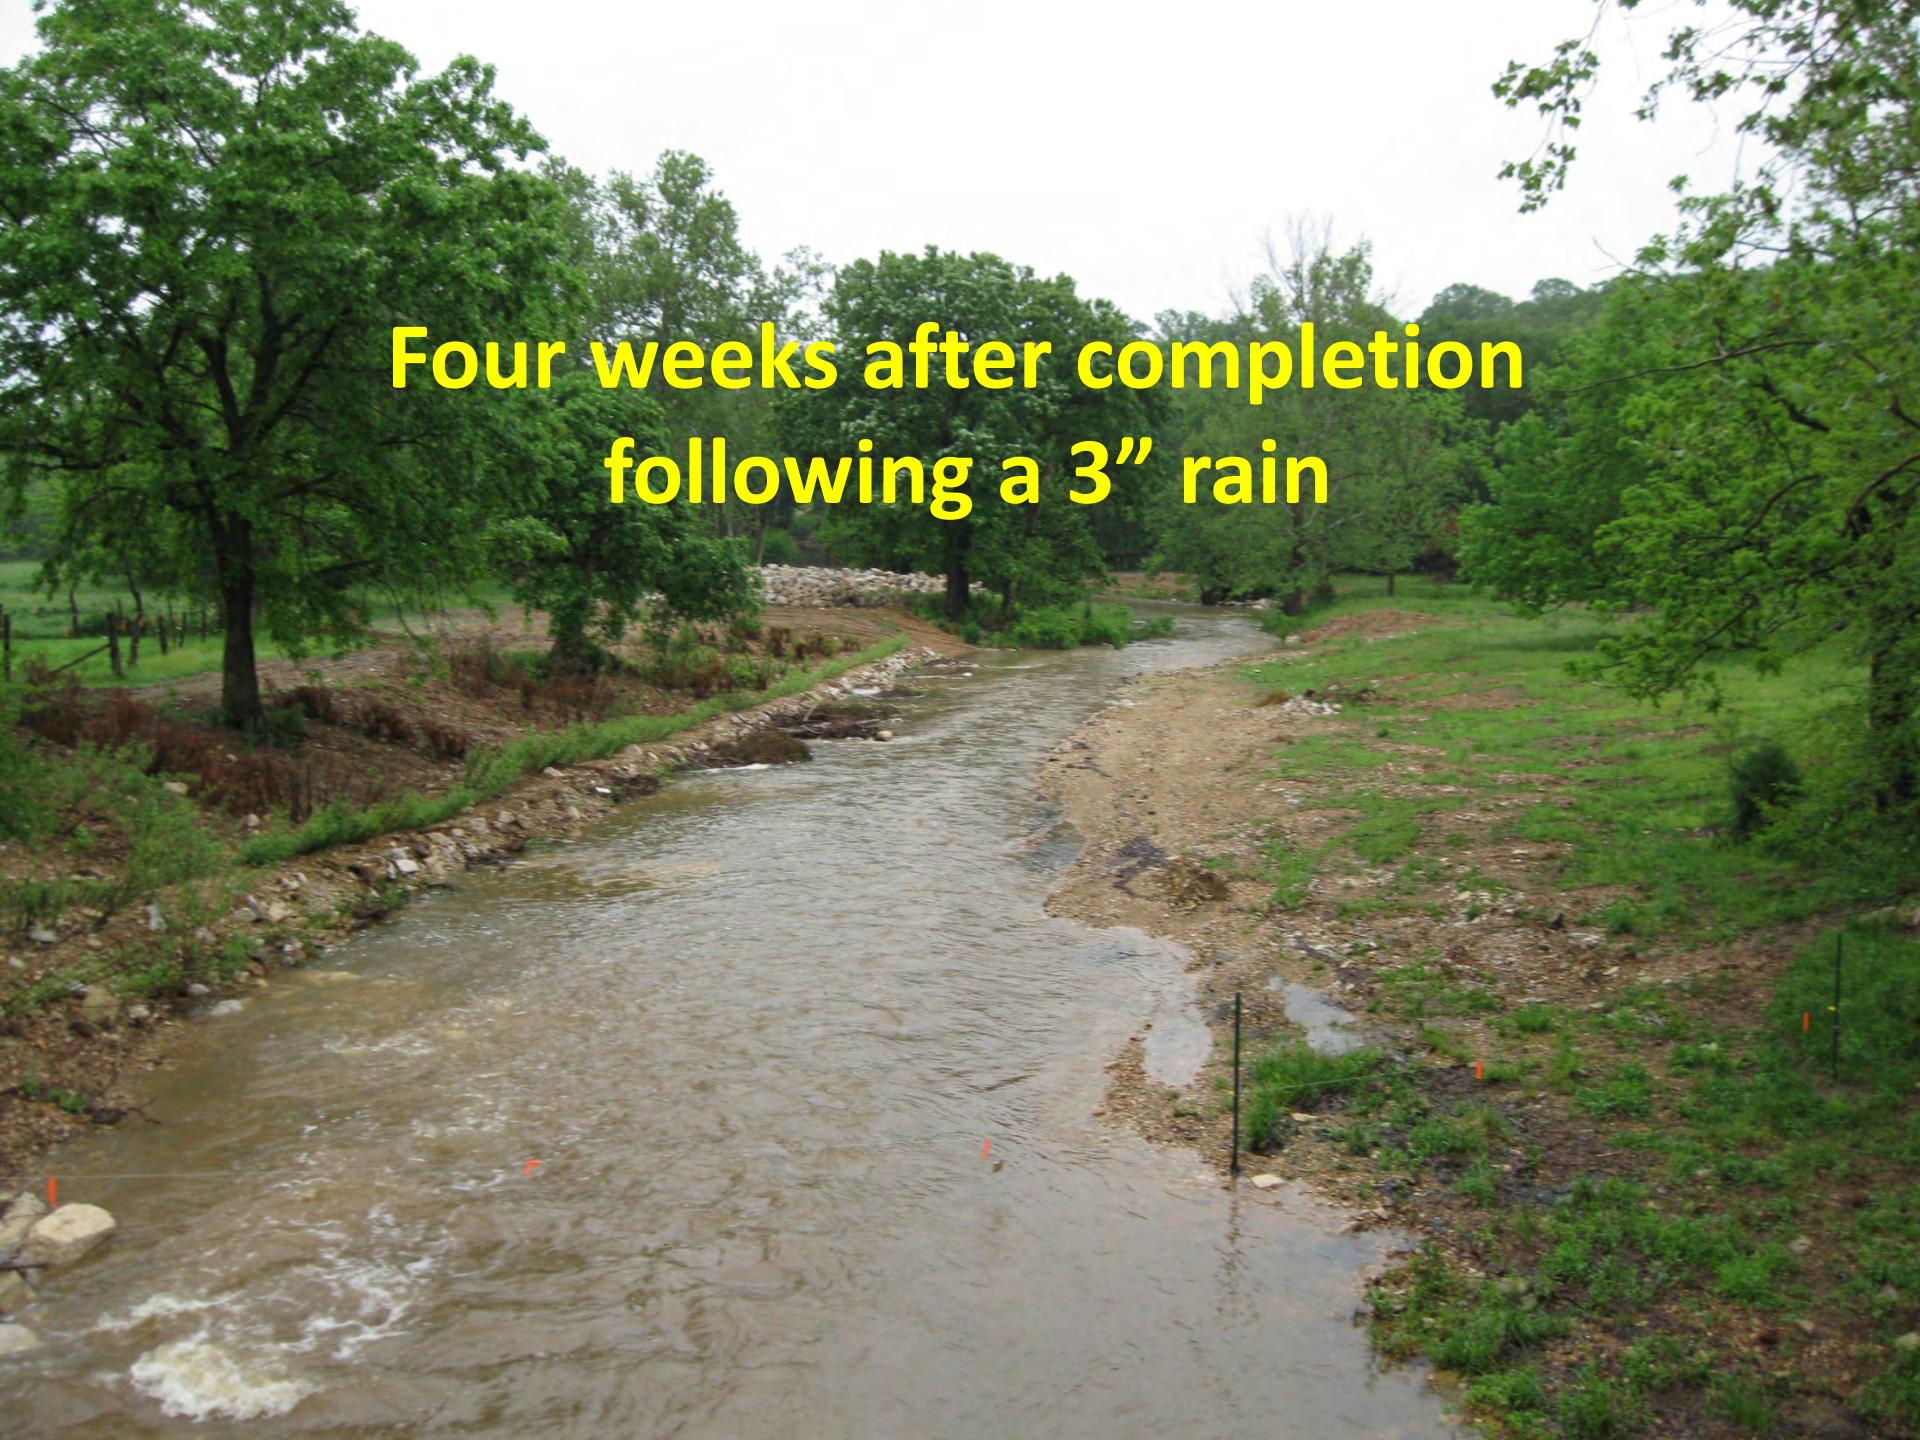
Four weeks after completion
following a 3" rain
