**Belews Creek Innovative
Streambank Stabilization
Seminar and Hands-On
Construction Workshop
April 10 – 12, 2012
(A Dave Derrick USACE Project)**

**Bank stabilization project funded
through an EPA 319 Implementation
grant obtained by Belews Creek
Watershed Partnership-
a citizen based non-profit organization**

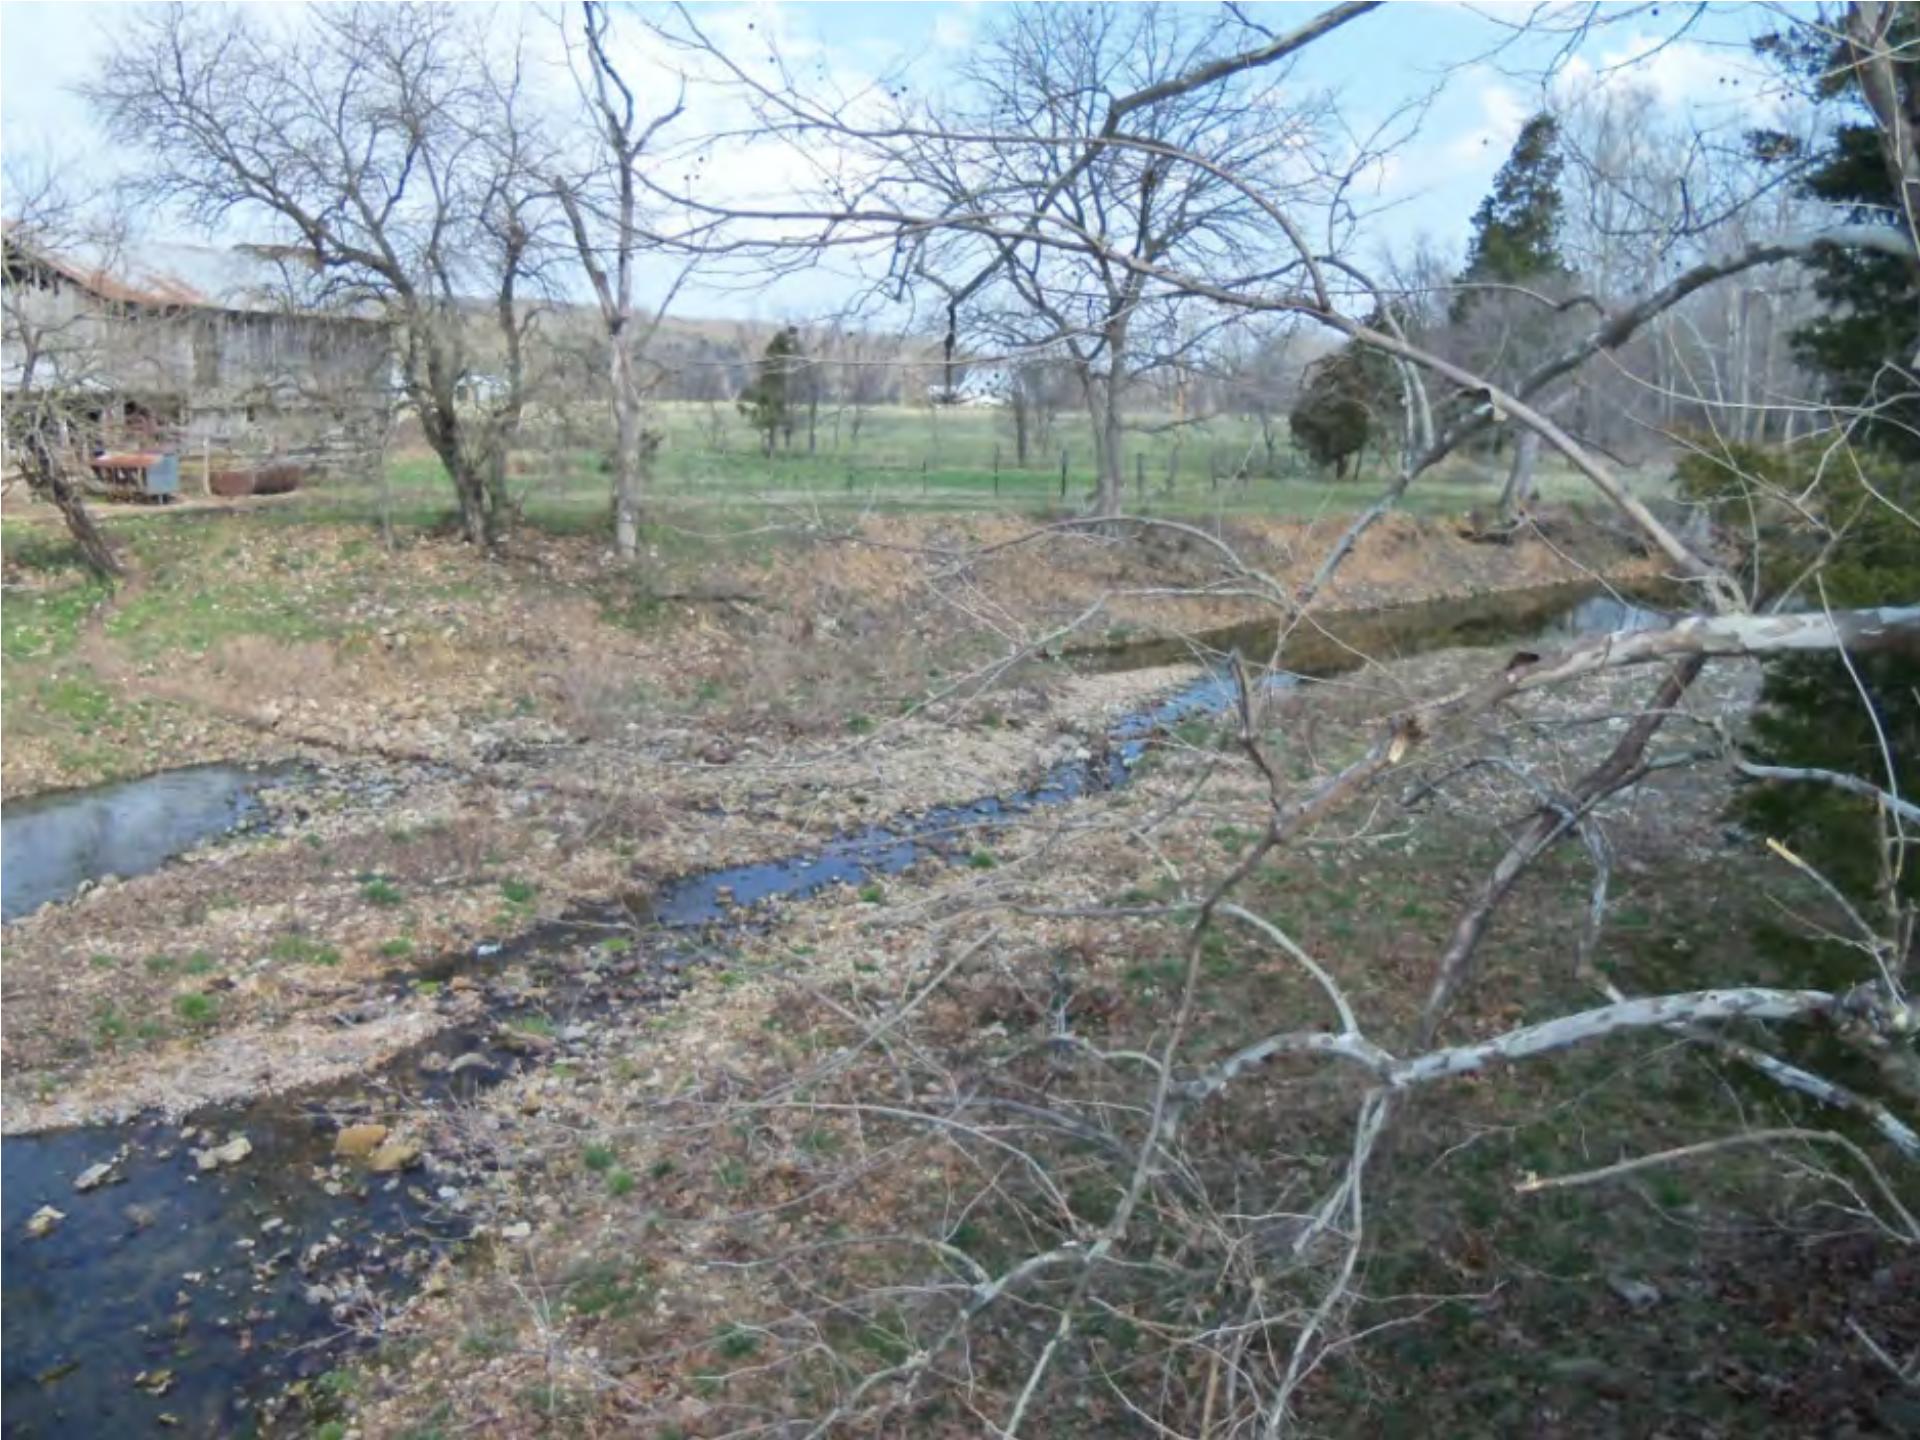
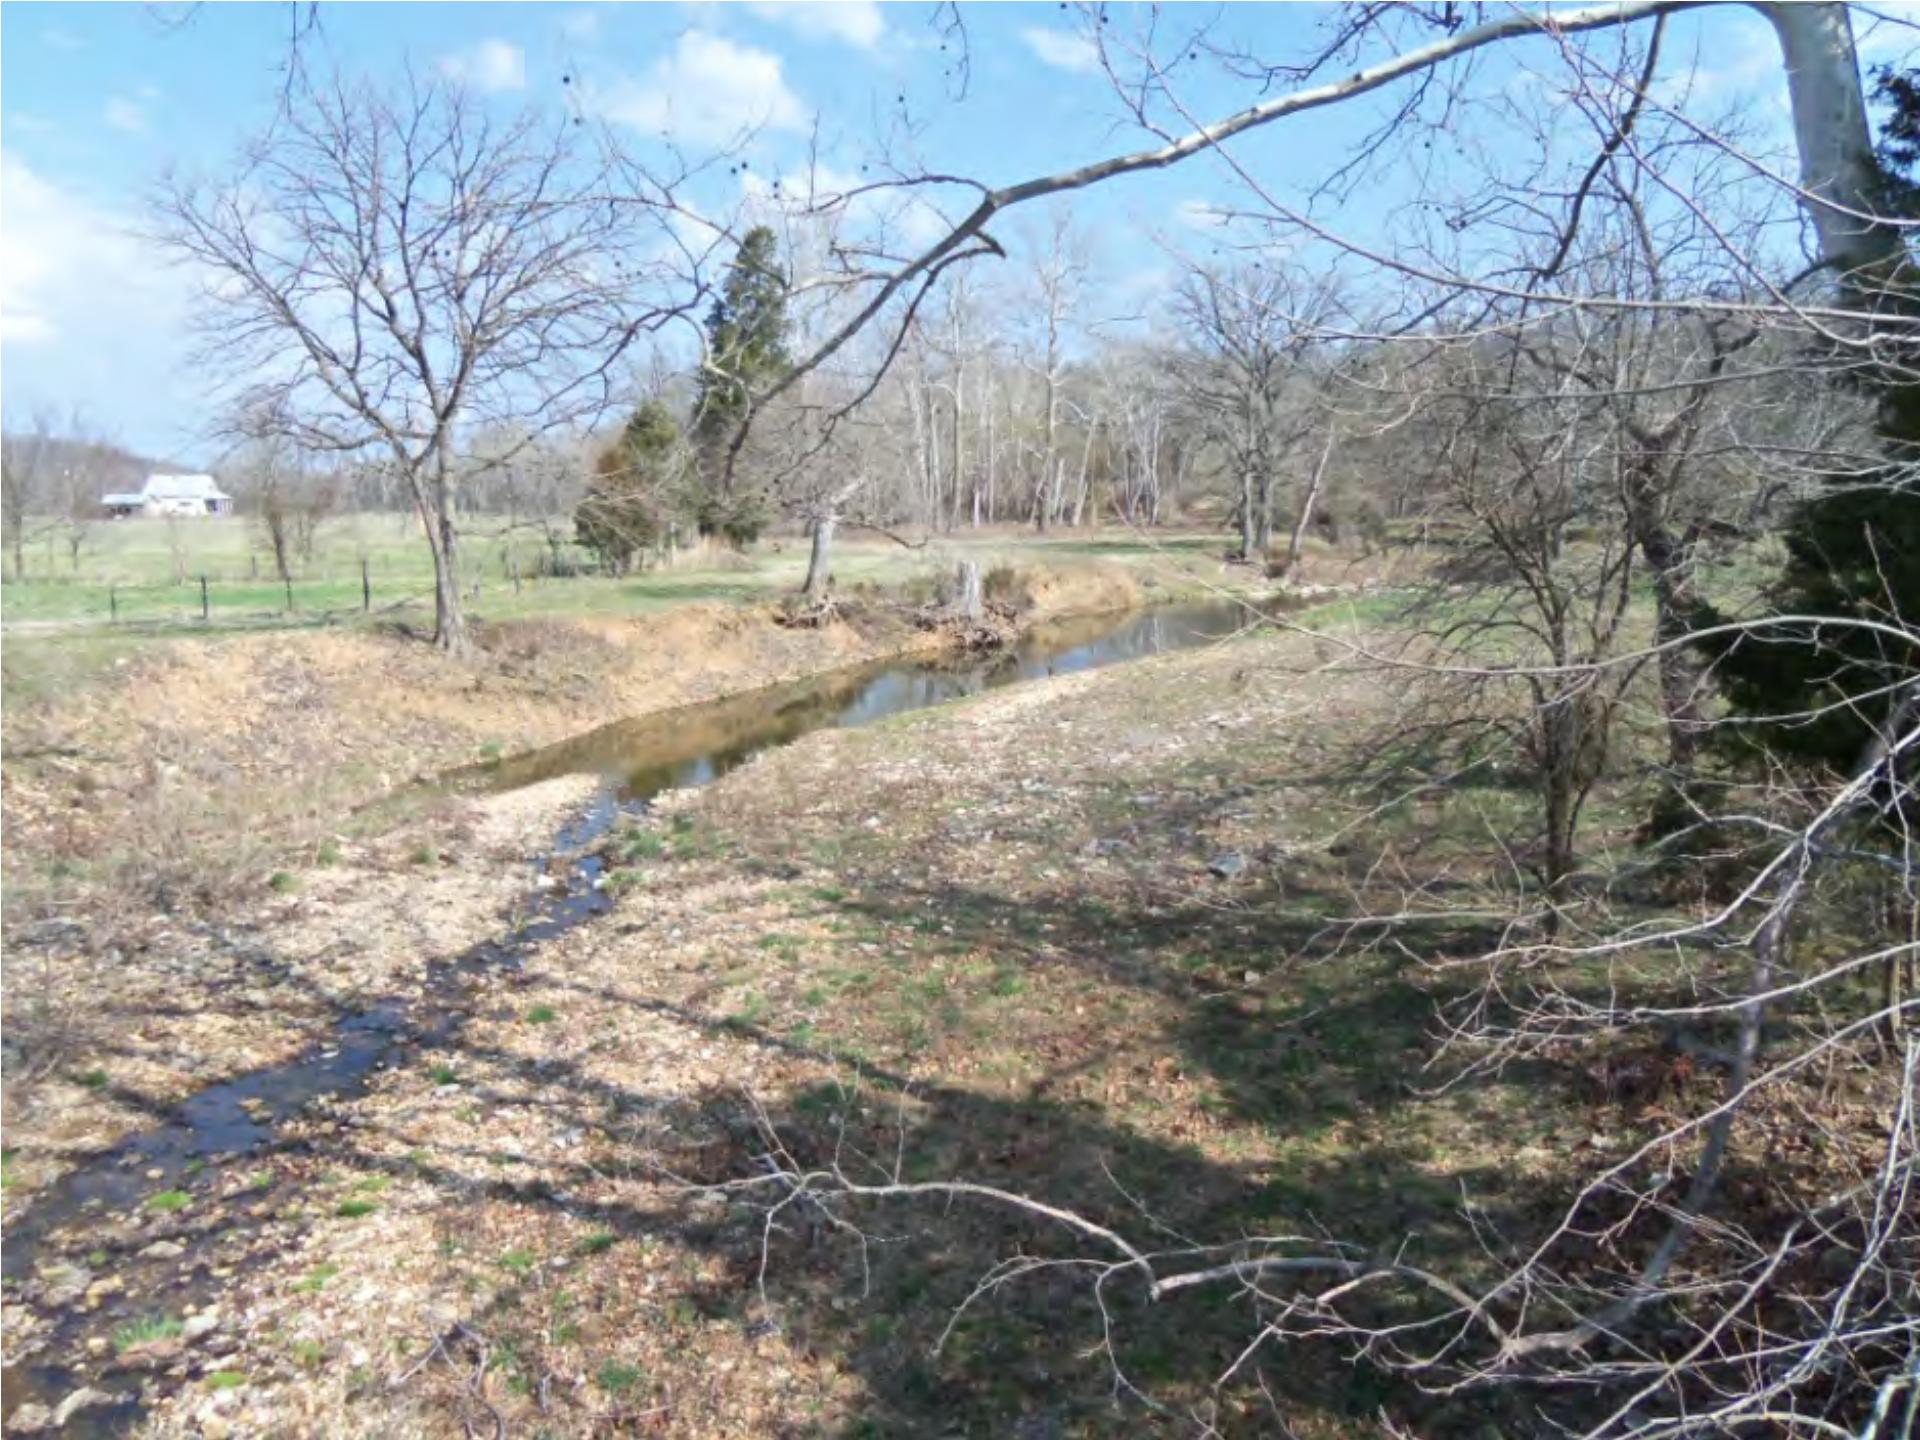
**Pre-Construction Bank Conditions
Looking Downstream –
312' in 1st portion of project**

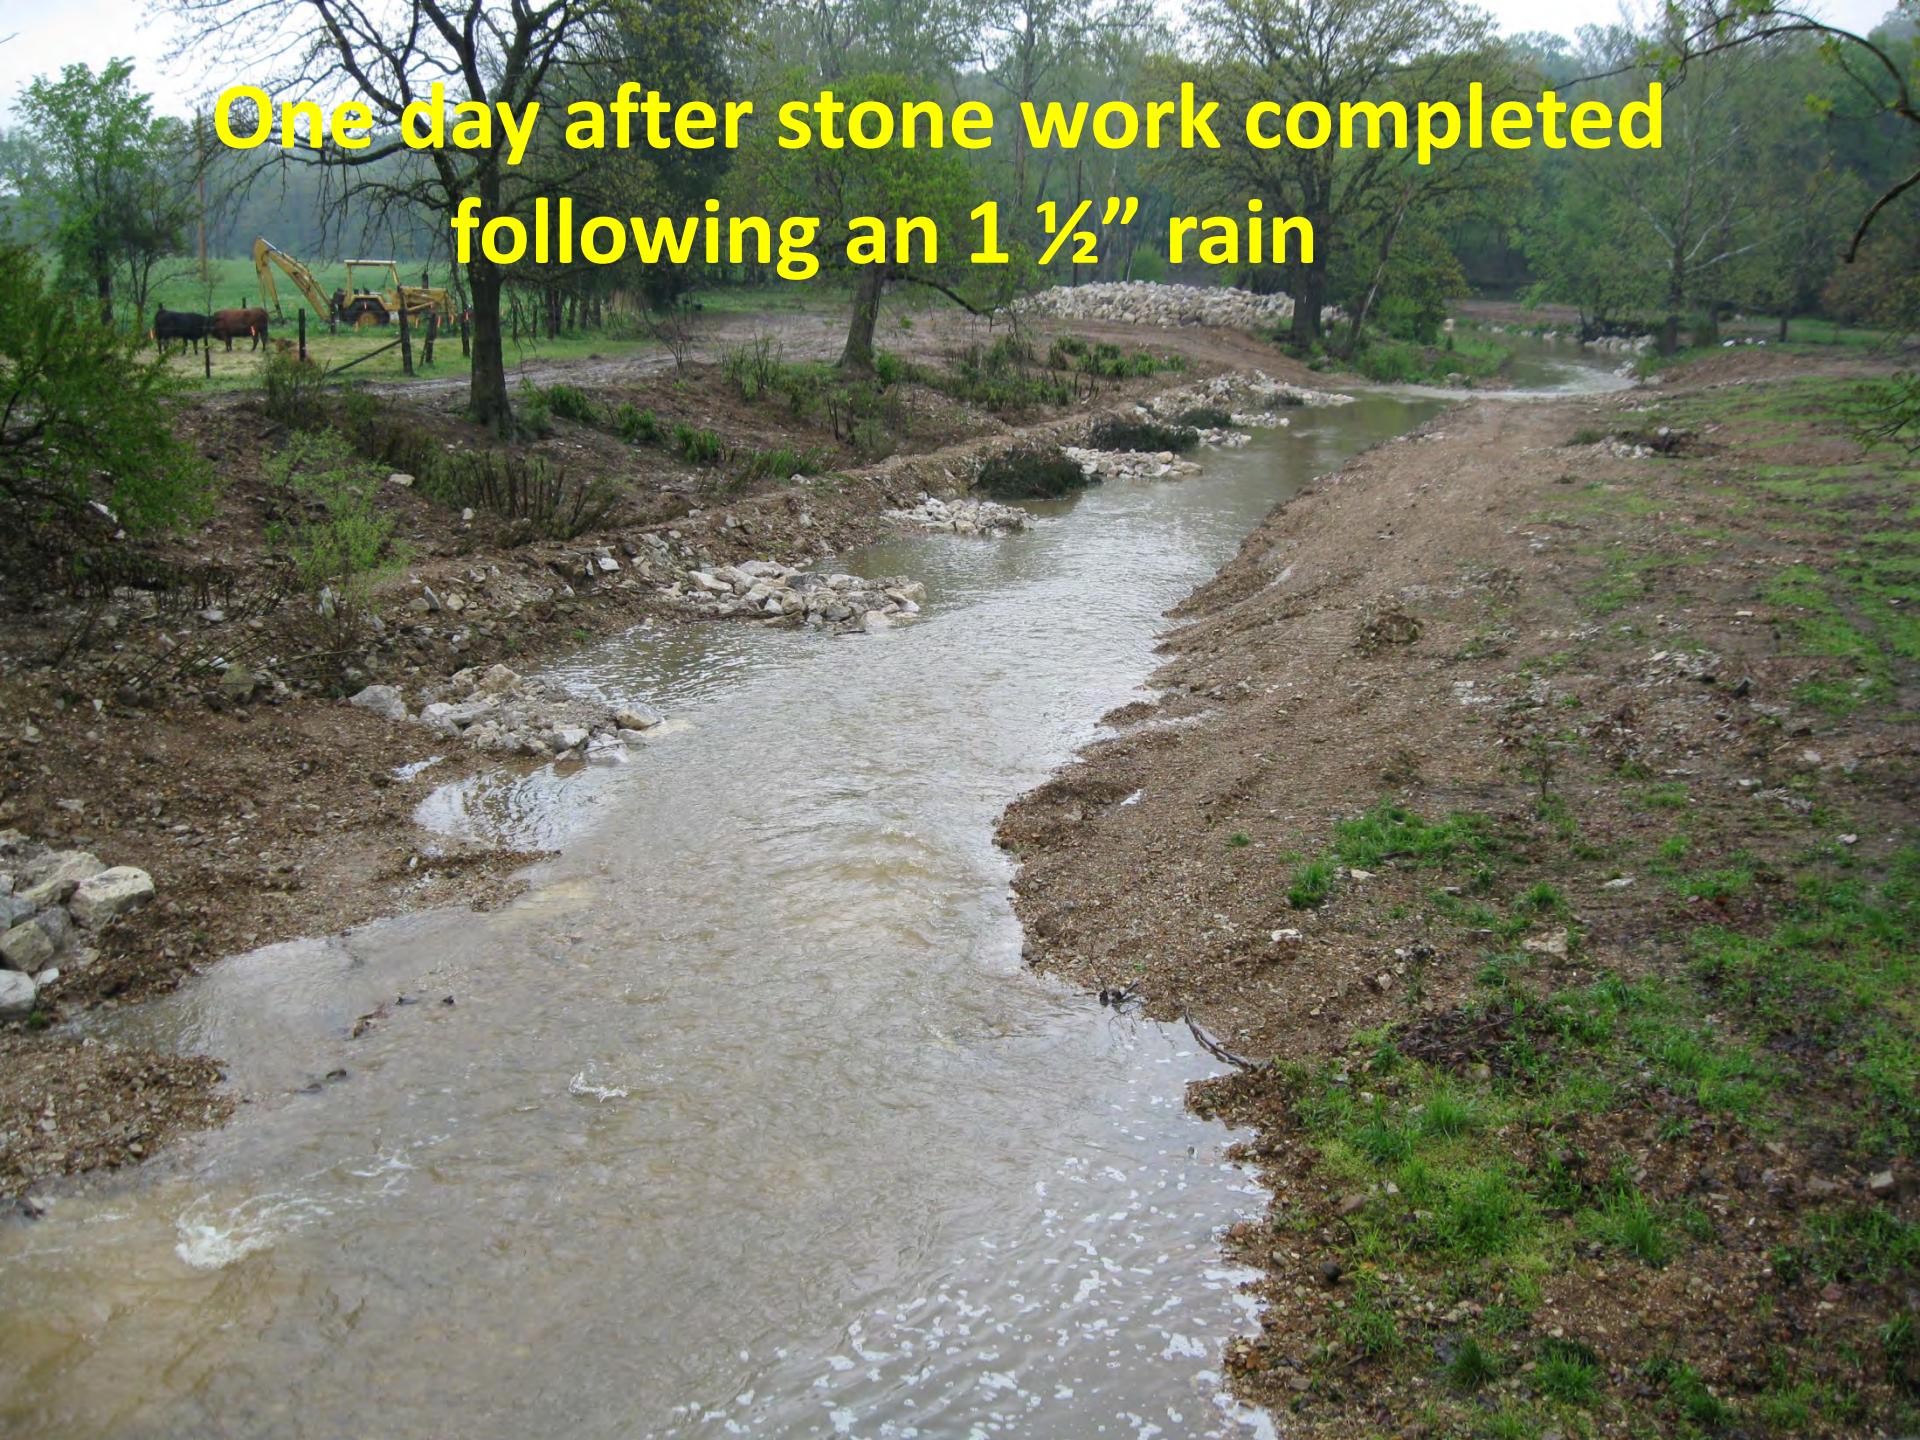
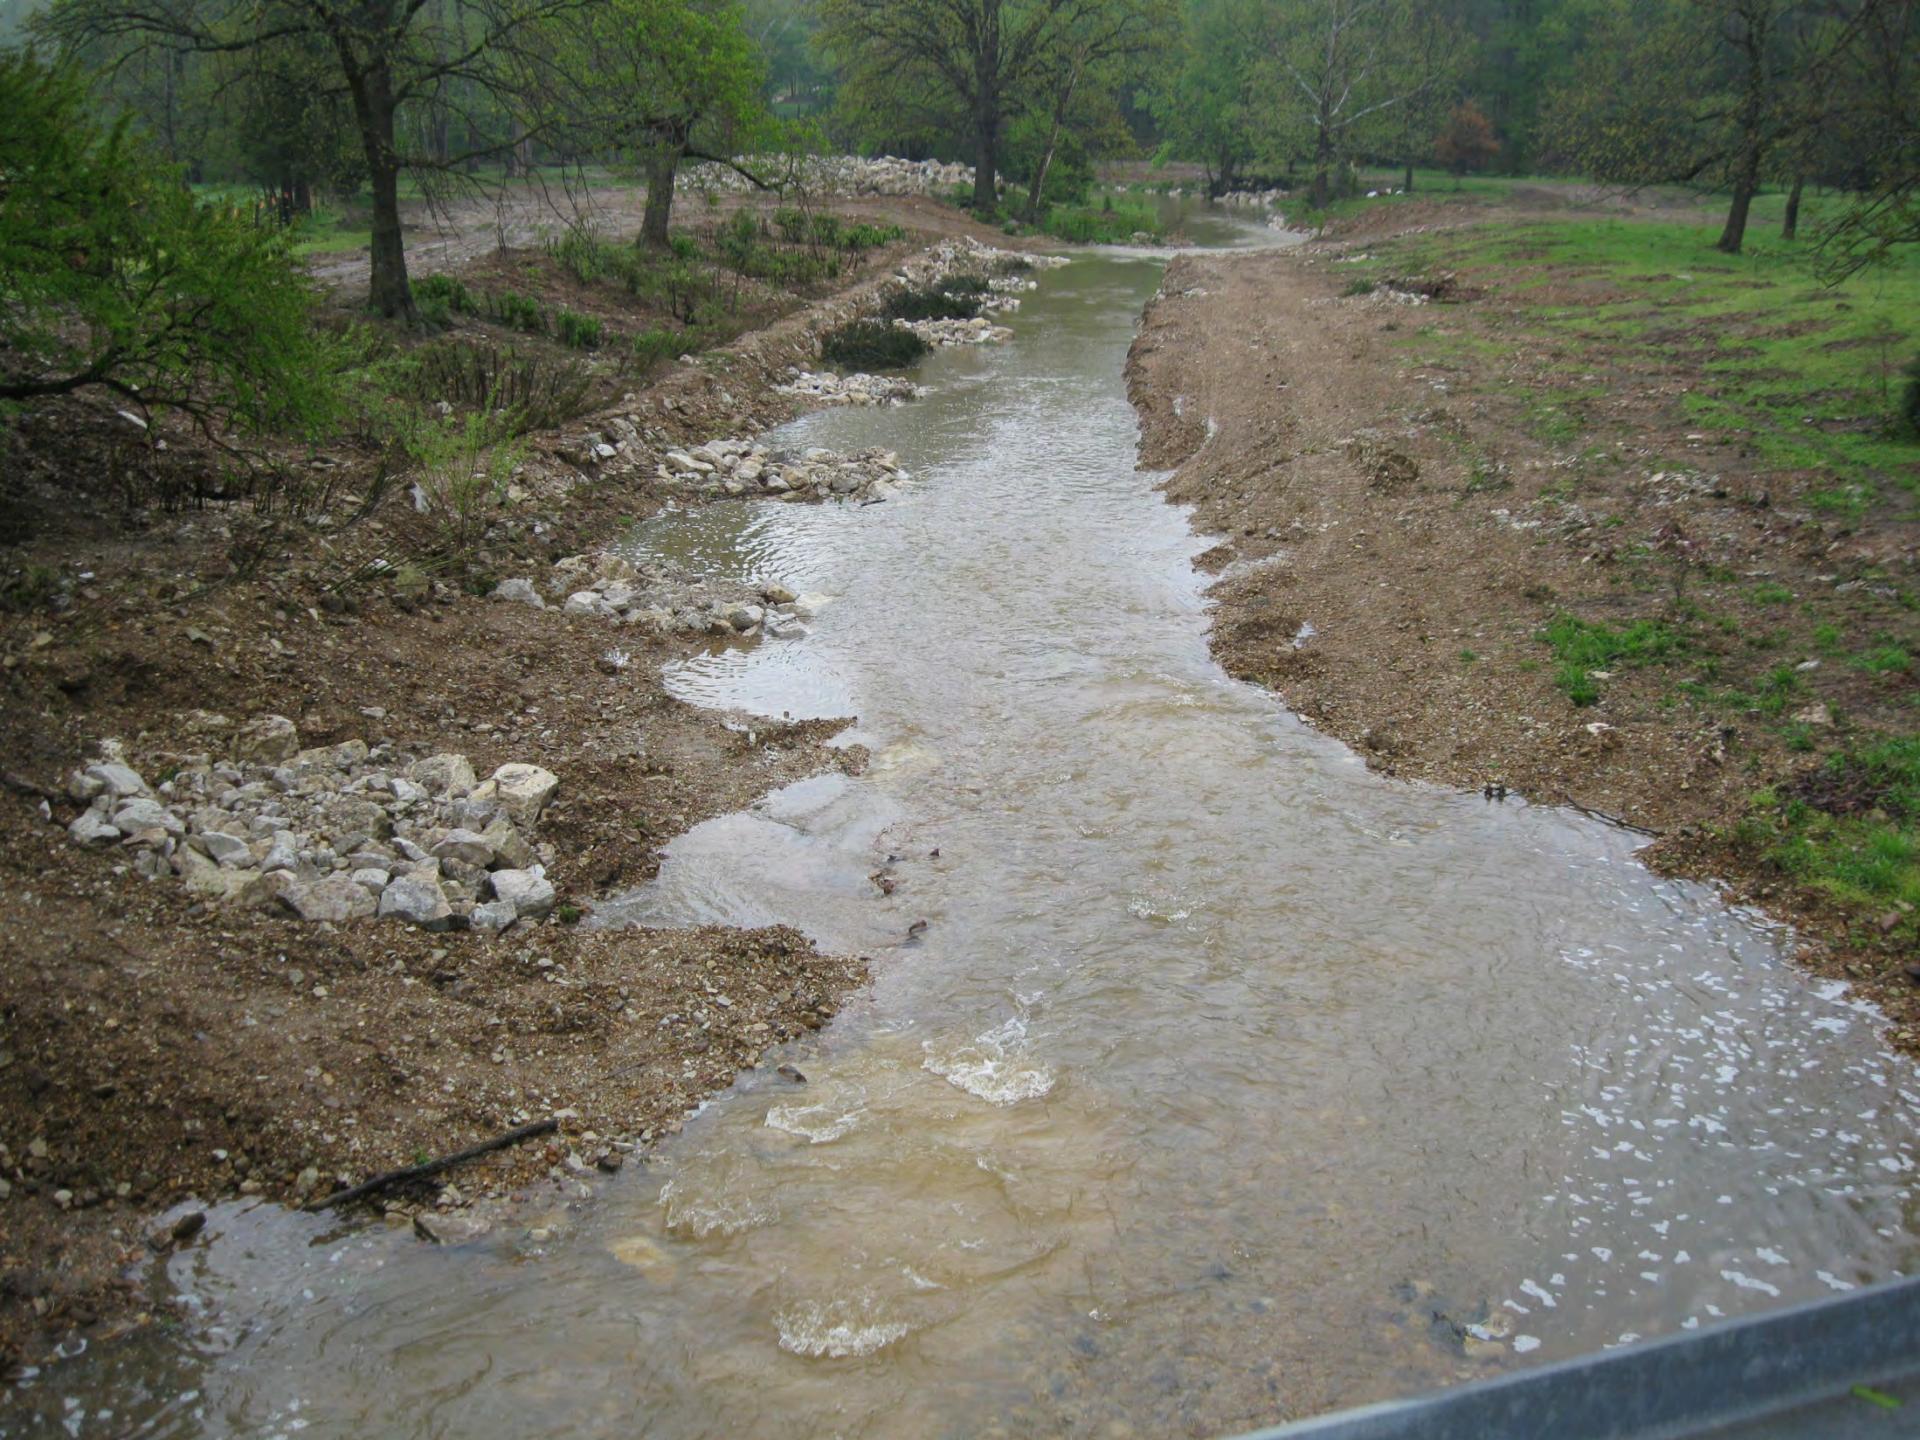
**One day after stone work completed
following an 1 ½" rain**

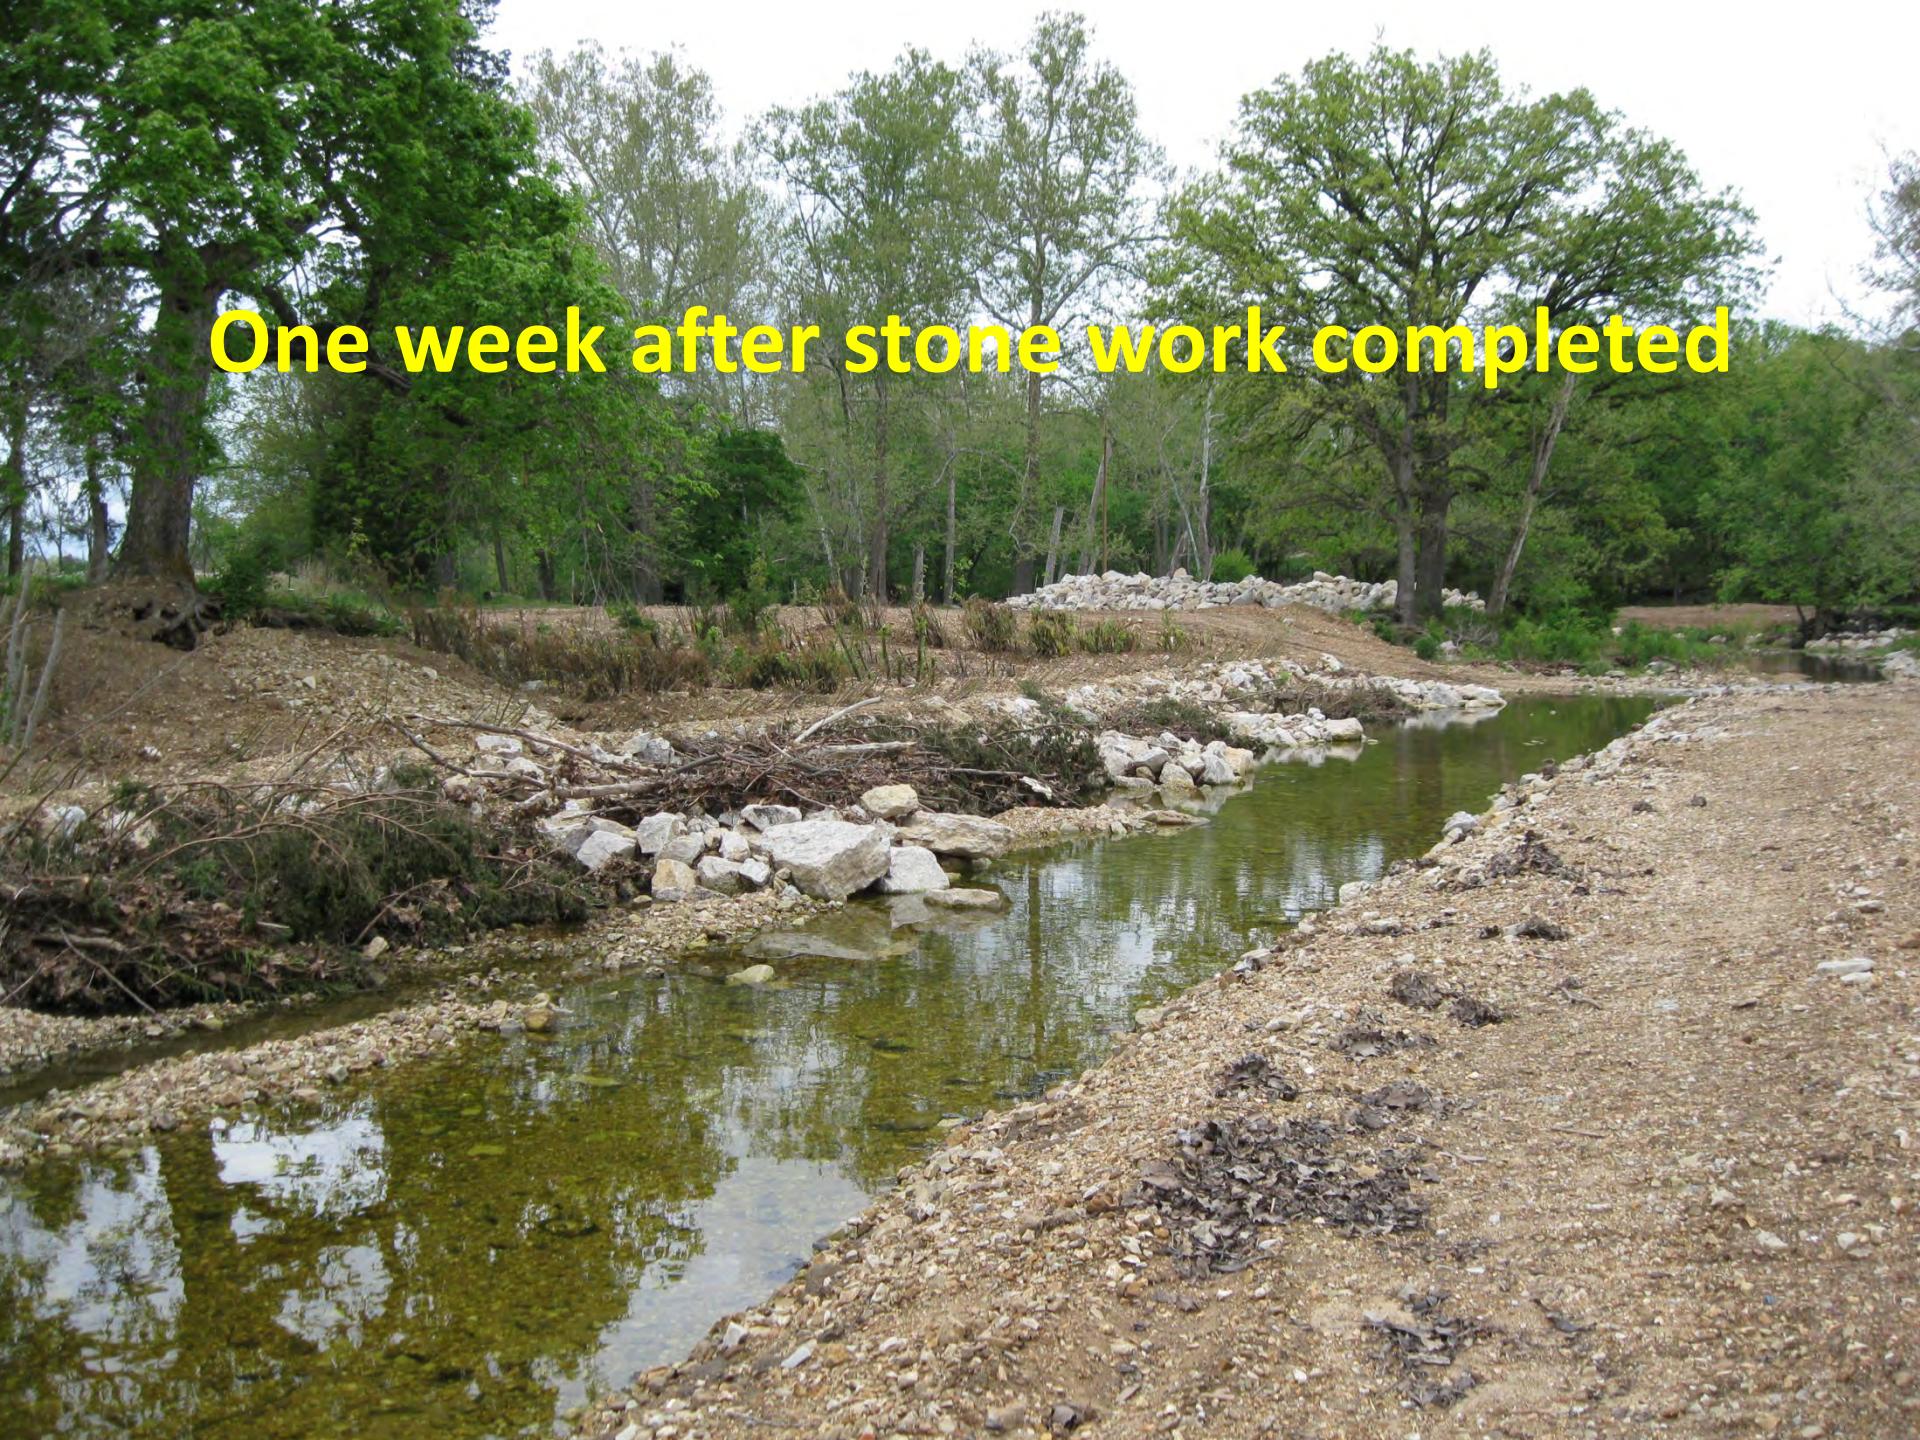
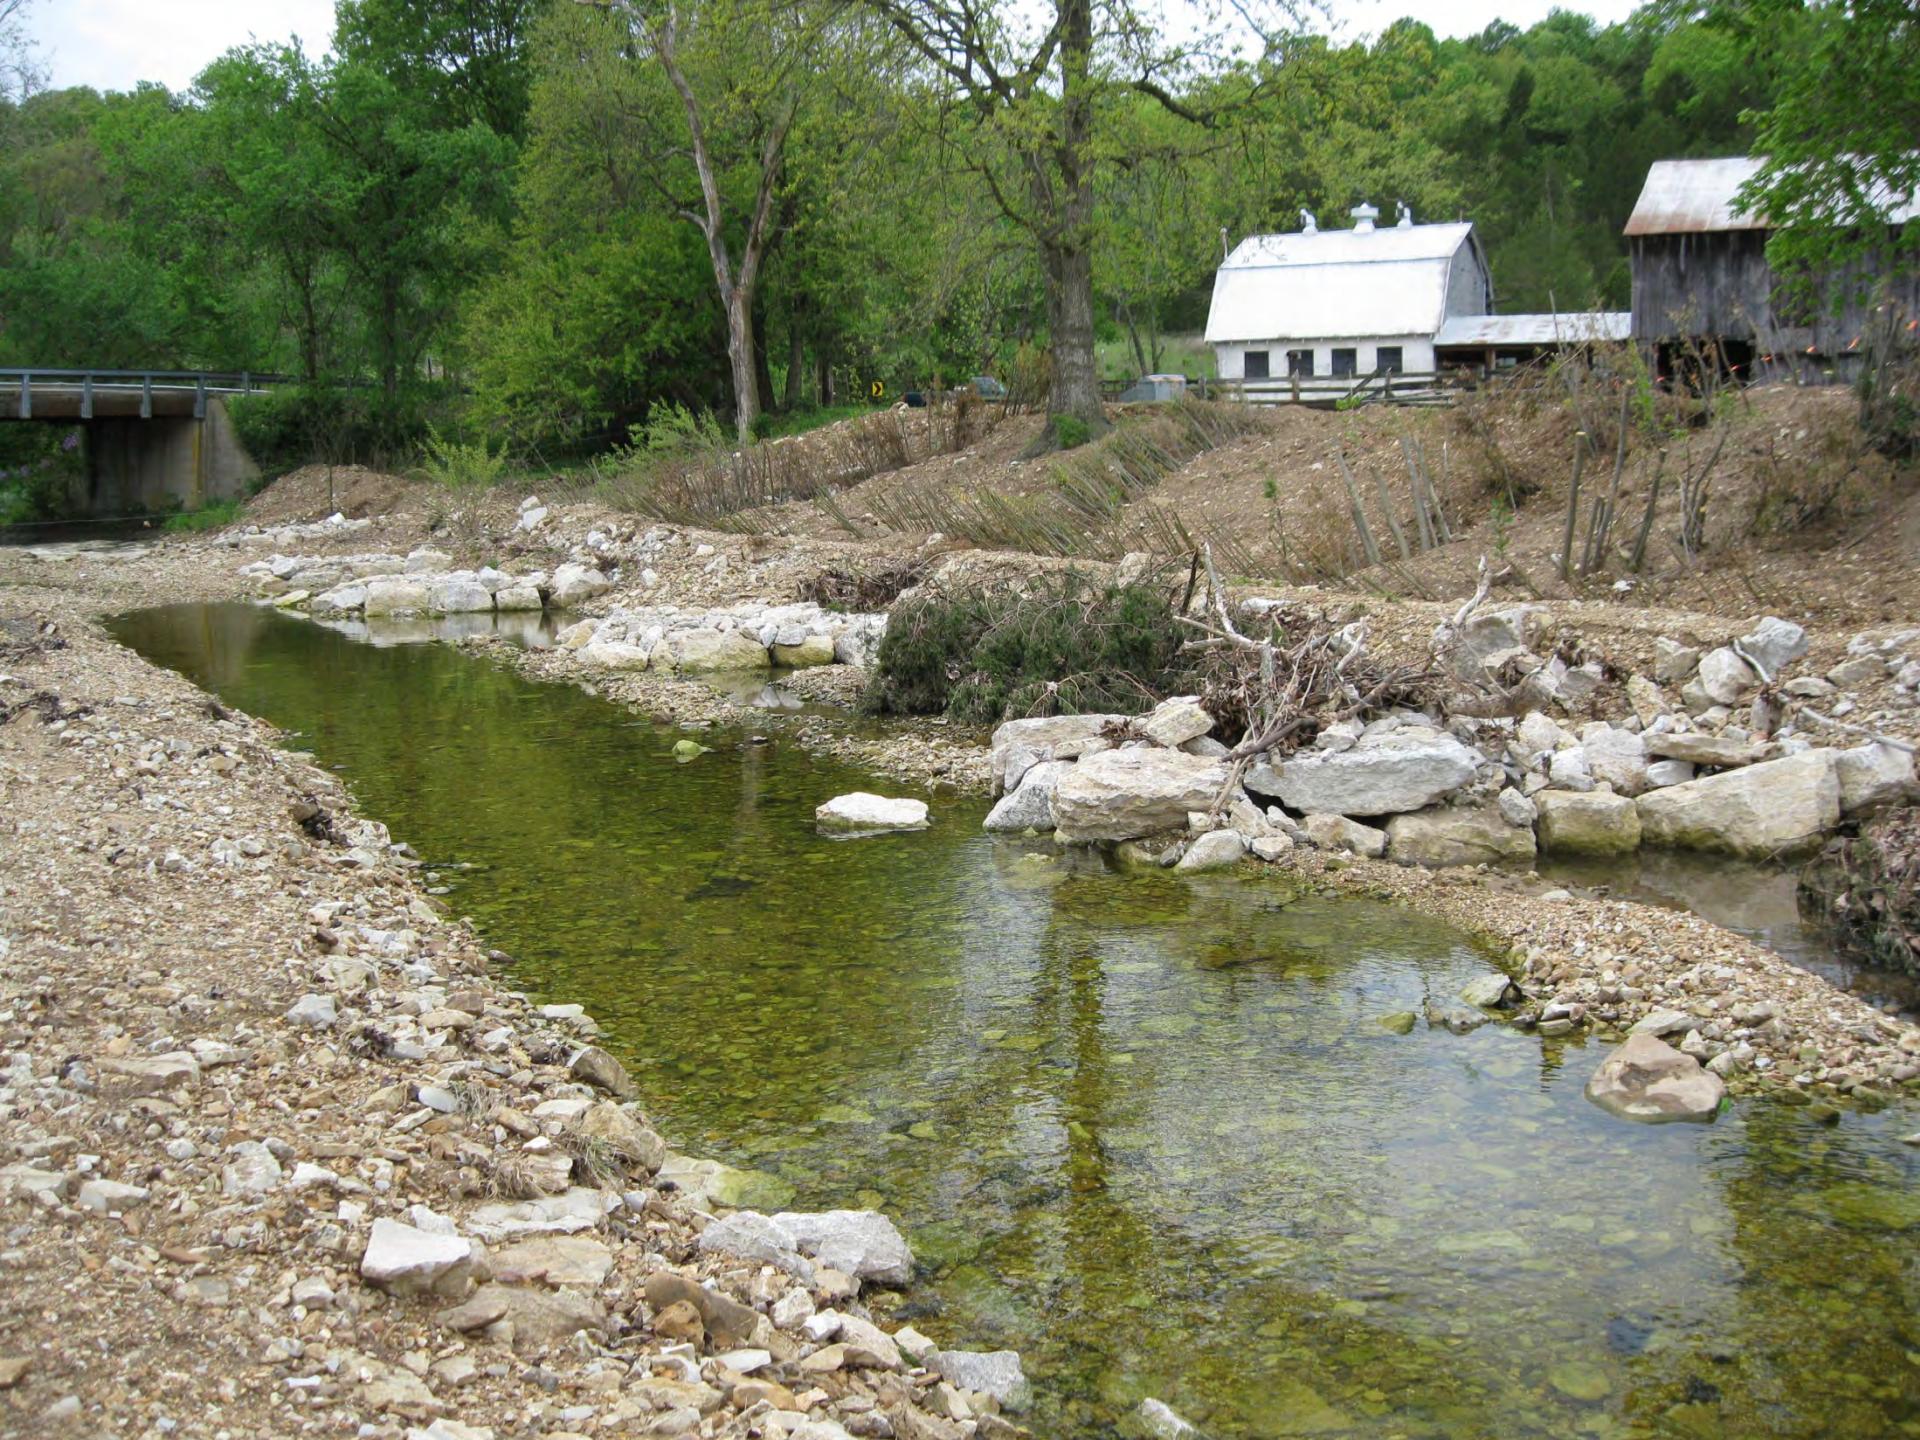
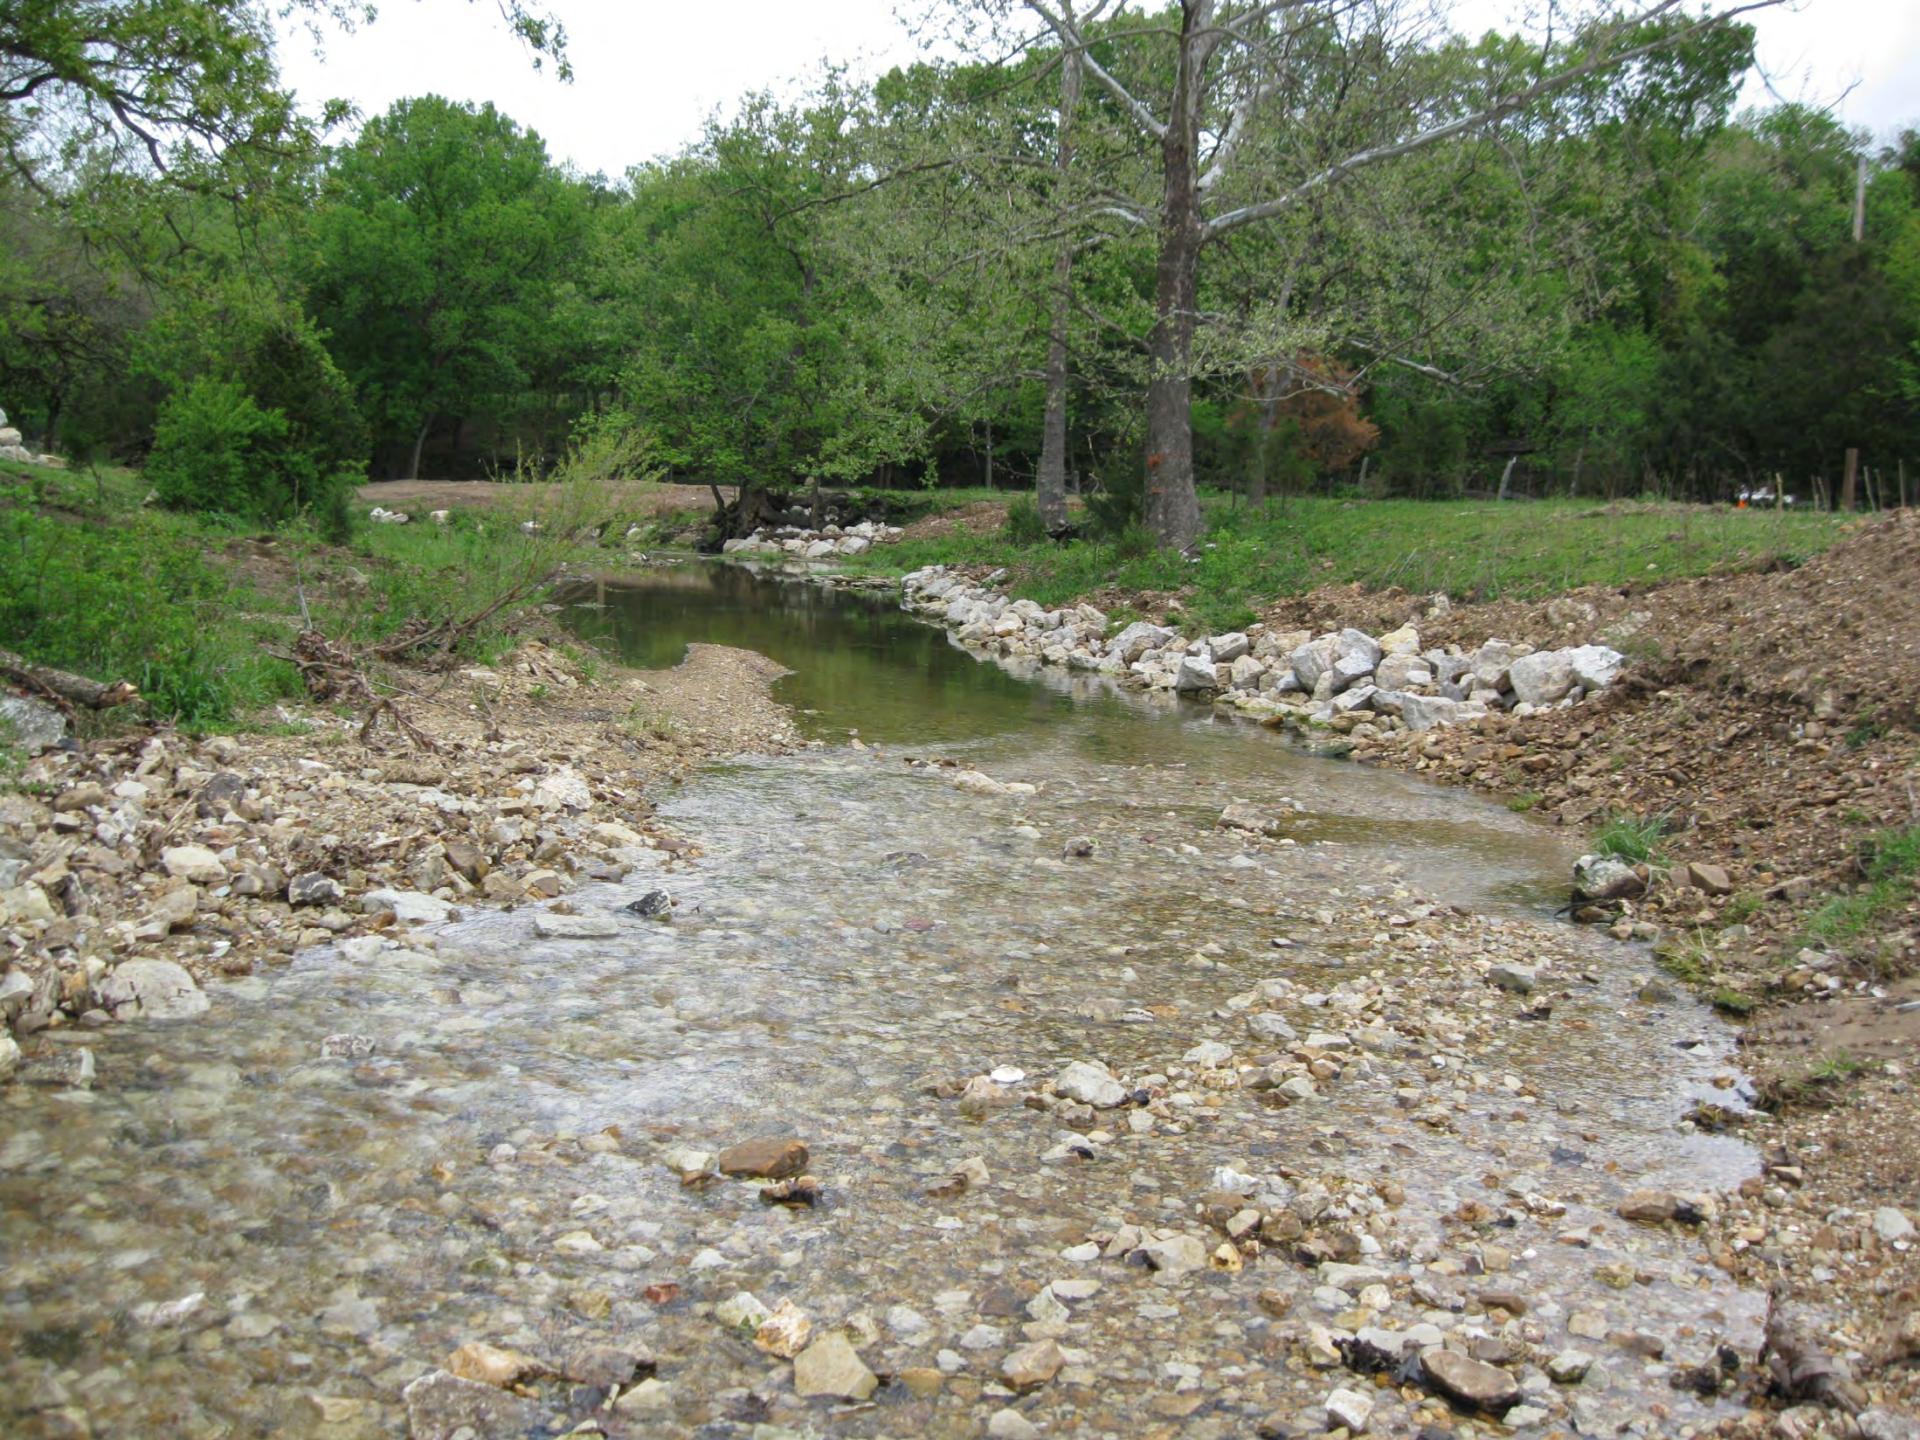
One week after stone work completed
