**Belews Creek Innovative
Streambank Stabilization
Seminar and Hands-On
Construction Workshop
April 10 – 12, 2012
(A Dave Derrick USACE Project)**

**Bank stabilization project funded
through an EPA 319 Implementation
grant obtained by Belews Creek
Watershed Partnership-
a citizen based non-profit organization**

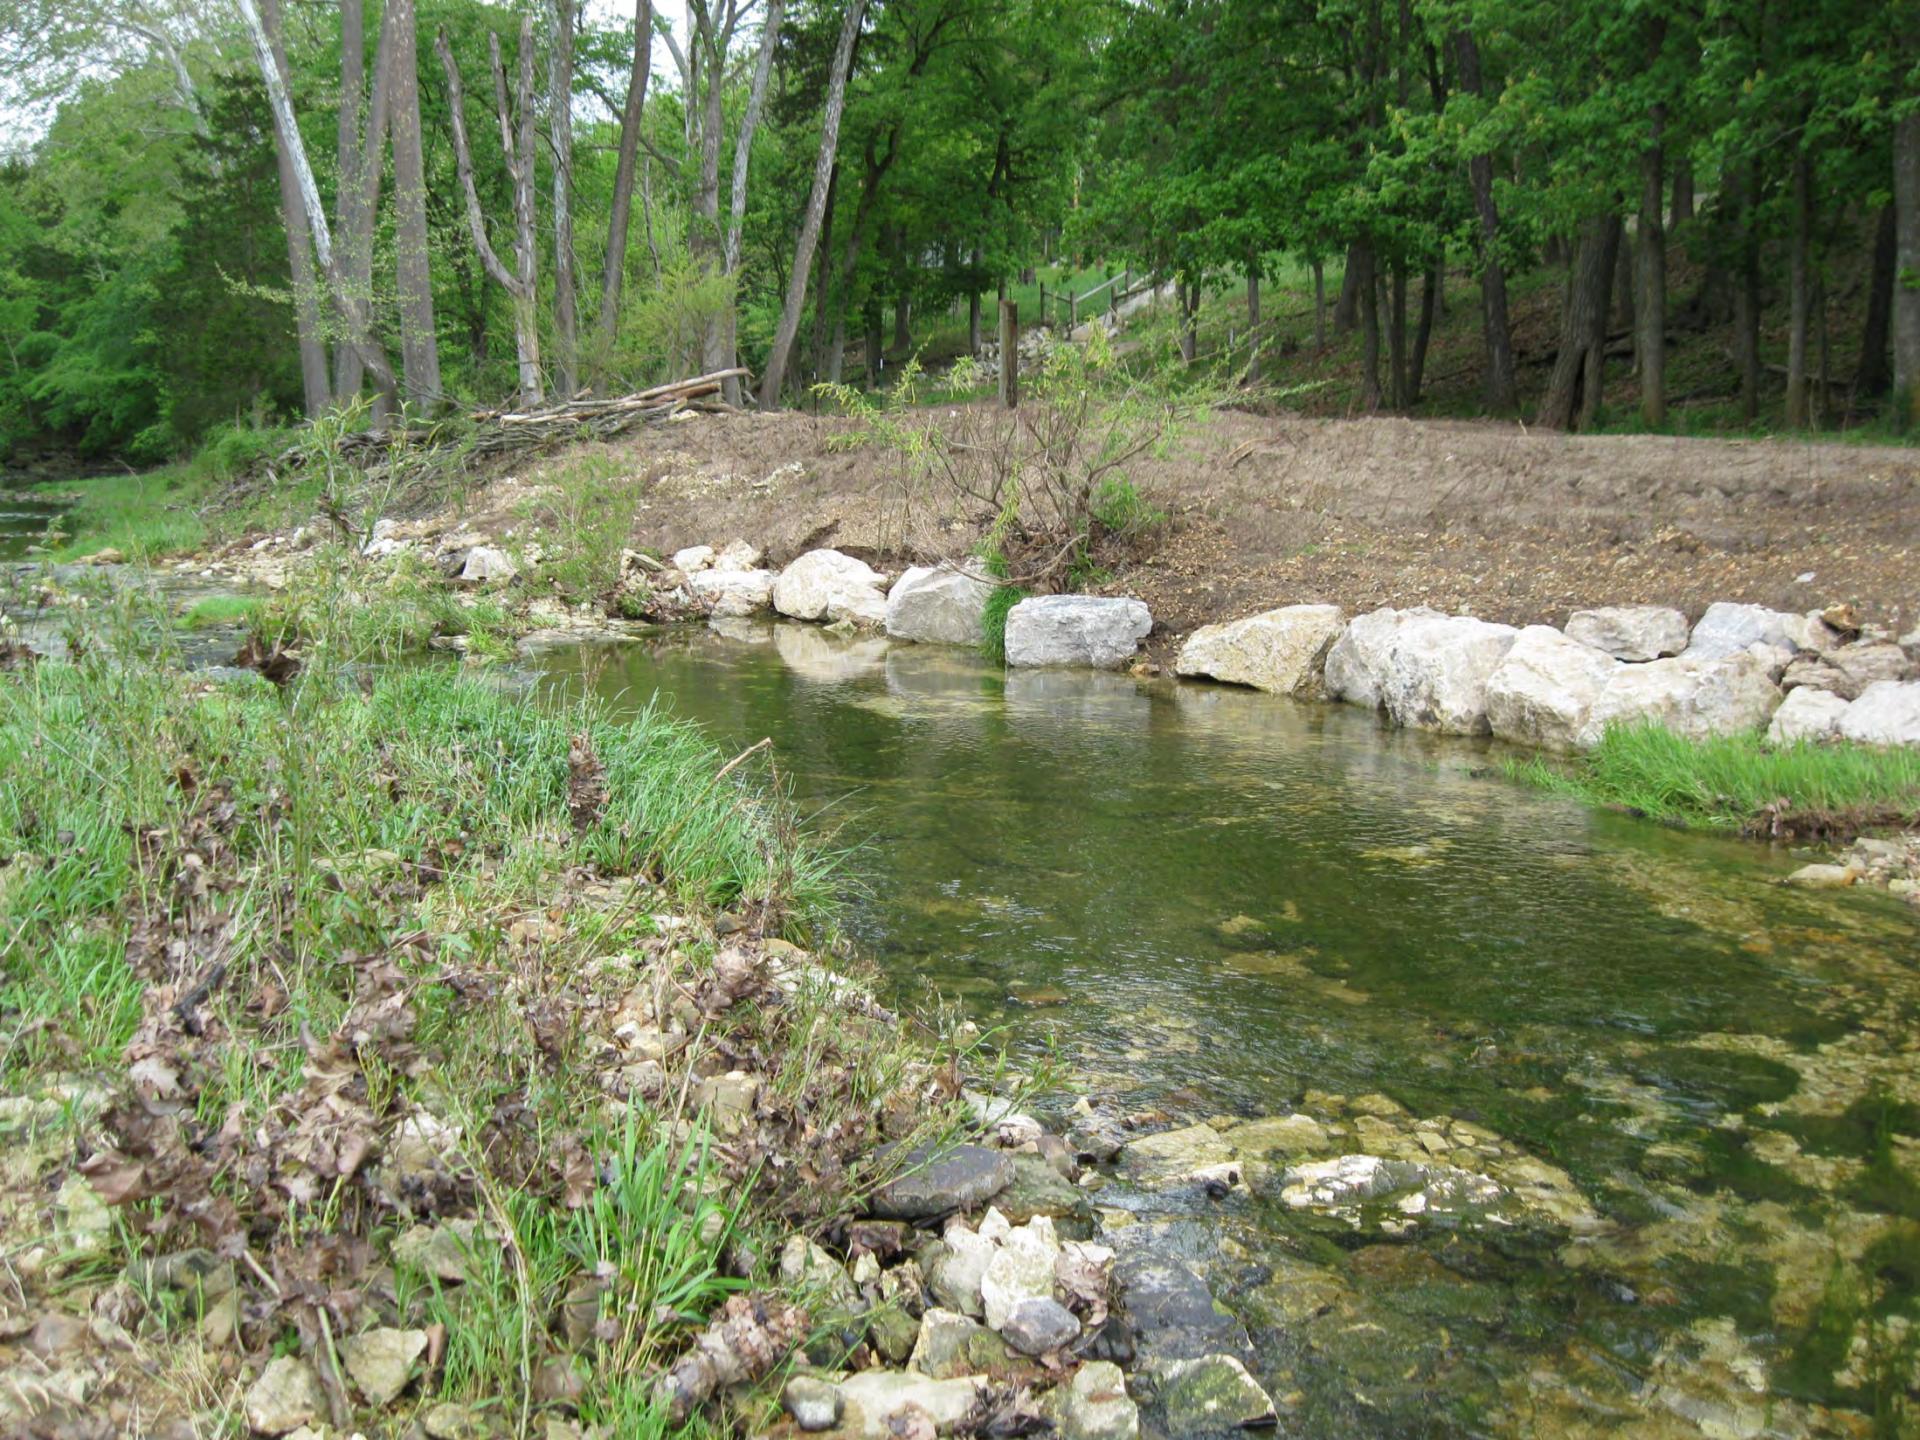
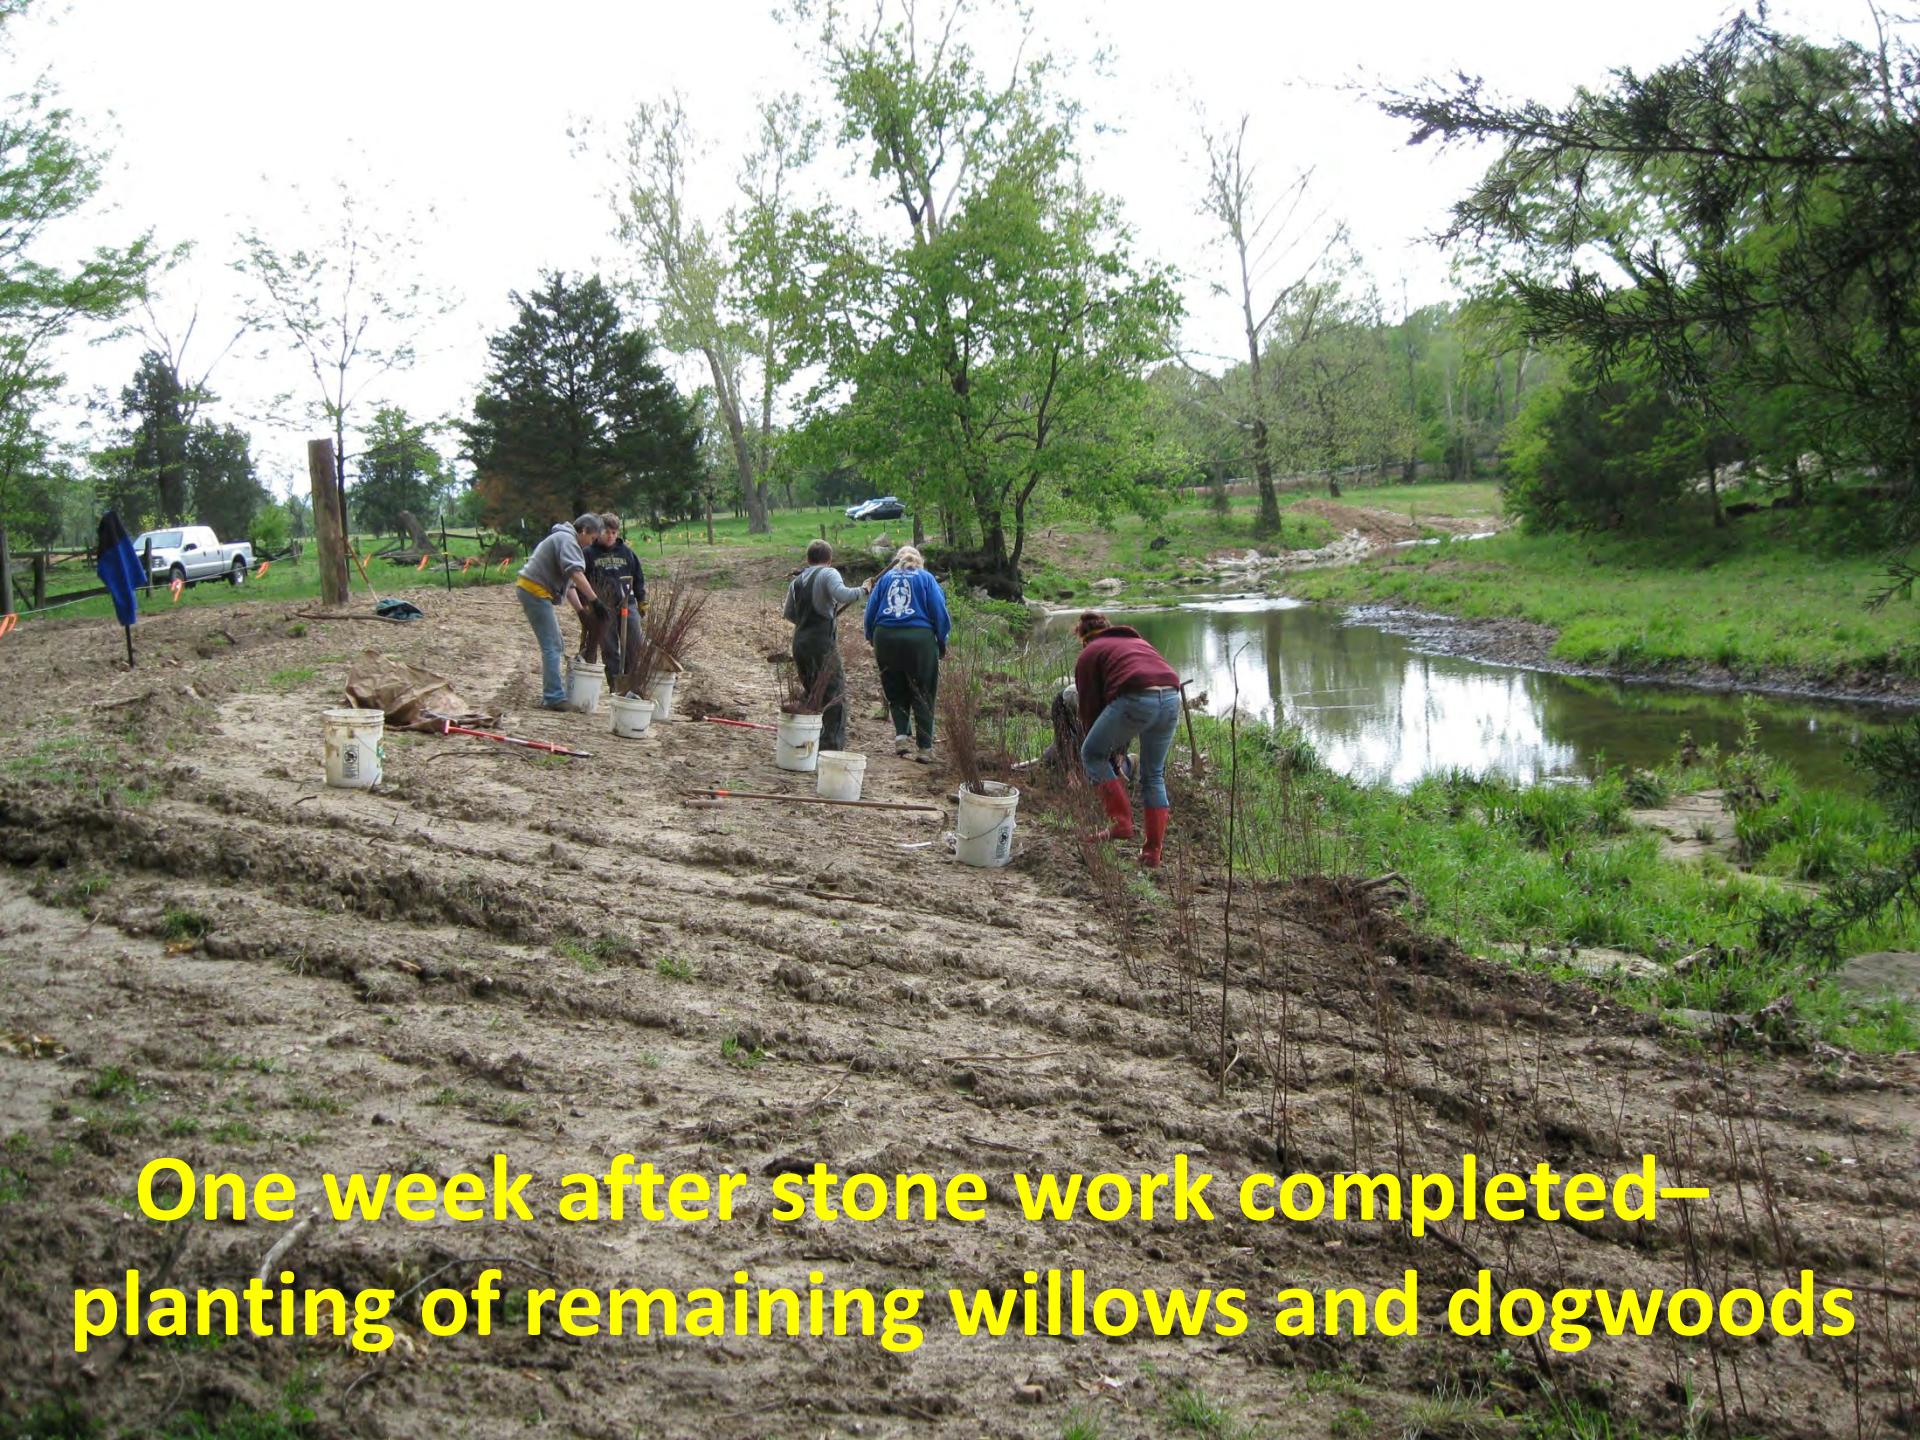
**One week after stone work completed—
planting of remaining willows and dogwoods**

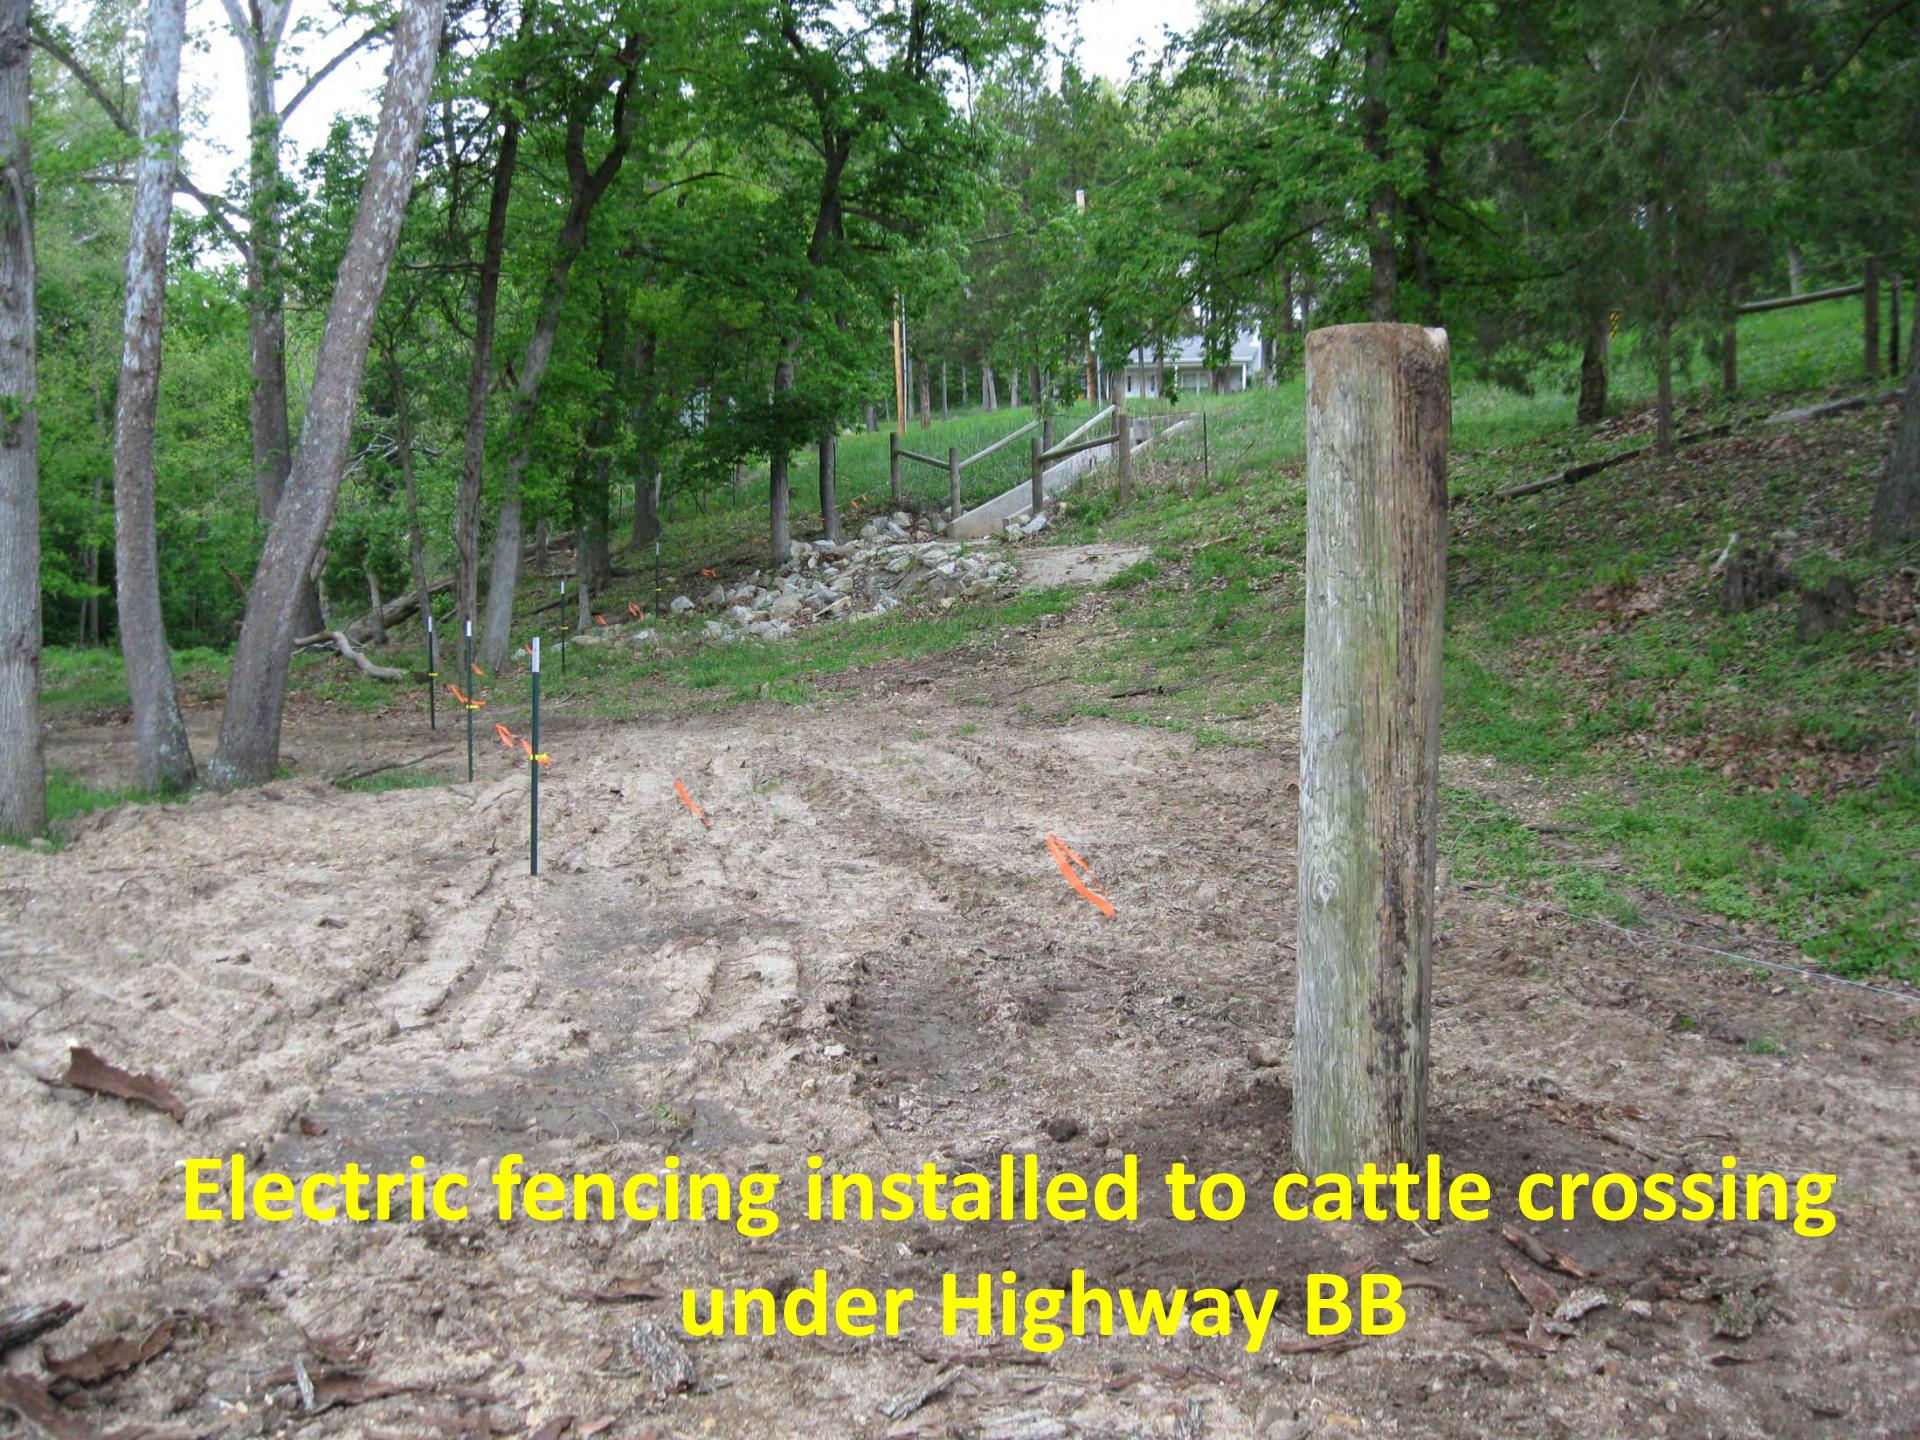
Electric fencing installed to cattle crossing
under Highway BB

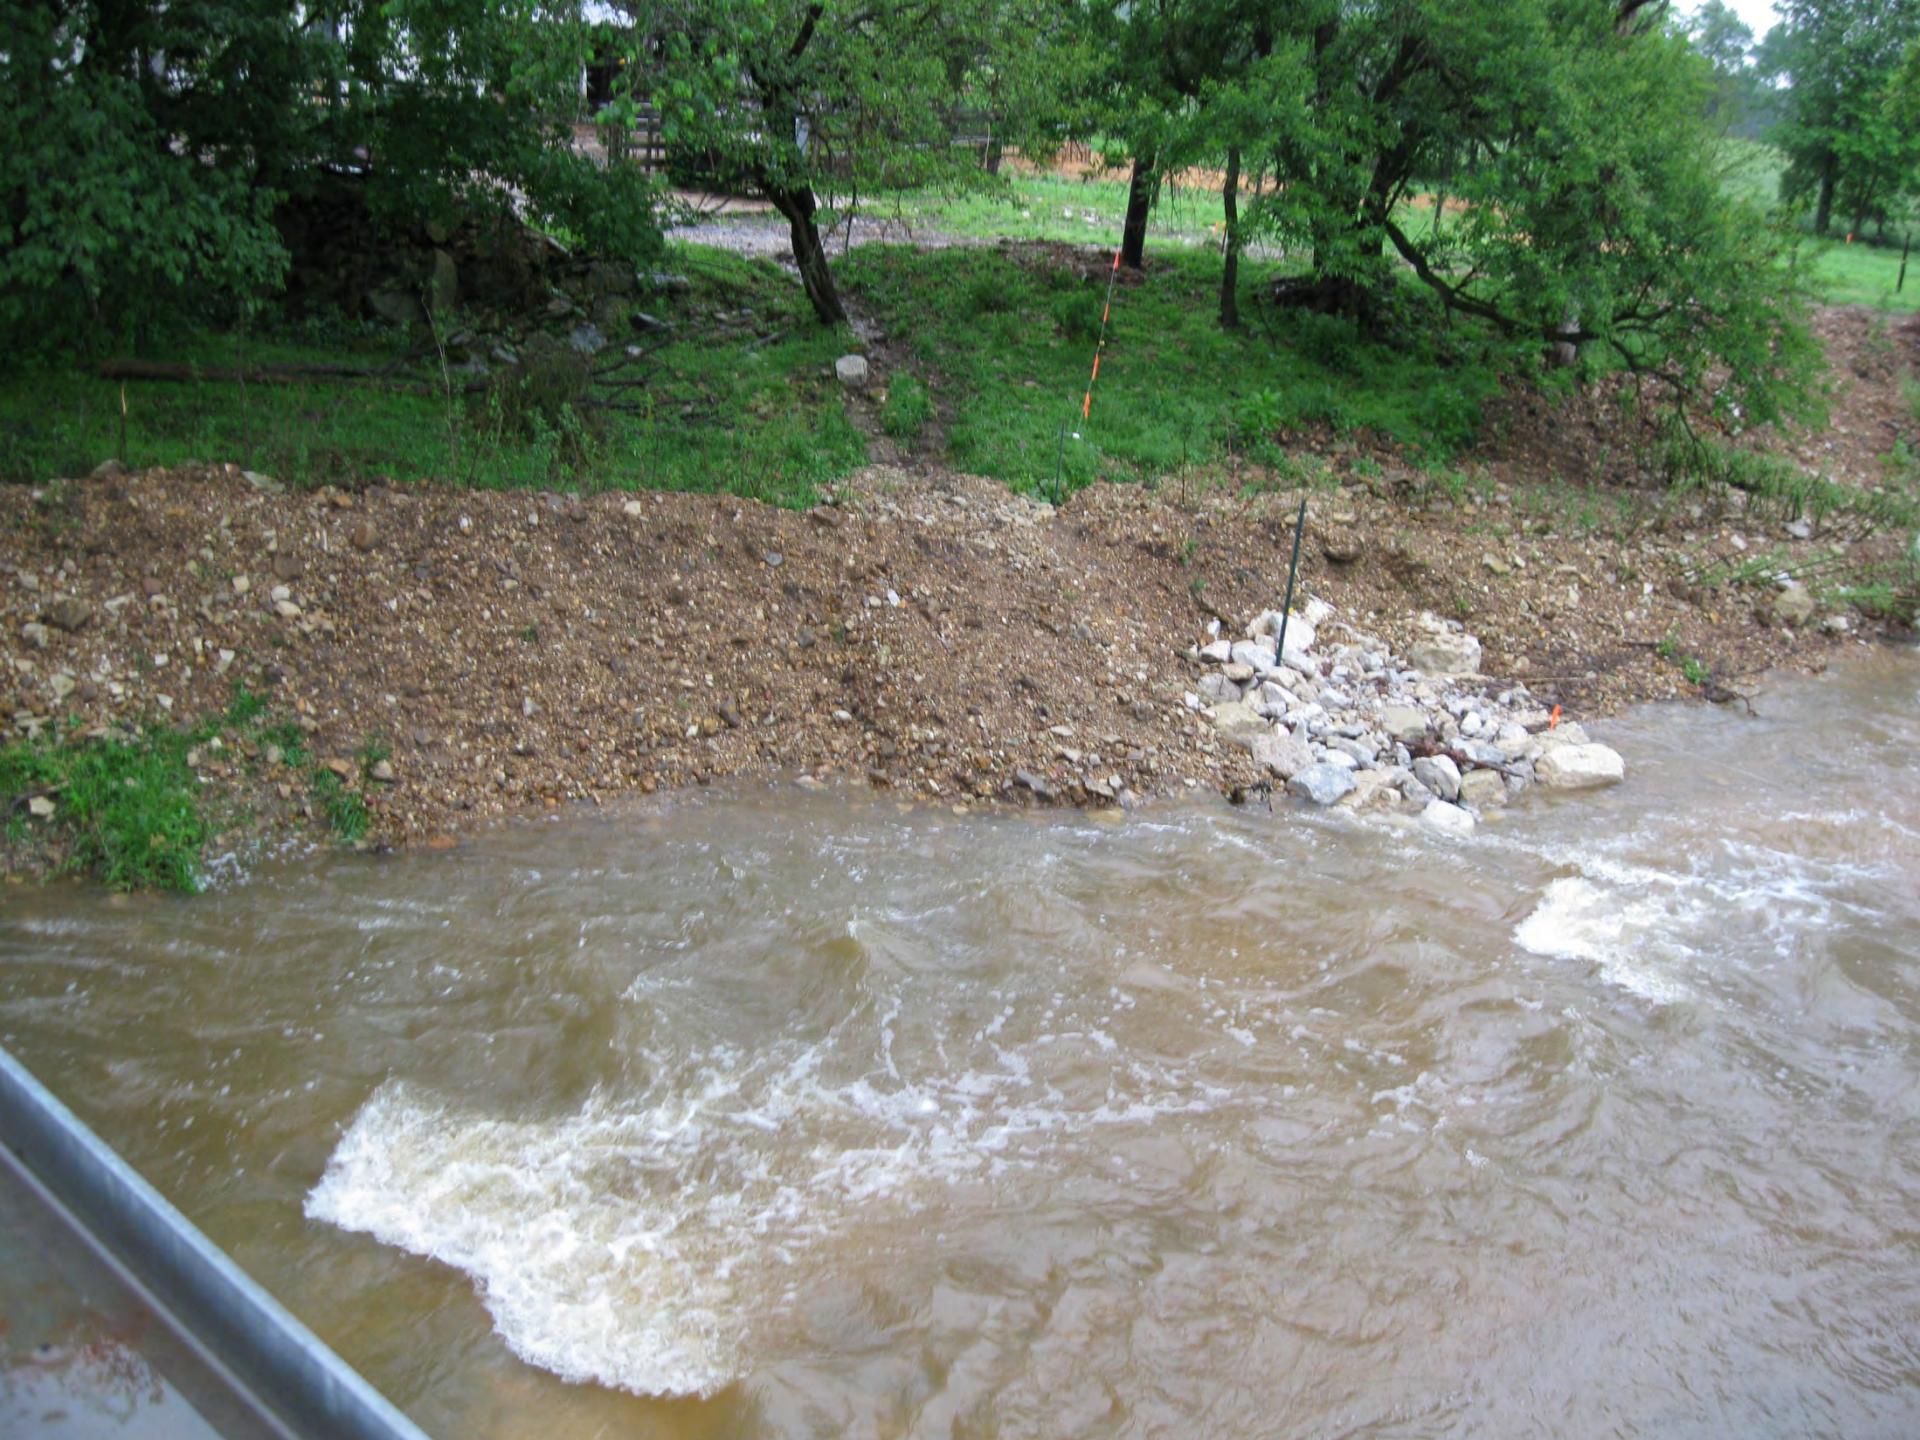
Four weeks after completion
following a 3" rain
